Embankment (Earth) Dam Inspection Form

Name of Dam: Lake Petit Dam

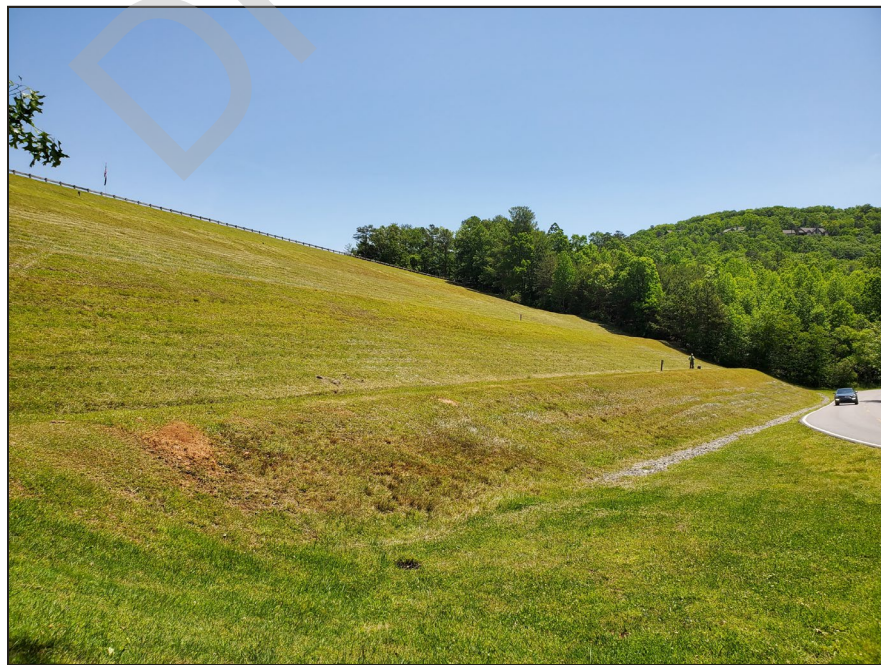
Photograph 2: Downstream Face, May 2020 – overview of downstream face in good condition

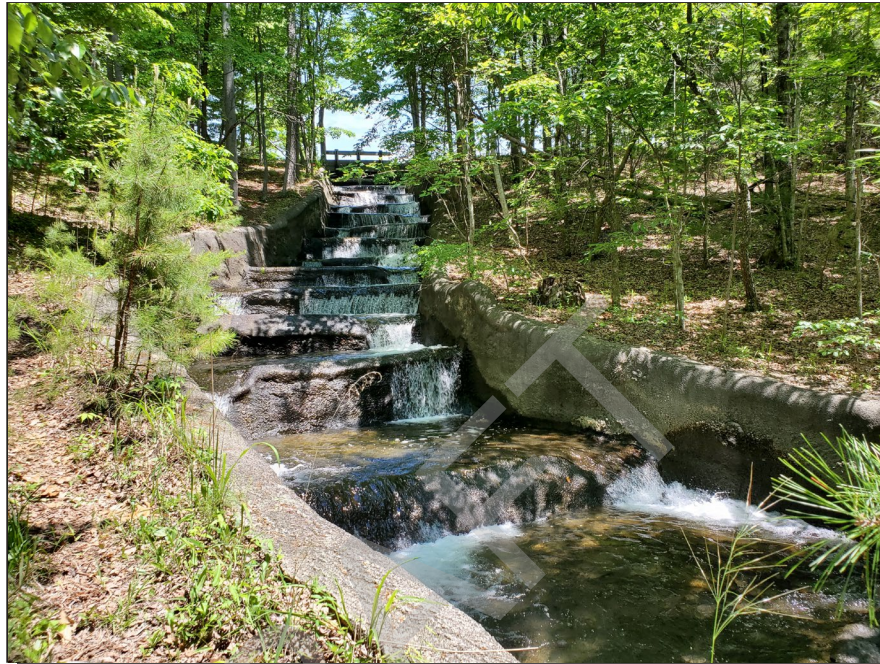
Photograph 3: Spillway, May 2020 – general view of stepped spillway with moderate flow, and tree limbs and debris noted during inspection.

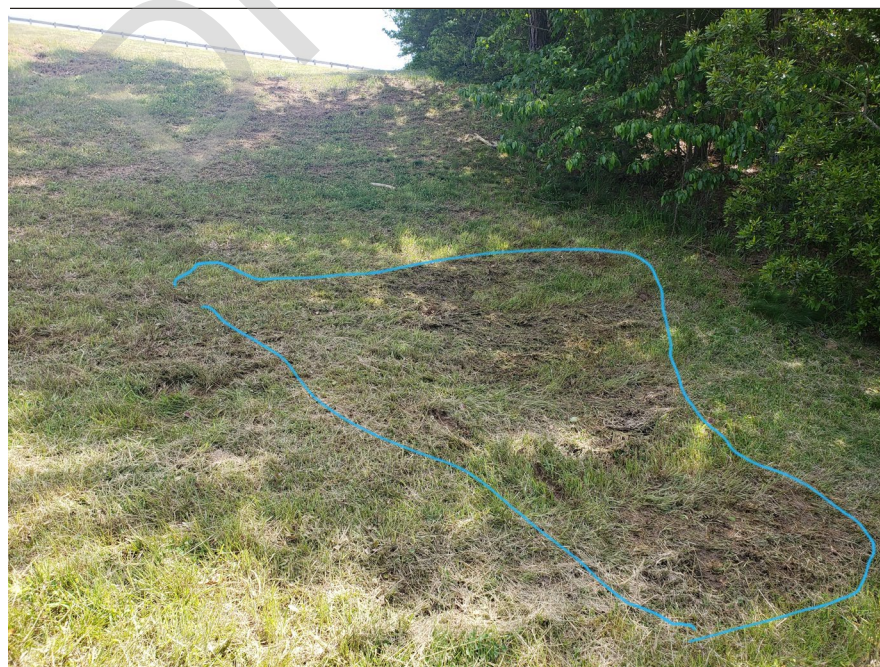
Photograph 4: Left Abutment, May 2020 – wet spot observed on the left side of the abutment (from approximately STA 1+95 to 2+05).

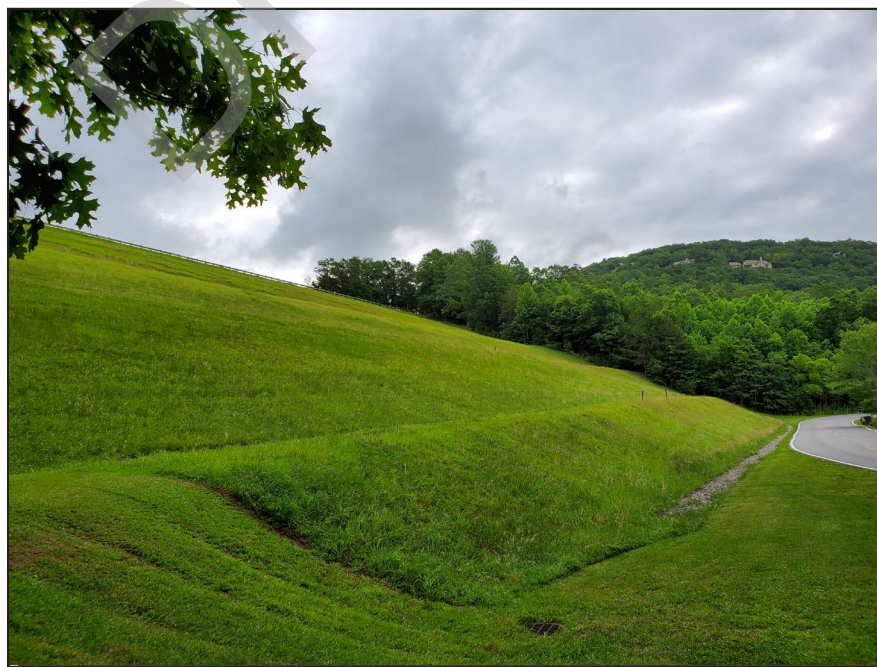
Photograph 2: Downstream Face, June 2020 – overview of downstream face in good condition

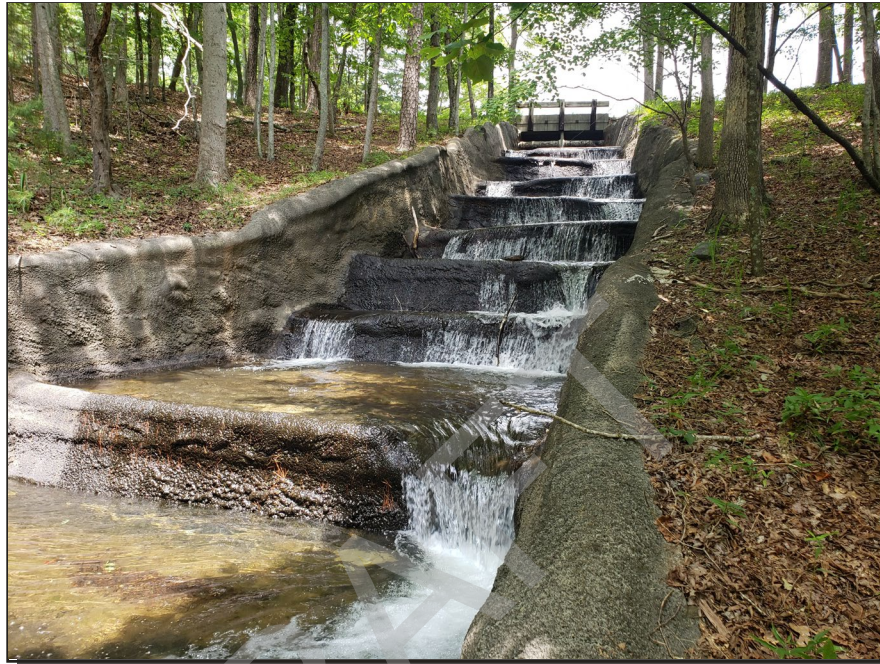
Photograph 3: Spillway, July 2020 – general view of stepped spillway with moderate flow, and tree limbs and debris noted during inspection.

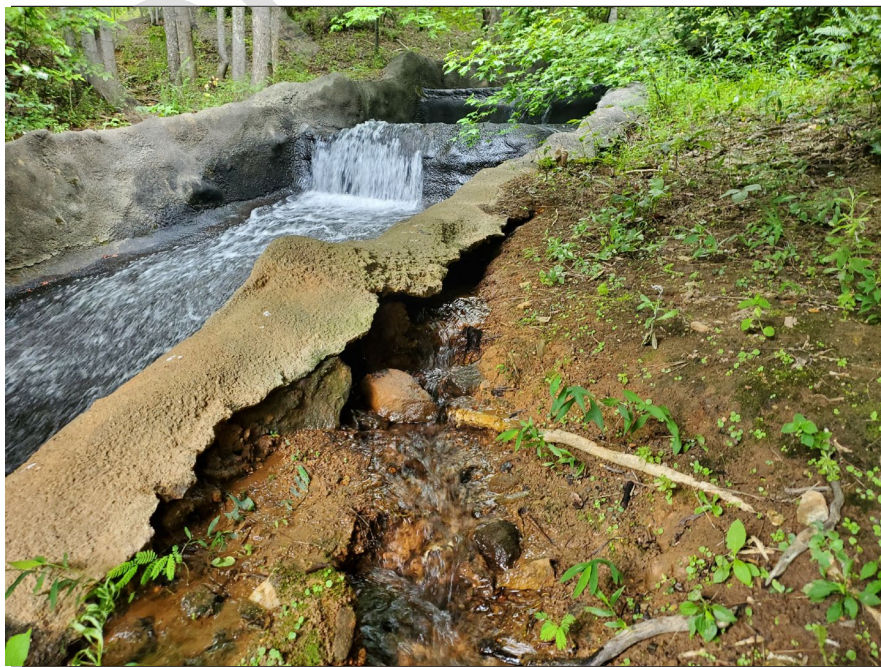
Photograph 4: Spillway, July 2020 – water flow observed behind the concrete lined channel.

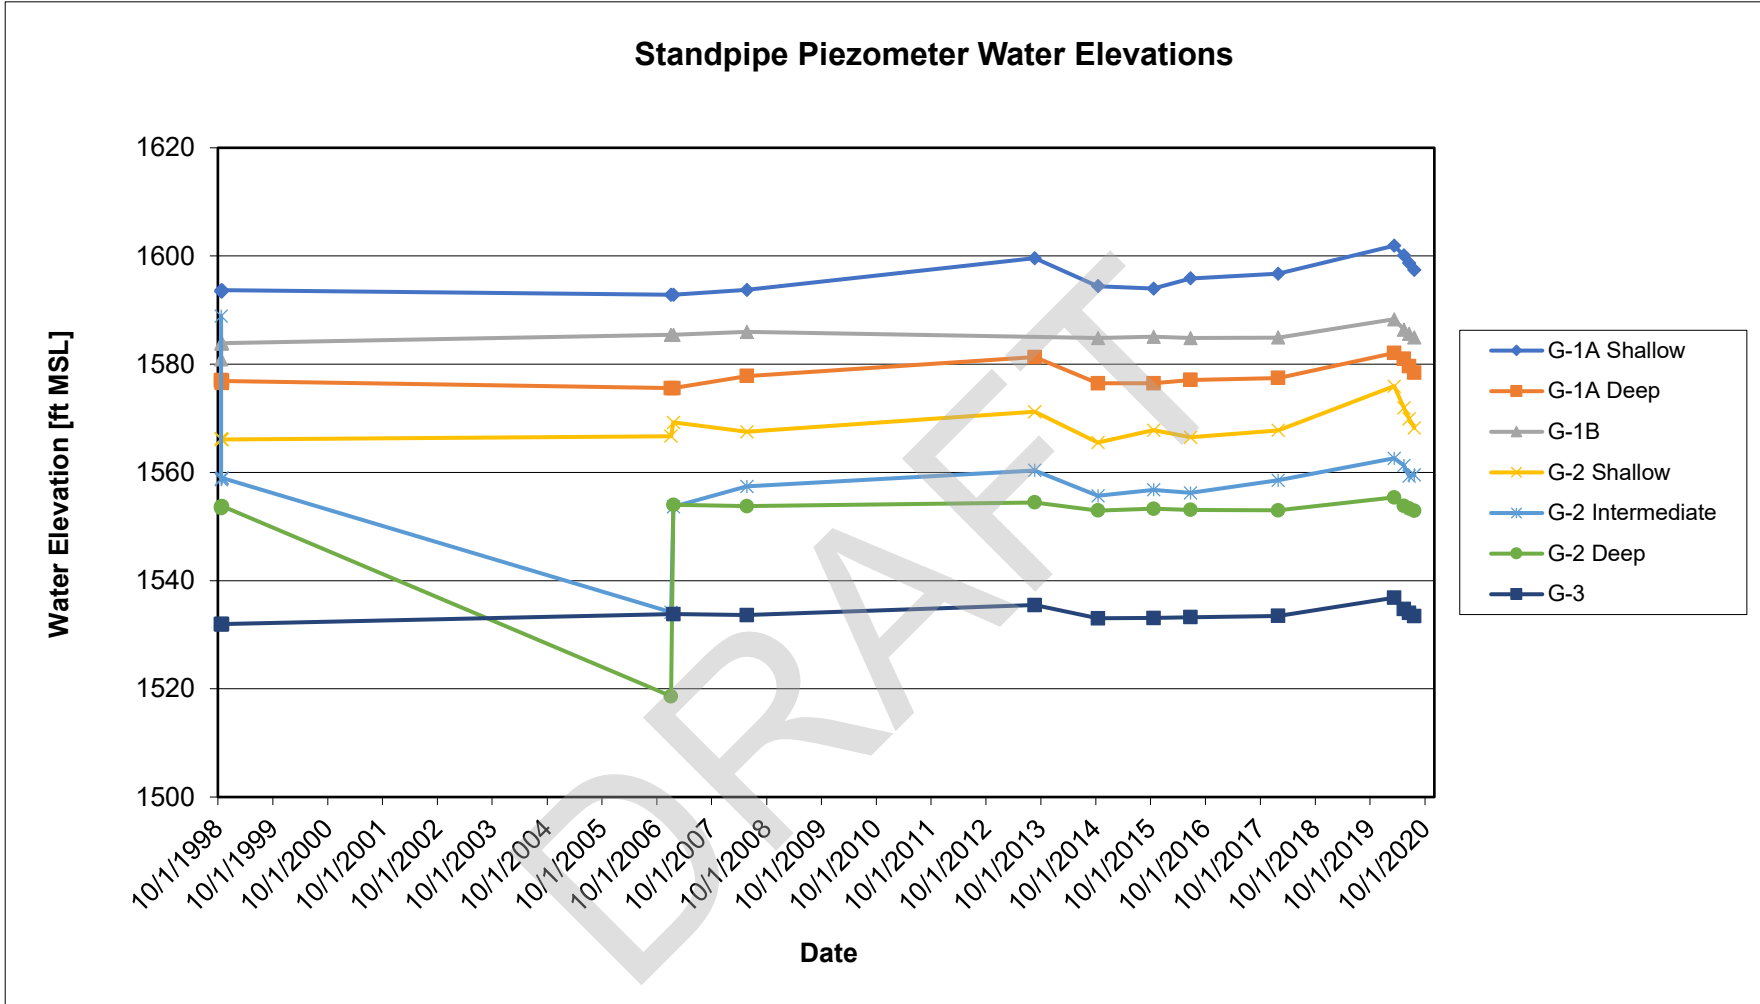
Note: G-2 Shallow water levels noted as anomolous on 3 Jan 2007. Re-measured 19 Jan 2007, and levels more consistent with previous readings.
