# Inspection Report

Date of Inspection: 2/3/2021

Name of Dam: Lake Petit Dam

County: Pickens

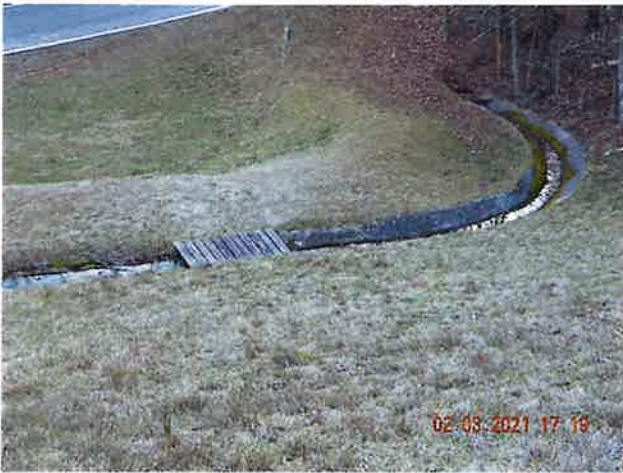
4. Seepage is seen in the lower concrete ditch and on the lower left abutment.
5. The low-level outfall, located below the embankment, is flowing.
6. The toe drains to the right of the low-level outfall cannot be measured. They are deteriorated CMP material, partially clogged, and partially submerged. They are flowing clear. The green pipe in this vicinity is accessible but not flowing. Additionally, seepage is emanating from behind the left wingwall, the location of another old CMP drainpipe. This drainpipe is no longer visible though.

seepage flowing in ditch in lower downstream slope

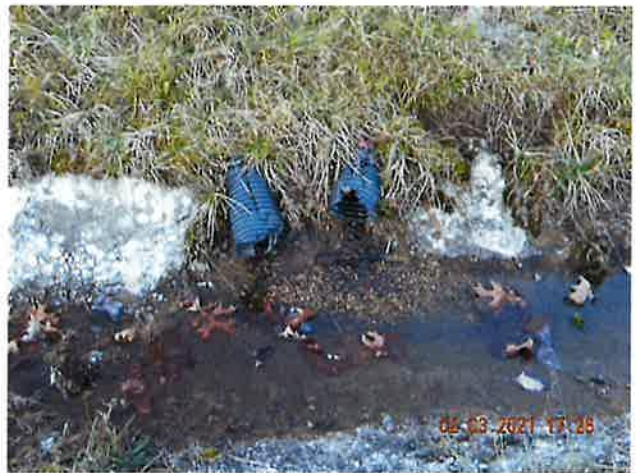
1. The lake is approximately one inch above normal pool.
2. Seepage and a change in vegetation is seen on the lower half of the downstream slope.
3. Multiple deteriorated black corrugated plastic pipes are observed on the downstream slope. Some are discharging into the lower concrete ditch.

deteriorated black corrugated pipes draining into lower ditch

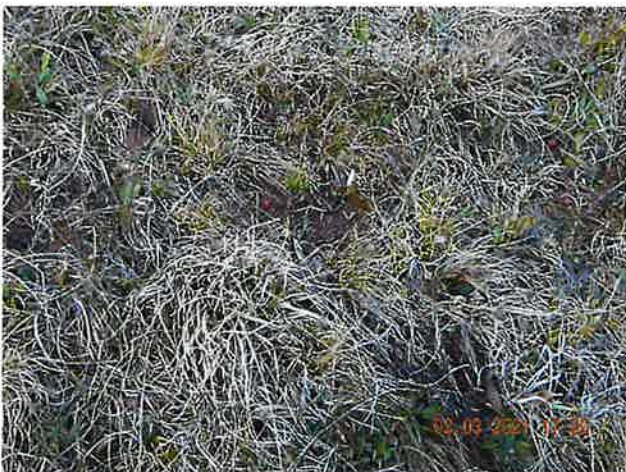
apparent seepage and soft ground on lower downstream slope

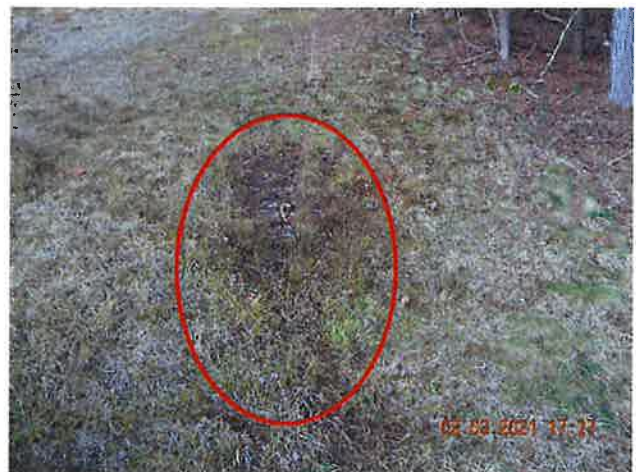
seepage on lower left abutment

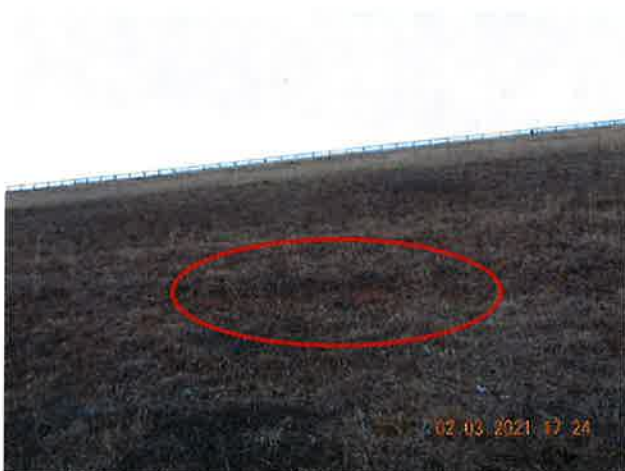
bare spots on lower downstream slope

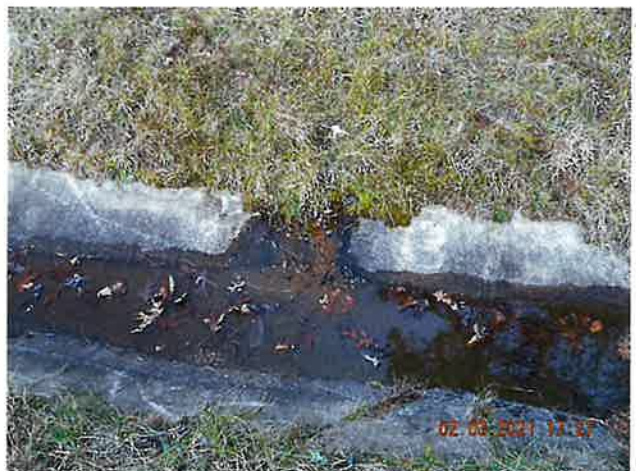
seepage into lower ditch

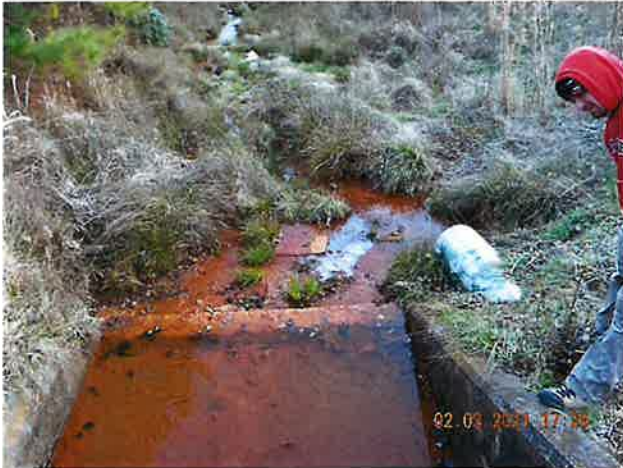
flow from low-level outlet, looking downstream at low-level outfall

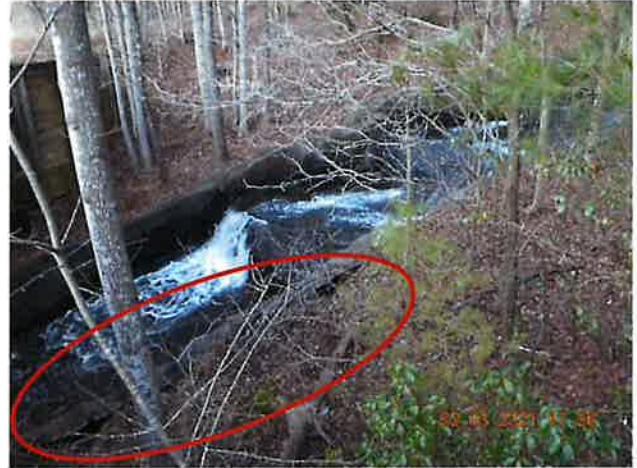
7. At the principal spillway chute, voidspace is noted behind the left wingwall at the base of the chute. Voidspace is also seen in other spots behind the spillway wall on the left side of the chute.

voidspace behind left wall along principal spillway

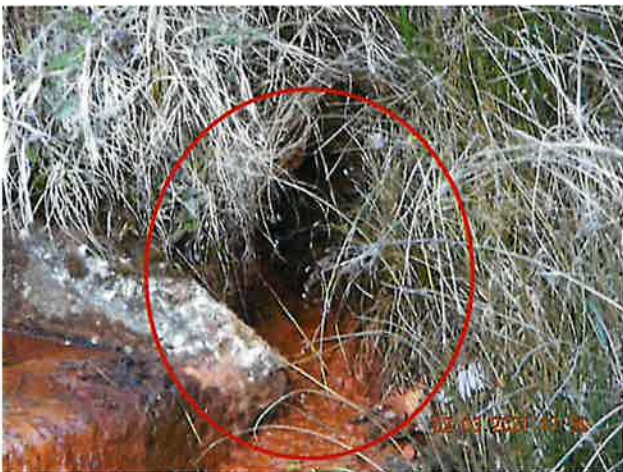
seepage from voidspace behind left wall at low-level outfall

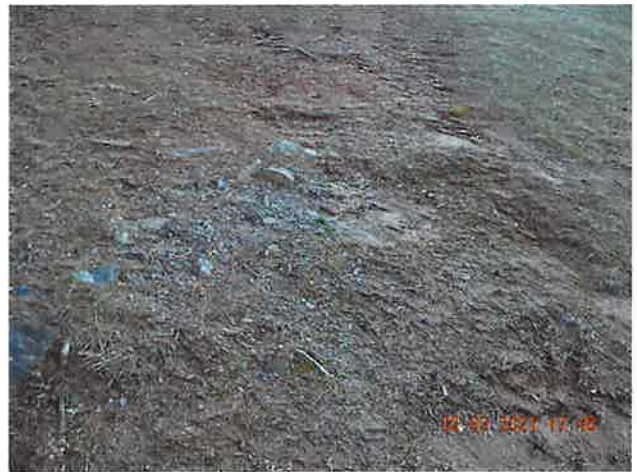
8. Bare spots are observed on the upstream slope.
9. Portions of riprap appear displaced down the upstream slope, into the water. Wave-action erosion is also apparent.

bare area on upstream slope

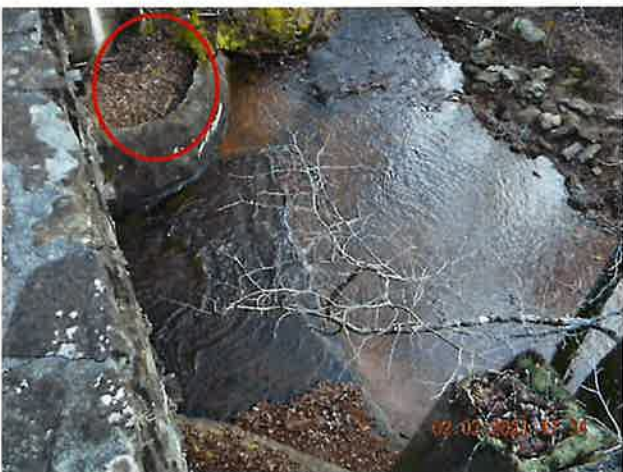
principal spillway plunge pool; notice voidspace behind left wall

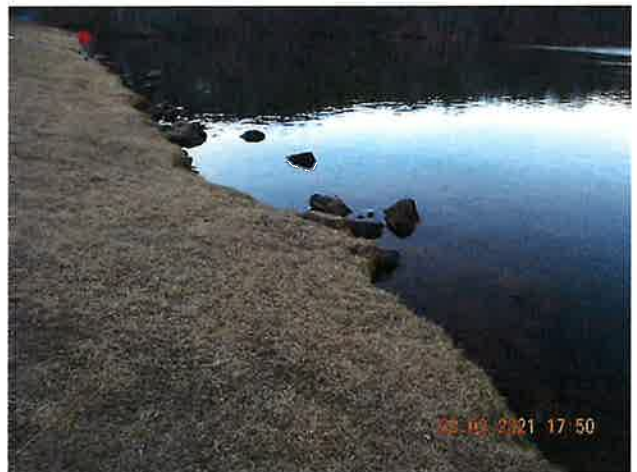
riprap displaced down upstream slope; wave-action erosion apparent
