**Subject: Owner Quarterly Inspection Reports 2020/2021 (Quarters 2, 3, and 4 of 2020 and Quarter 1 of 2021)  
Lake Petit Dam (ID Number (No.) 112-009-00462), Pickens County**

**ATTACHMENT A**  
**2020/2021 Reporting Year Quarterly Inspections**

## Embankment (Earth) Dam Inspection Form

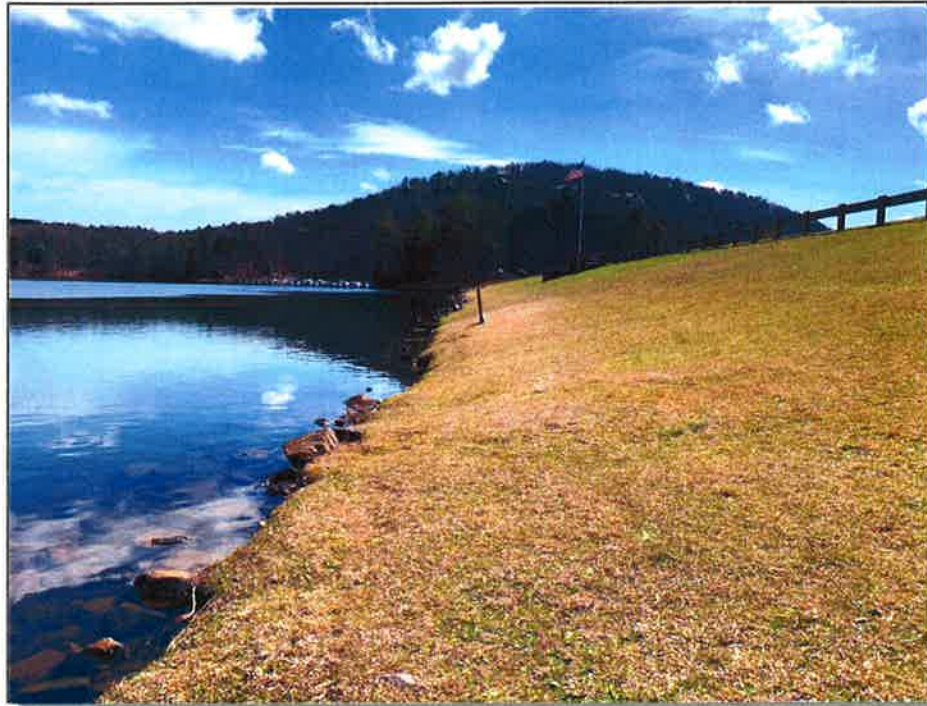
5. Are there any eroded areas on the slope (such as wave erosion along the shoreline)? Yes X No \_\_\_\_\_  
If yes, describe (size of area, location, severity, etc.)/Corrective Action: Slight "beaching" observed/reported in 2008 continued to be observed. Conditions do not appear to have worsened. Some erosion on the L and R groins due to suspected pedestrian use.

Photograph 1: Upstream Face, May 2020 – localized areas of erosion and beaching along shoreline.

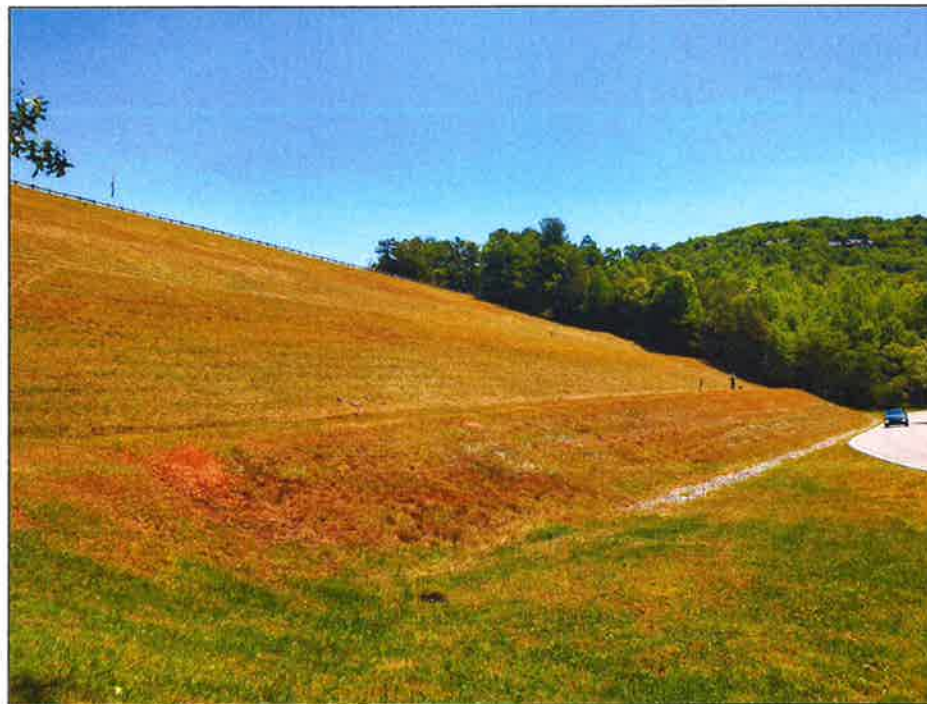
Photograph 2: Downstream Face, May 2020 – overview of downstream face in good condition

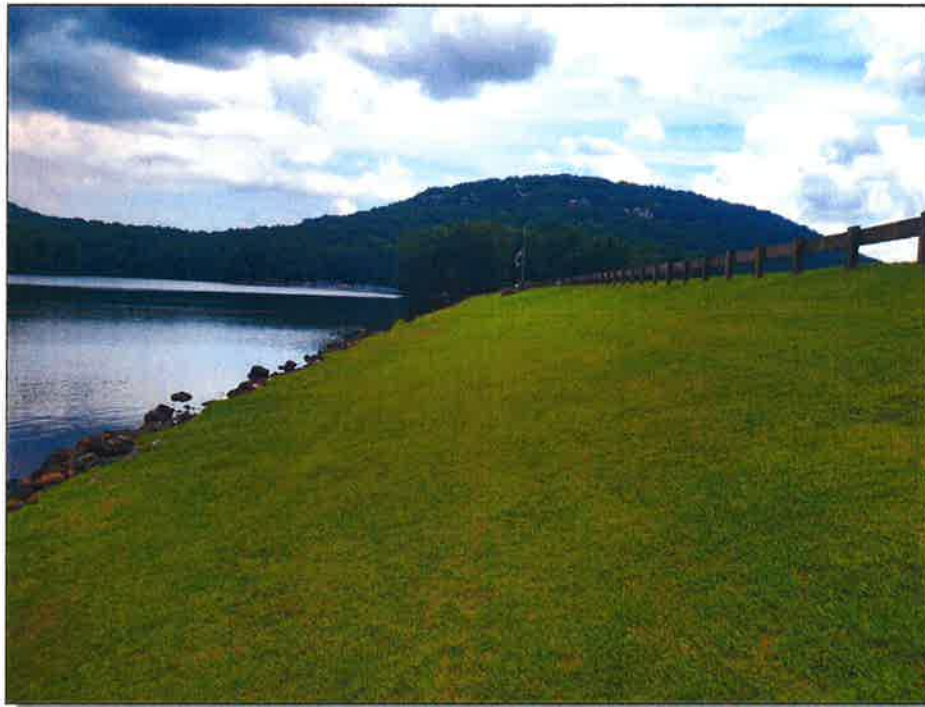
5. Are there any eroded areas on the slope (such as wave erosion along the shoreline)? Yes  X  No \_\_\_\_\_  
If yes, describe (size of area, location, severity, etc.)/Corrective Action: Slight "beaching" observed/reported in 2008 continued to be observed. Conditions do not appear to have worsened. Some erosion on the left and right groins due to suspected pedestrian use – no change since previous inspection. Surficial erosion should be re-established and seeded to prevent further erosion as part of on-going maintenance.

Photograph 1: Upstream Face, July 2020 – localized areas of erosion and beaching along shoreline.

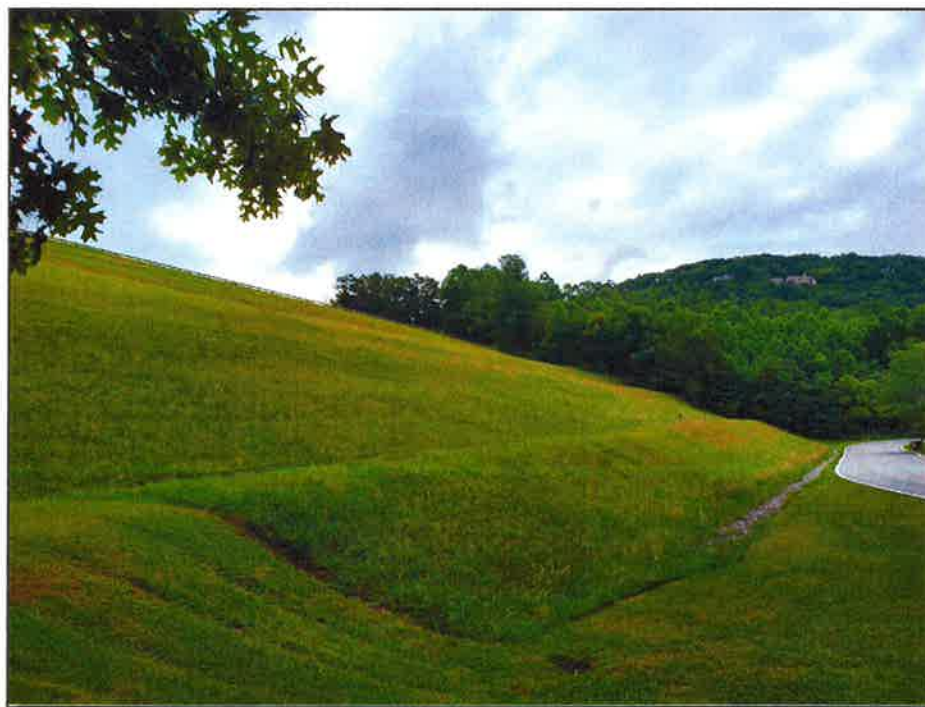
Photograph 2: Downstream Face, June 2020 – overview of downstream face in good condition

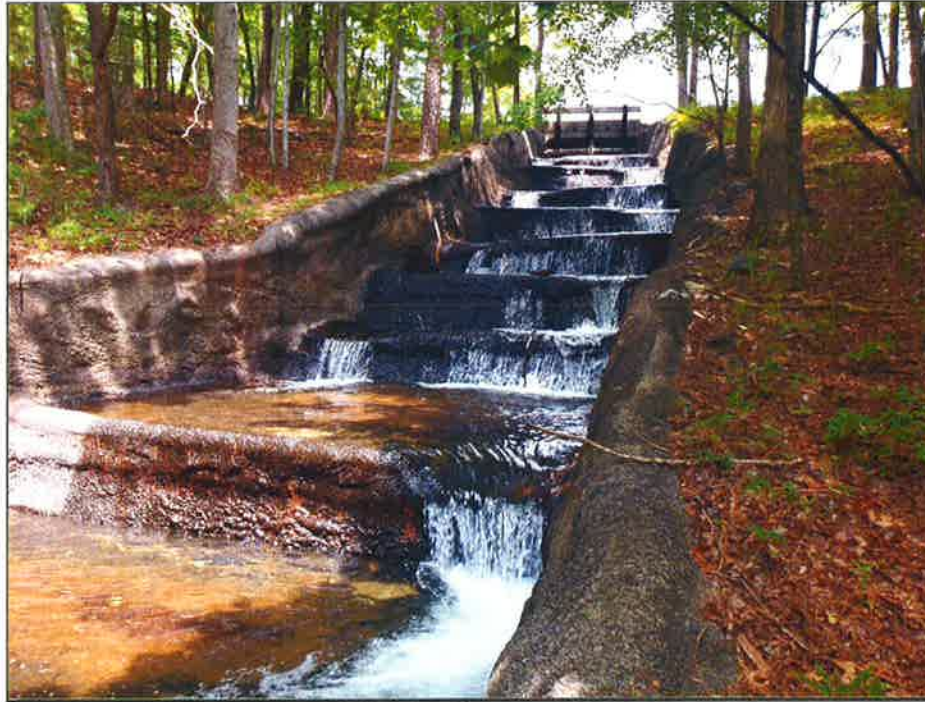
Photograph 3: Spillway, July 2020 – general view of stepped spillway with moderate flow, and tree limbs and debris noted during inspection.

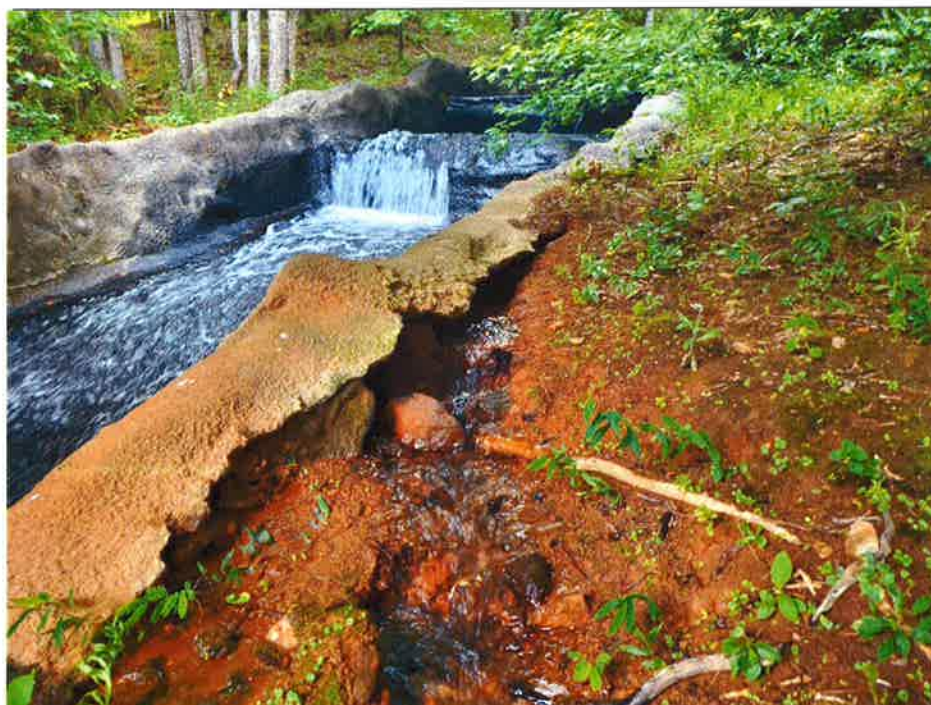
Photograph 4: Spillway, July 2020 – water flow observed behind the concrete lined channel.

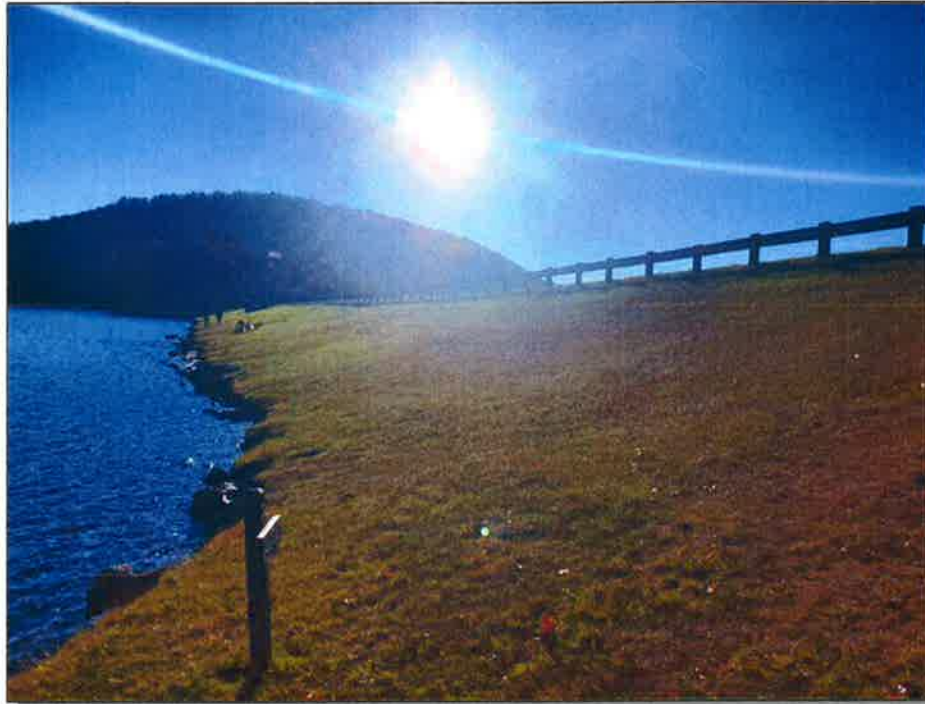
Photograph 1: Upstream Face, Nov. 2020 – localized areas of erosion and beaching along shoreline.

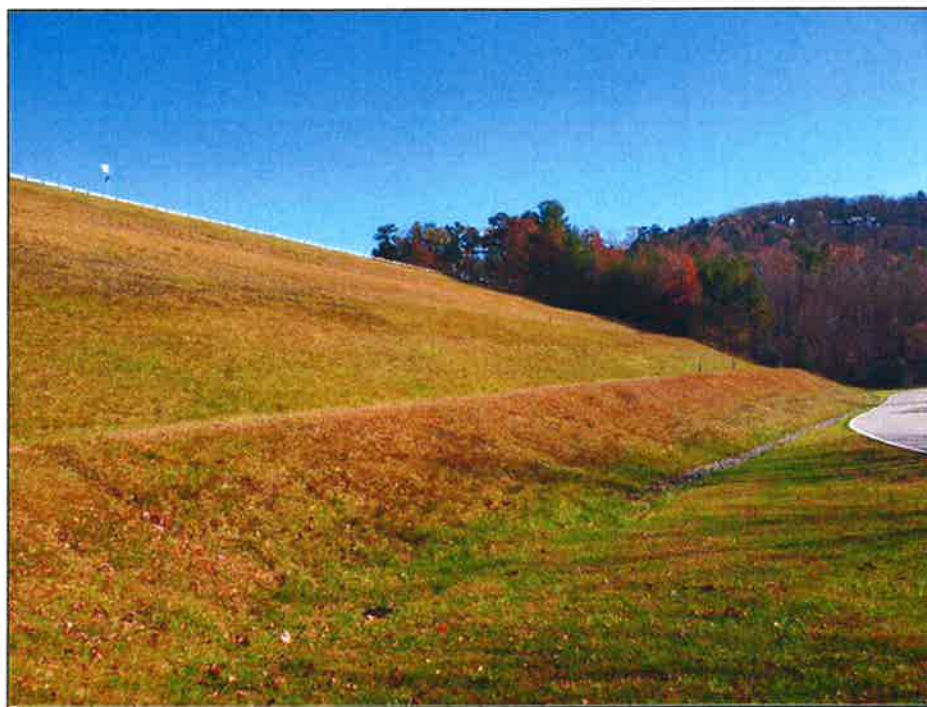
Photograph 2: Downstream Face, Nov. 2020 – overview of downstream face in good condition

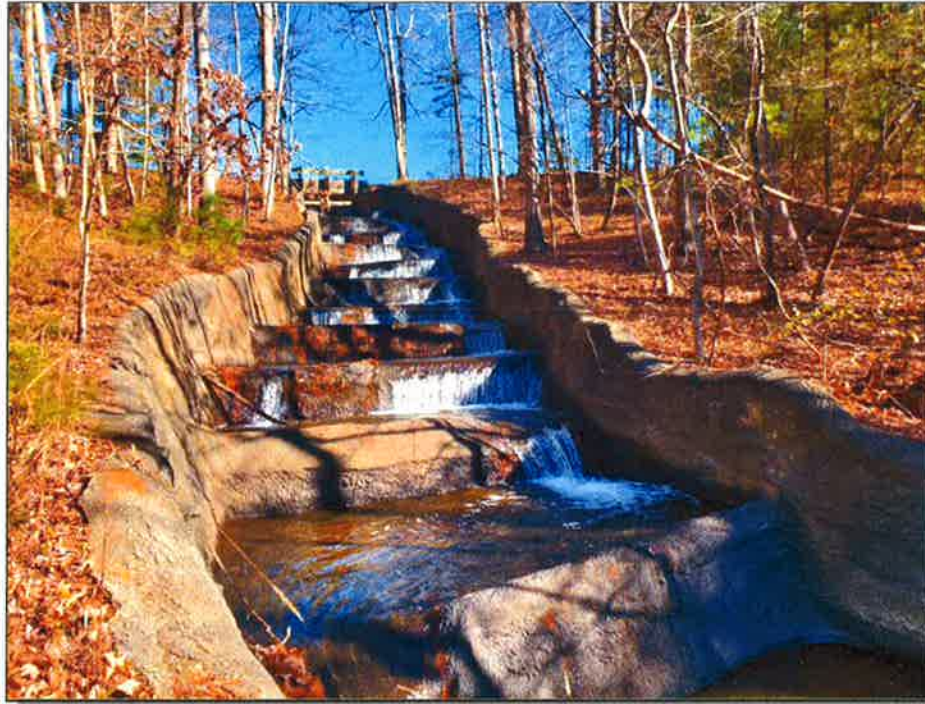
Photograph 3: Spillway, Nov. 2020 – general view of stepped spillway with moderate flow, and tree limbs and debris noted during inspection.

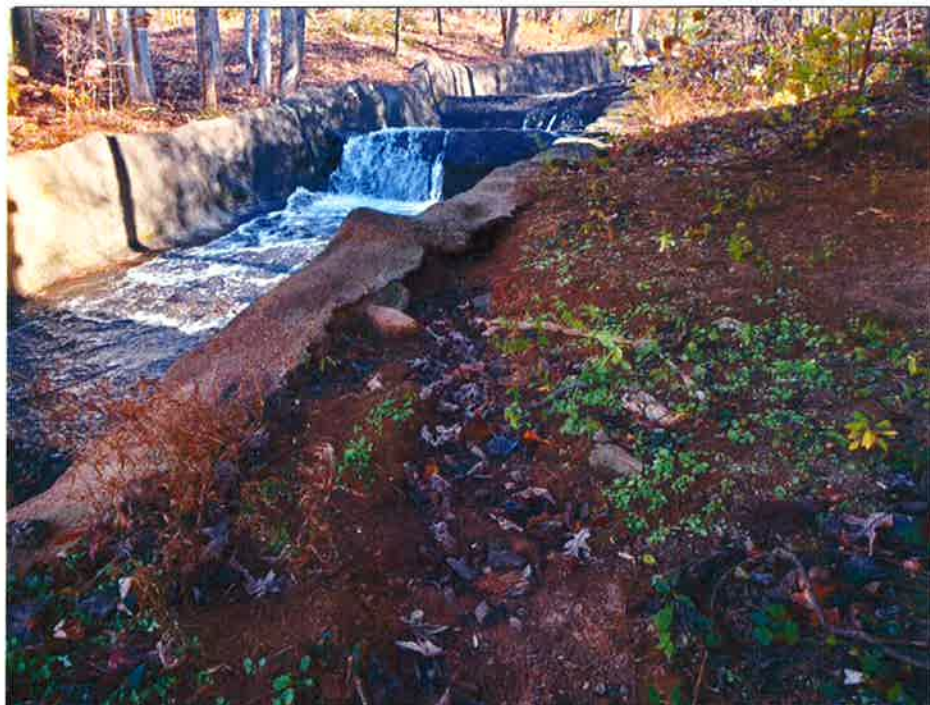
Photograph 4: Spillway, Nov. 2020 – Area of previously identified water flow behind concrete lined channel. Water flow was observed to continue but did not daylight at surface in depicted location.

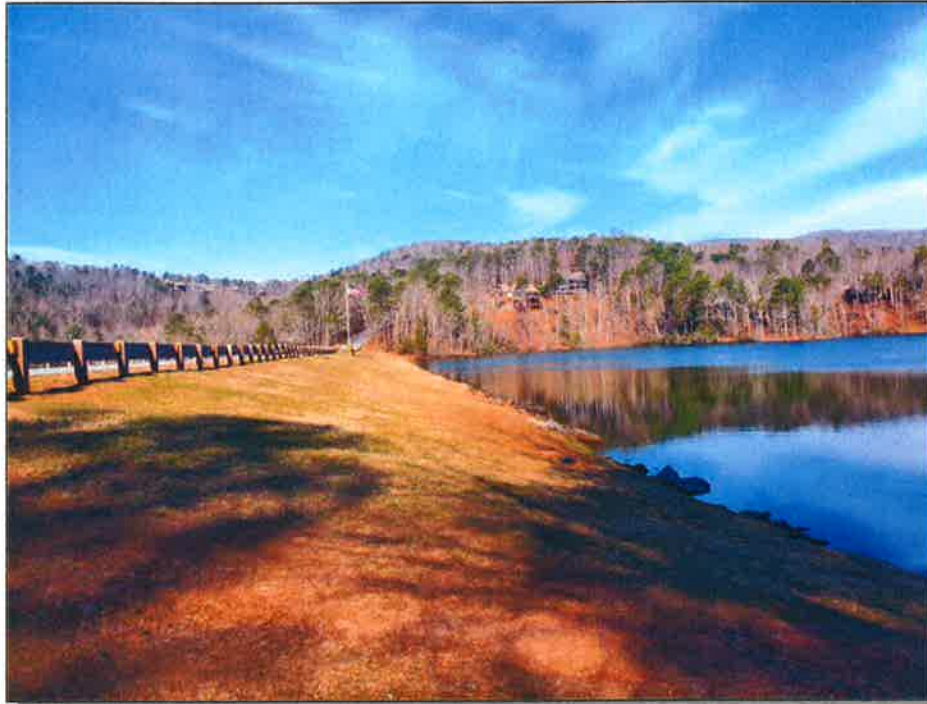
Photograph 1: Upstream Face, Mar. 2021 – localized areas of erosion and beaching along shoreline.

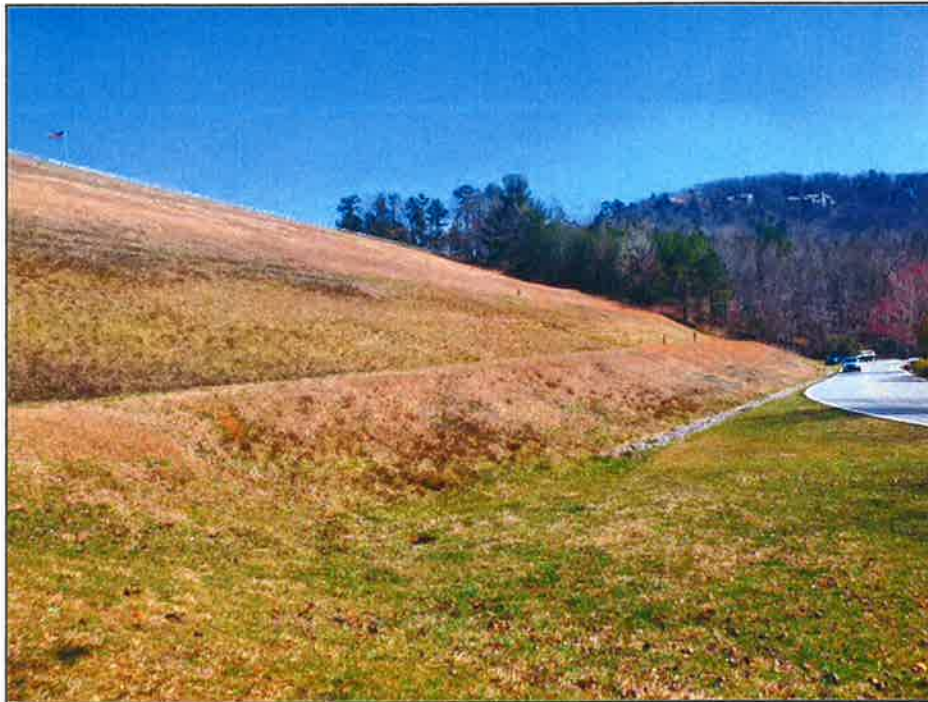
Photograph 2: Downstream Face, Mar. 2021 – overview of downstream face in good condition

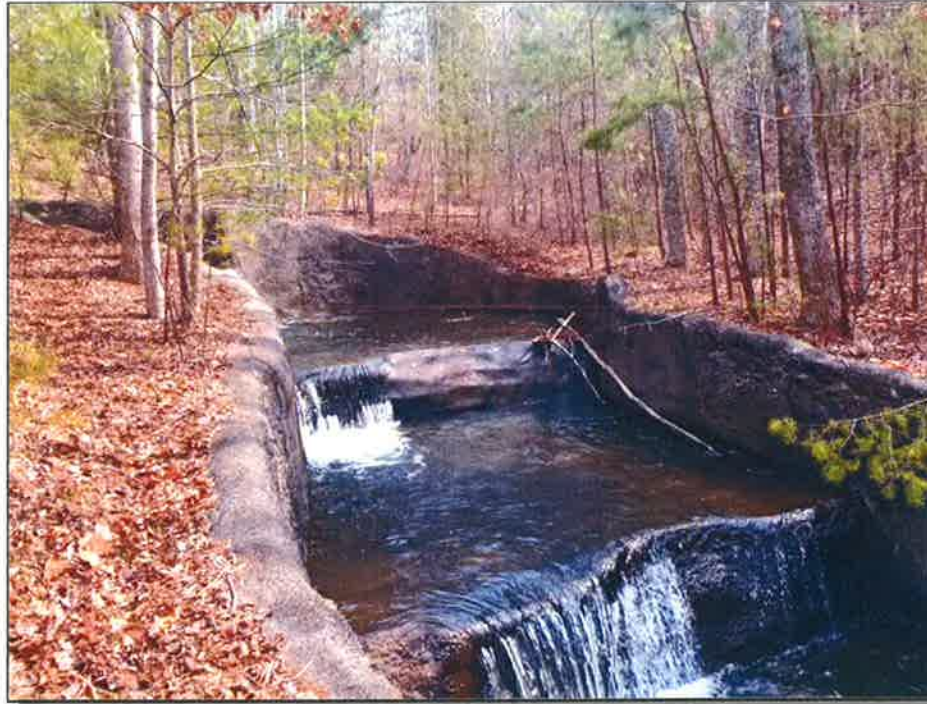
Photograph 3: Spillway, Mar. 2021 – general view of stepped spillway with moderate flow, and tree limbs and debris noted during inspection.

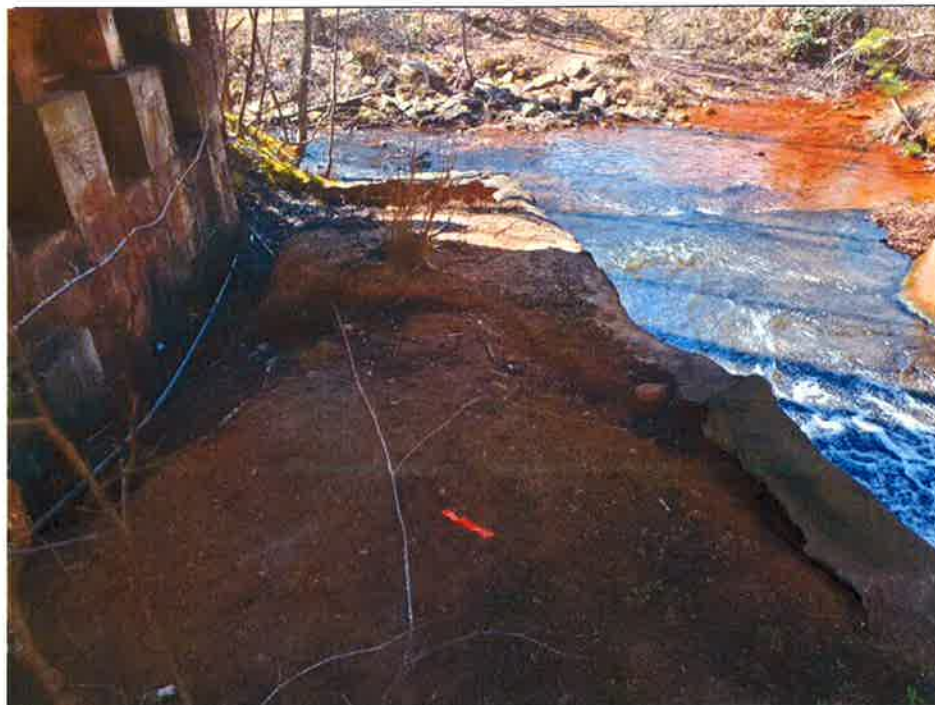
Photograph 4: Spillway, Mar. 2021 – area of previously identified water flow behind concrete lined channel. Water flow was observed to continue but did not daylight at surface in depicted location.
