SUBJECT: Petit Lake Dam
Pickens County
Permit #112-009-00462

On February 3, 2021, our staff performed the FY21 quality assurance inspection on the subject dam. During the inspection, we noted the following compliance and maintenance items:

Inspection Report

Name of Dam: Lake Petit Dam

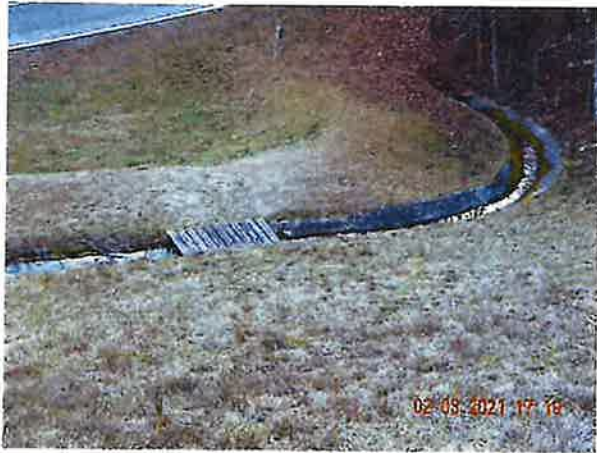
1. Seepage and a change in vegetation was seen on the lower half of the downstream slope. Additionally, it appeared that seepage was flowing in the lower concrete ditch and was also present on the lower left abutment. An Engineer of Record (EOR) must investigate the seepage.

seepage flowing in ditch in lower downstream slope

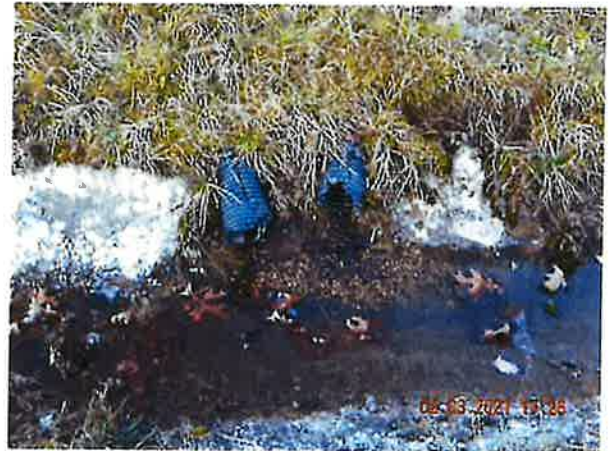
1. Multiple deteriorated black corrugated plastic pipes were observed on the downstream slope. Some were discharging into the lower concrete ditch and some may have been covered in vegetation. Similarly, the toe drains to the right of the low-level outfall could not be measured. These pipes were deteriorated, partially clogged, and partially submerged. Finally, seepage was emanating from behind the left wingwall, the location of another old CMP toe drainpipe. All surface and toe drainpipes must be cleared of vegetation and sediment clogs and allowed to flow. The vicinity of the discharges must also be cleared so that flow measurements can be taken with a small bucket. In terms of the black corrugated pipes, their deterioration may mean some need to be replaced. This office must be notified if replacement of these pipes requires intrusive work.

deteriorated black corrugated pipes draining into lower ditch

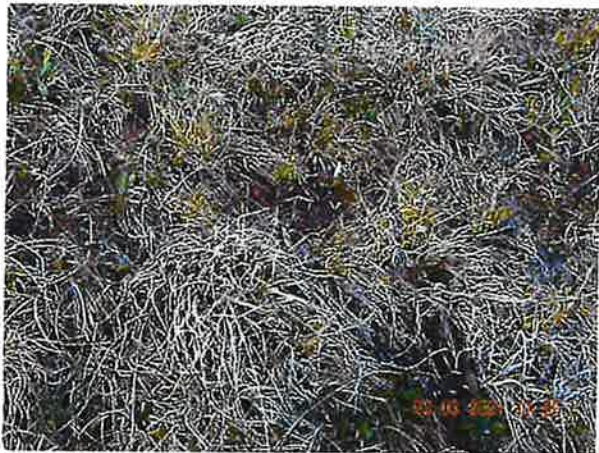
apparent seepage and soft ground on lower downstream slope

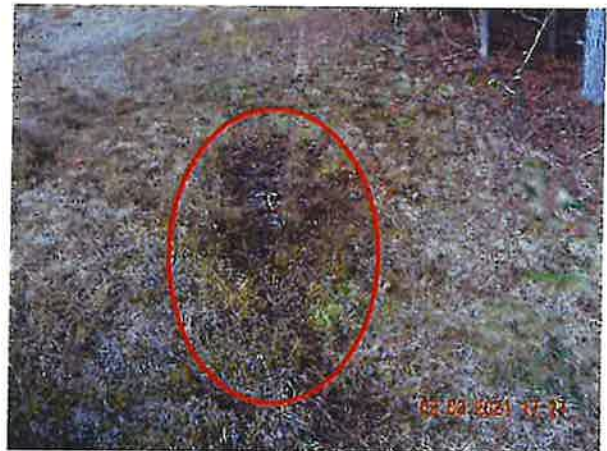
seepage on lower left abutment

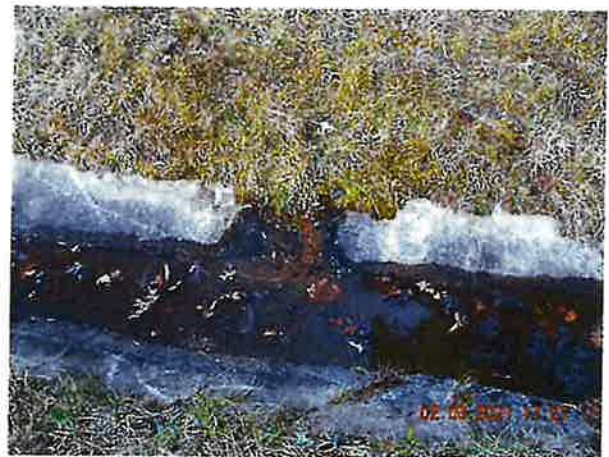
seepage into lower ditch

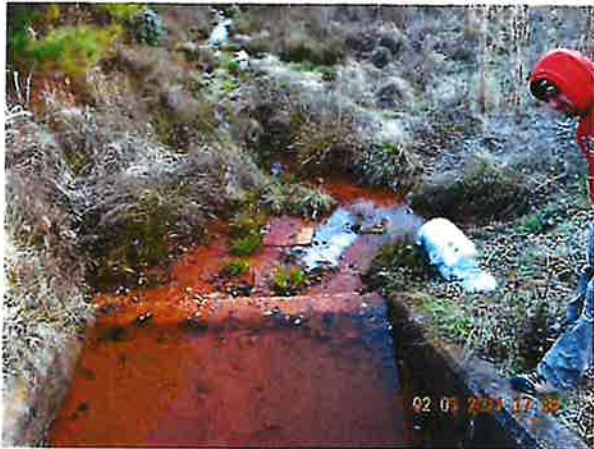
2. The low-level outfall, located below the embankment and below the road, was flowing. An EOR must investigate if the low-level valve is slightly open or if leaks exist in the intake or within the dam into the low-level pipe. Be reminded that, in accordance with according with Rule 391-3-8-.10, all spillway and outlet gates and any other mechanical devices must be operated at least once per year, and you must certify that such gates and appurtenances are in good repair and working order.

flow from low-level outlet, looking downstream at low-level outfall

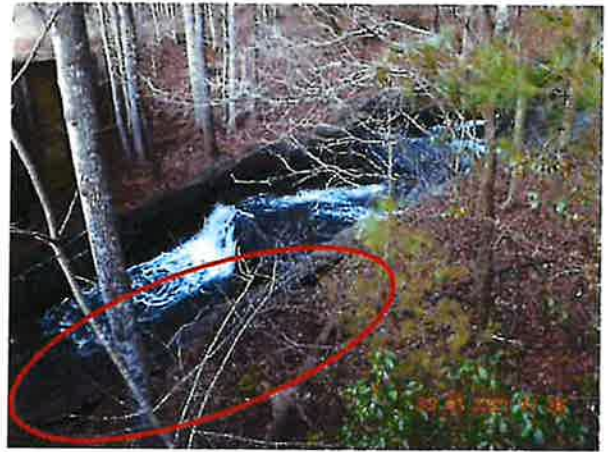
3. At the principal spillway chute, voidspace was noted behind the left wingwall at the base of the chute. Voidspace was also found in other spots behind the spillway wall on the left side of the chute. An EOR must investigate these voids.

voidspace behind left wall along principal spillway

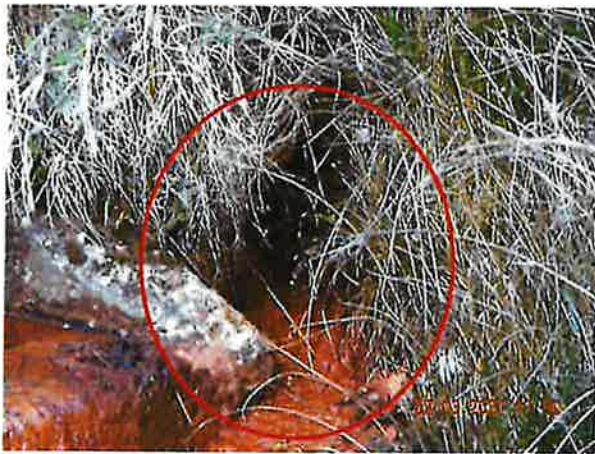
seepage from voidspace behind left wall at low-level outfall

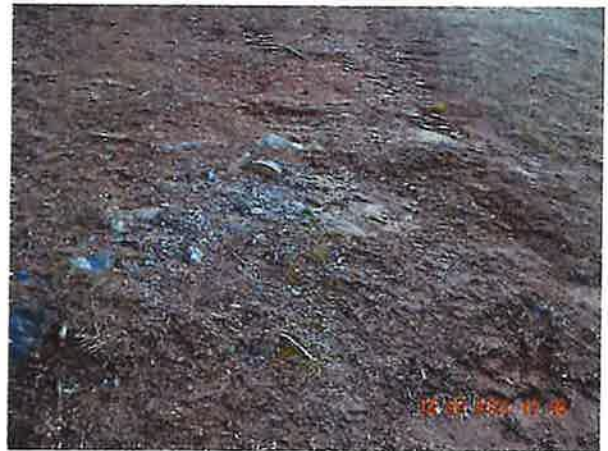
2. Bare spots were observed on the upstream slope. A low-growing grass species must be established across this area.

bare area on upstream slope

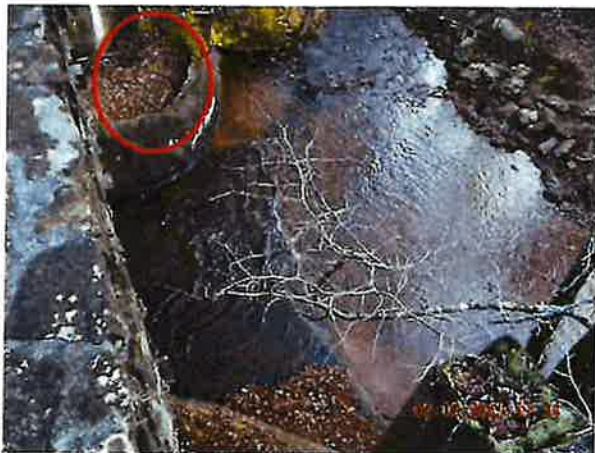
principal spillway plunge pool; notice voidspace behind left wall

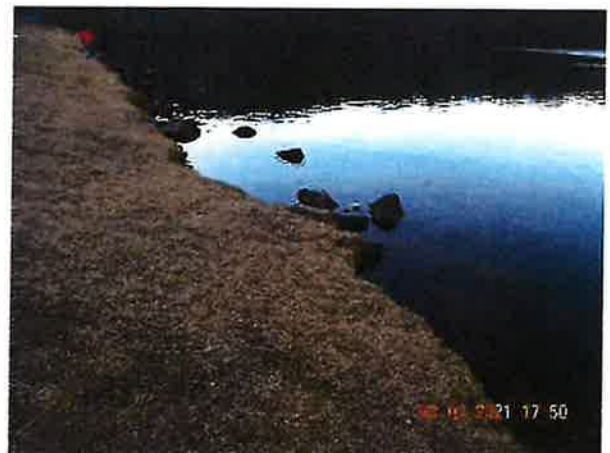
4. Portions of riprap appeared displaced down the upstream slope, into the water. Wave-action erosion was also apparent. An EOR must investigate this deficiency.

riprap displaced down upstream slope; wave-action erosion apparent
