LAKE PETTIT DAM

PHASE I INSPECTION REPORT NATIONAL DAM SAFETY PROGRAM

JULY 24, 1979

Name of Dam: Lake Pettit Dam
County and State: Pickens, Georgia
Inventory Number: Ga. 685

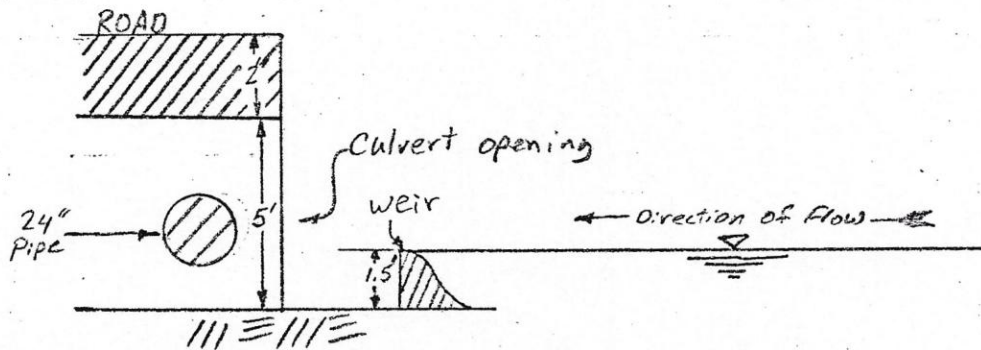
Primary Spillway

The spillway is composed of Twin 6'x5' box culverts. The culverts are obstructed by a 24" pipe running along the direction of the Road. The culvert is preceded by a weir 1.5' above the bottom of the culvert.
