RE: Petit Lake Dam Site
Summary of Preliminary Engineering Evaluation

*Lake Petit Dam
(Big Canoe)
Dickens Co.*

Exhibit A - Spillway Slab Repair Detail

Exhibit B - Schematic Illustration of Water Surface Conditions

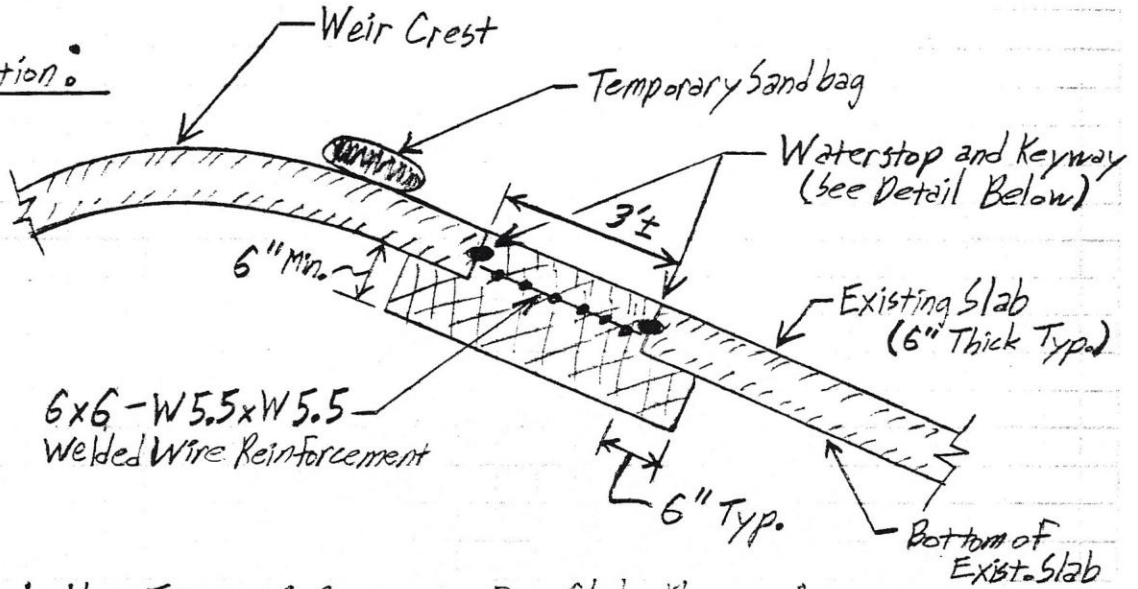
Cross-Section:

appears to be leaking under the principal control weir and then exiting through the spillway slab on the right side (looking downstream). Upon closer field inspection, this condition does not appear to be caused by water seepage flows beneath the spillway slab. Instead, there is a small steady discharge from the cold water release pipes onto the spillway and flowing over an irregularity in the concrete finish of the slab downstream. This irregular surface of the concrete slab is causing a small hydraulic jump as water flows over it, and this condition may have been misinterpreted by Safe Dams as leakage underneath the spillway. The irregularity should be fixed by using sand bags to temporarily deflect water flows away from the small depression, and then repair slab in accordance with enclosed Detail A to match the relatively smooth uniform finish of the adjacent concrete slab areas.

- Notes:
1. Use 5000 psi Concrete For Slab Repair Area.
 2. Sawcut Existing Slab to remove small depression and about 6" to either side (approx. 3'x3' area).
 3. Use sand bags to reroute water flows away from repair area and keep exposed subgrade in dry condition.

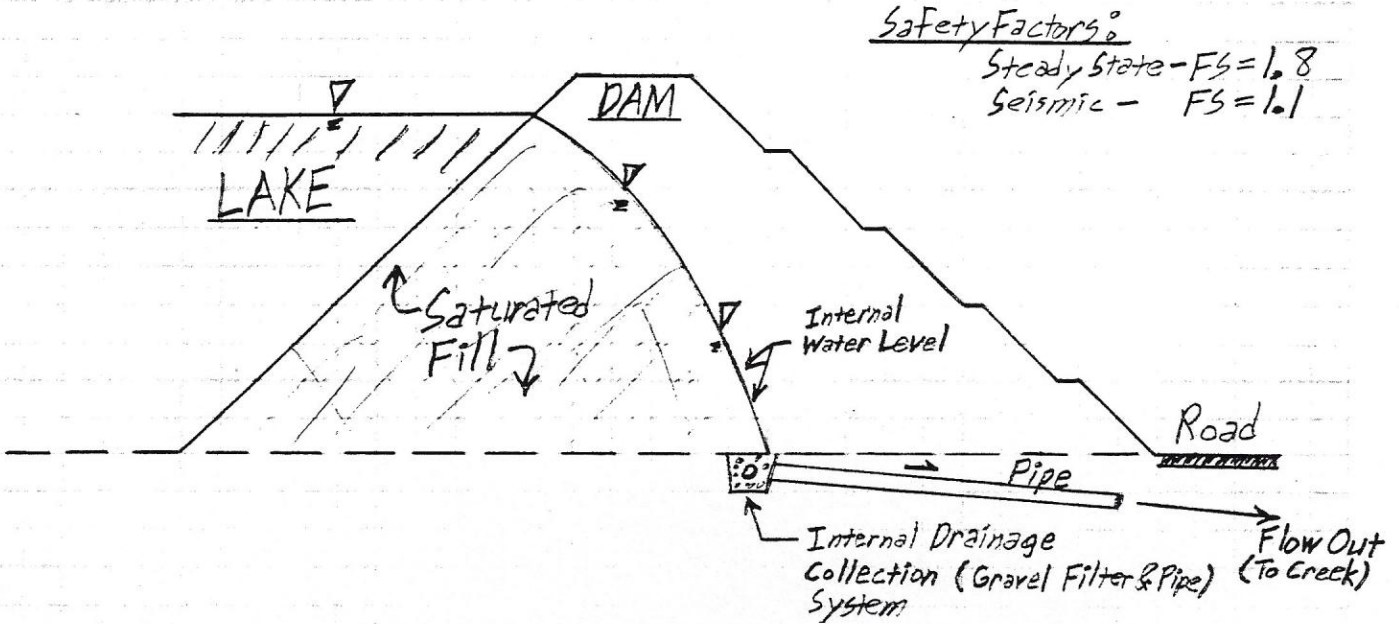
"As Designed" Water Surface (Idealized):

The "as-designed" cross-section geometry was based on the original construction plans showing 6 berms connected by 2.5H:1V slopes, and the resulting minimum safety factors were 1.8 for steady state conditions and 1.1 for seismic event. These two safety factors exceed the Safe Dams' required minimum values of 1.5 and 1.1 respectively for these two design conditions.

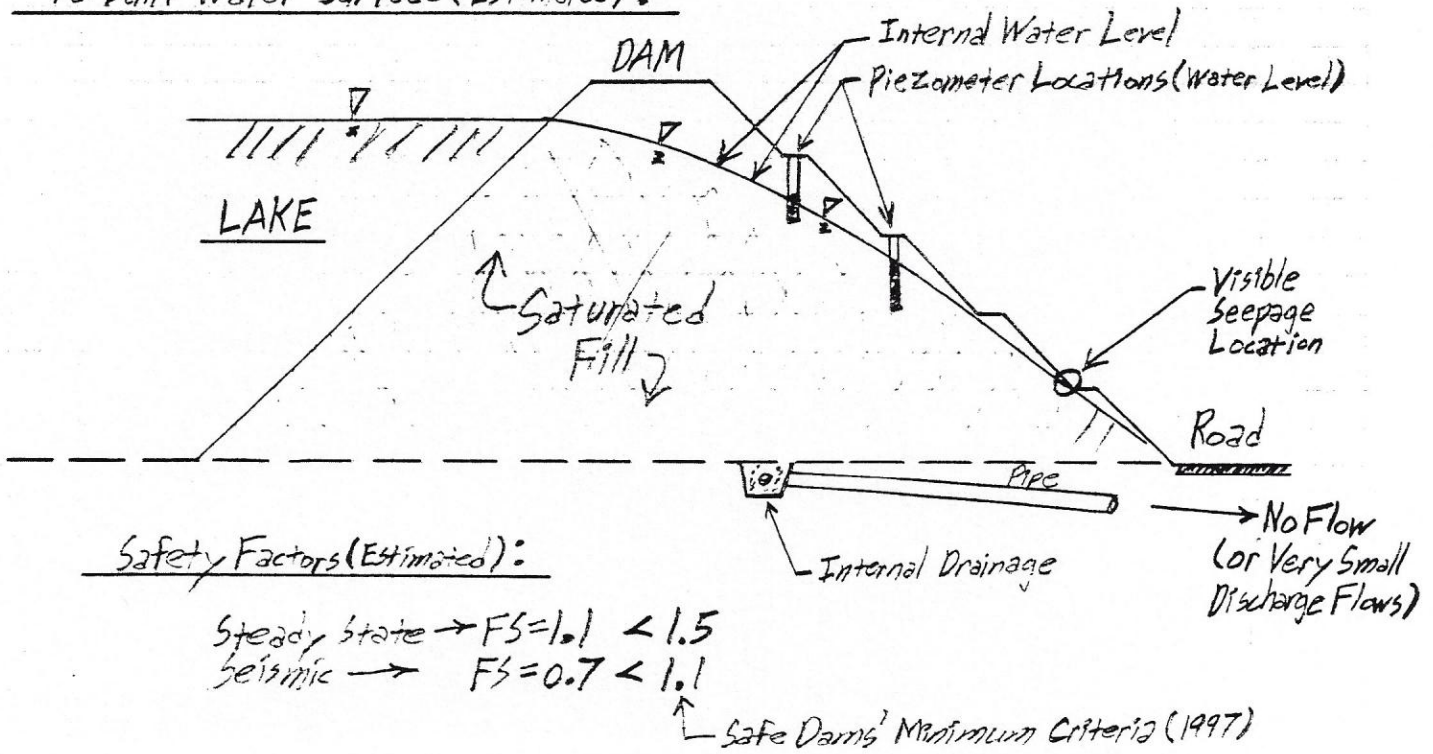
"As Built" Water Surface (Estimated):

Next, the "as-built" embankment geometry was evaluated using the surveyed cross-section from the Corps of Engineers Phase I inspection report (5 berms connected with 2H:1V slopes). This condition also incorporated an assumed phreatic surface interpolated from the piezometer readings and location where seepage has been observed at the surface (see exhibit B for schematic illustration of water level conditions). The resulting calculated minimum safety factors were 1.1 for steady state conditions and 0.7 for the seismic event. These values are well below the Safe Dams' design requirements, and raise some serious concerns about the potential stability of the existing dam structure.

It is important to note that these analyses were relatively simplified and based on several assumptions made due to lack of detailed geotechnical information. However, it is our preliminary opinion that if there is an elevated phreatic surface in the dam, it could cause a potentially dangerous condition within the downstream slope face. Our preliminary evaluation indicates that additional studies are needed as soon as possible to obtain field data to confirm or adjust these assumptions, and then evaluate the dam with data more representative of actual field conditions.

1. JJ&G should prepare 2-3 field surveyed cross-sections of the existing embankment slopes.
2. Additional historical data should be assembled including original design calculations, construction monitoring records, and laboratory testing data.
3. Several water surface observation wells should be installed down the downstream slope face and regularly monitored to determine phreatic levels at various locations and depths.
4. The borings performed for the observation walls will provide the opportunity to obtain undisturbed soil samples and Standard Penetration Tests needed to evaluate existing soil conditions and strength parameters.
