REPORT OF ENGINEERING EVALUATION

PETIT COVE DAM

DAWSON COUNTY, GEORGIA

March 18, 1974

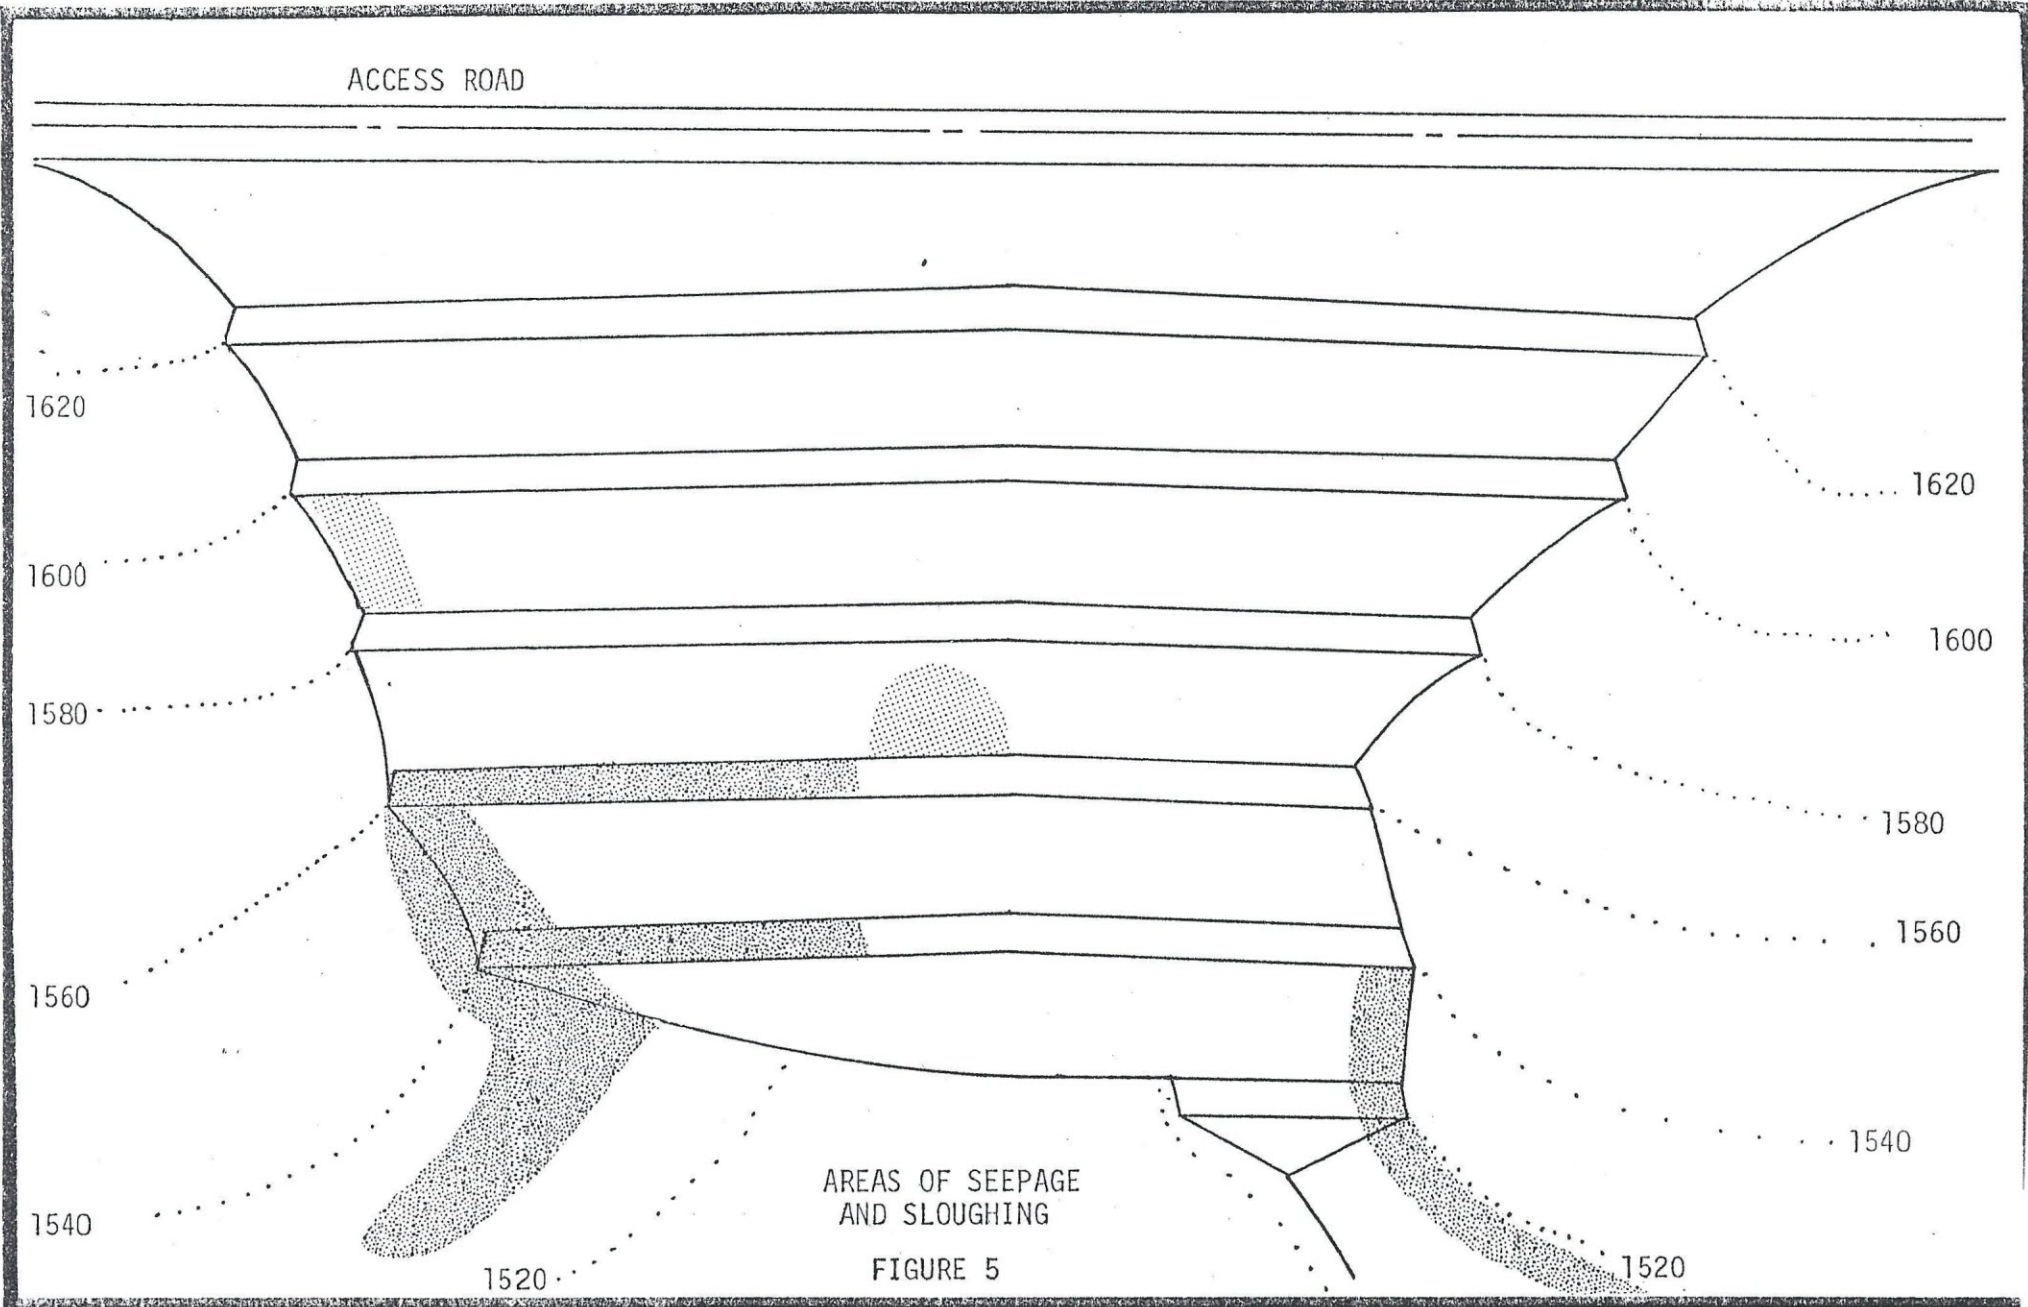
The problems associated with the seepage can be categorized into each area and the type of seepage problem (see Figure 5). The left abutment on

the downstream side of the dam has major seepage occurring at the abutment-embankment interface, and through the residual soils of the abutment. The right abutment also has seepage through the abutment residual soils and the embankment fill as well as sloughing near the interface of embankment and abutment on the third berm, Elevation 1580. On the downstream face of the dam, minor sloughing has occurred approximately at the middle of the second berm, Elevation 1560. The three upper berms on the downstream face (Elevation 1580, 1600 and 1620 respectively), has ponding of surface runoff, while the two lower berms (Elevations 1540 and 1560) has seepage water ponding due to the high phreatic line intersecting at these berms.

Remedial action in the areas of concentrated seepage (see Figure 5) should consist of undercutting of the loose soils and the installation of filtered drains. The undercutting and removal must be done under the inspection of a qualified soils engineer to avoid excessive removal of the embankment soils. The depth of undercutting as determined by the soils engineer can be accomplished by manual labor or by a tractor-mounted backhoe. Installation of the filtered drain can be as follows (see Figure 6):

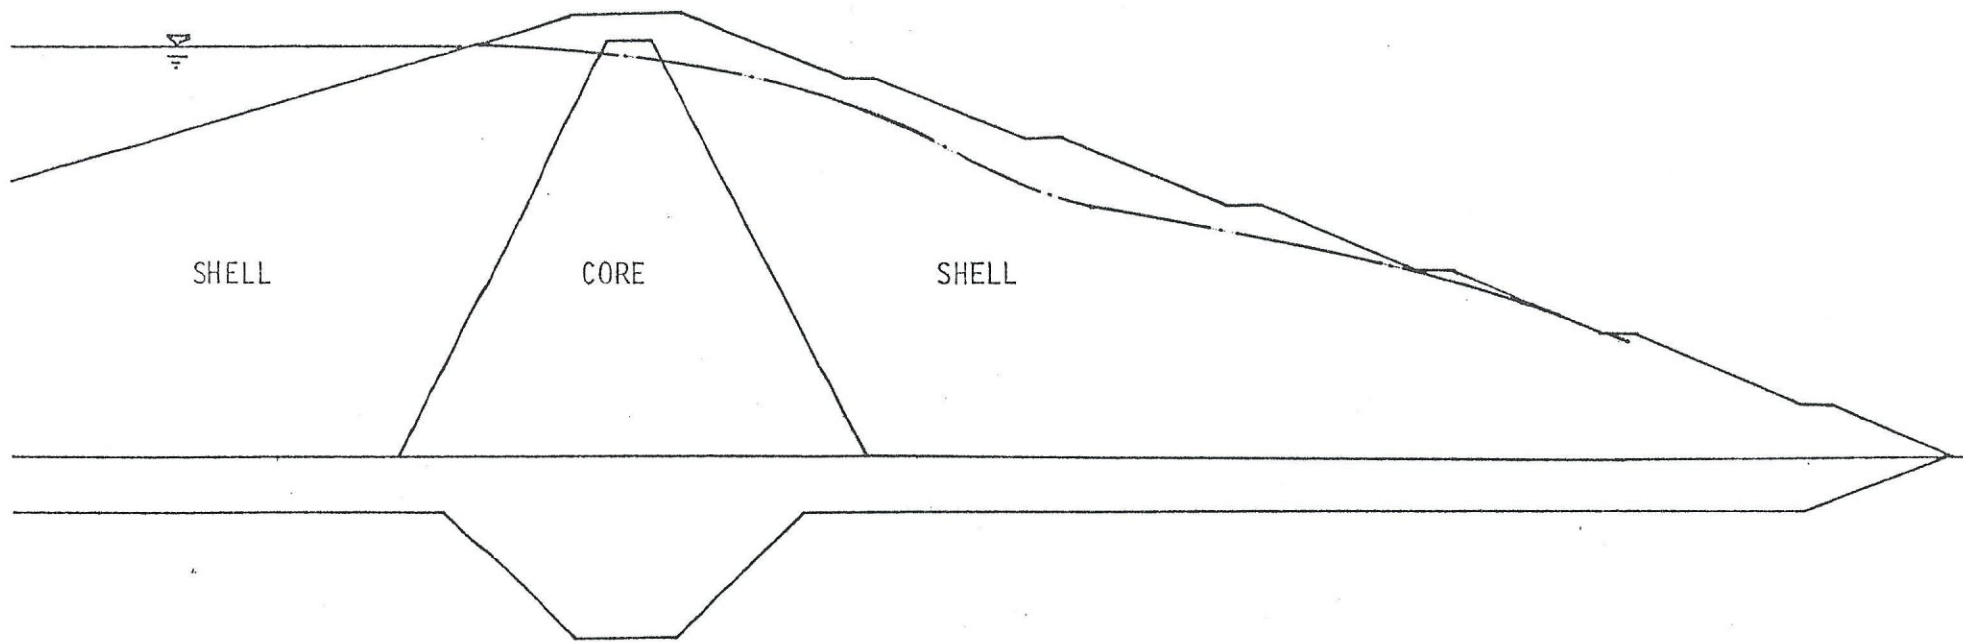
FIGURE 10

Piezometers: The phreatic surface on the downstream face of the dam was measured by piezometers. Five piezometers were installed on the downstream berms by augering 20 feet into the dam. A casing (2 inch diameter minimum) was inserted into the auger boring, and a small diameter pipe was located within the casing. The small diameter pipe extends below the outside casing pipe and is seated into a well graded sand. The sand is used to fill the void created by the pipes. A bentonite clay is used for sealing the void from rising water.

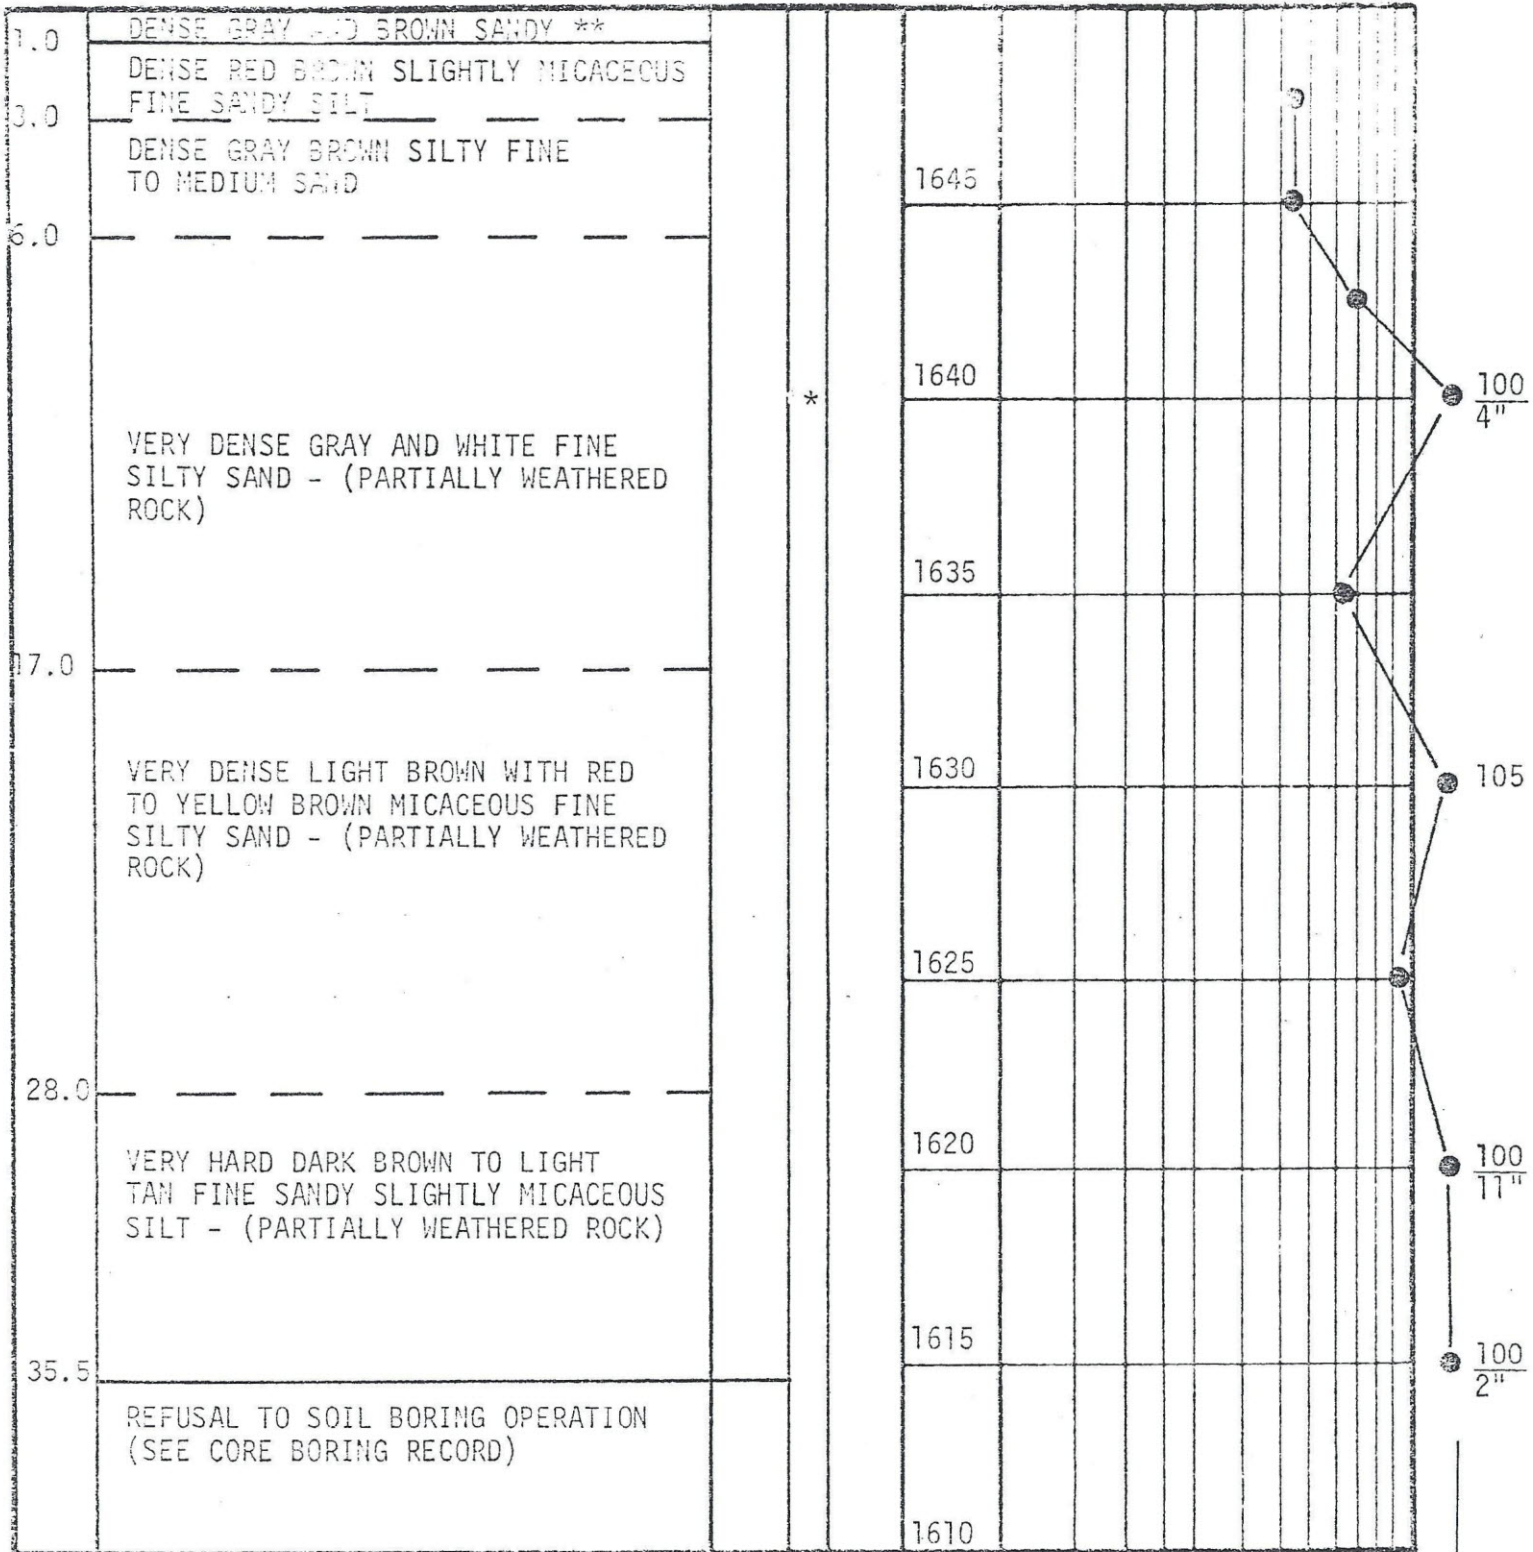
BORING NUMBER B-1
DATE DRILLED 12-19-73
JOB NUMBER 7502

DEPTH FT.	DESCRIPTION	CORE %	BIT SIZE	ELEV. 1615	REMARKS
35.5	HARD DARK GRAY GNEISS				CONTAINS NUMEROUS JOINTS AND SEAMS.
37.5		40 RQD =0	NX	1605	
	SOFT TO MODERATELY HARD LIGHT BROWN AND GRAY WEATHERED GNEISS	68 RQD =0		1595	
		60 RQD =0			
62.5	HARD GRAY GNEISS			1585	
65.5	NO RECOVERY OF SAMPLE	0 RQD =0		1575	
75.5	MEDIUM HARD TO SOFT BROWN TO GRAY GNEISS	55 RQD =0		1565	HAS WEATHERED SEAM AT 85.5'
88.0	VERY HARD DARK GRAY GNEISS	97 RQD =6		1555	SAMPLE CONTAINS VERTICAL FRACTURES
95.0	CORING TERMINATED

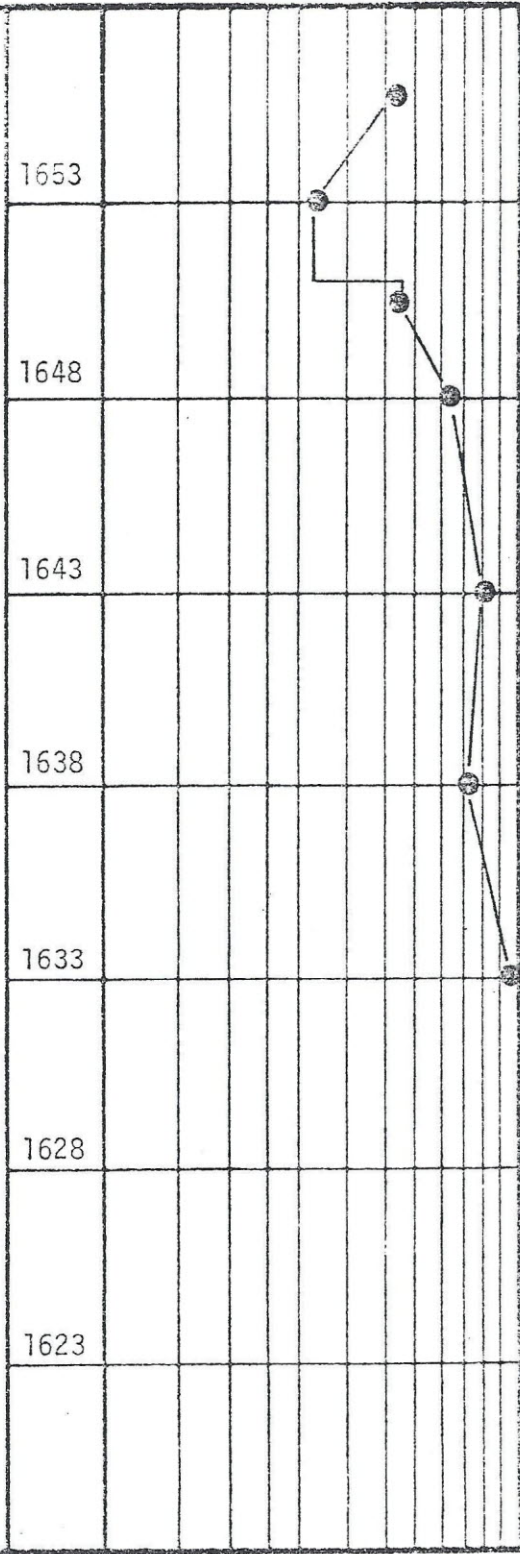
BORING NUMBER B-2
 DATE DRILLED 1-2-74
 JOB NUMBER 7502

DEPTH FT.	DESCRIPTION	CORE BIT % SIZE	ELEV. 1629	REMARKS
29.0	HARD DARK GRAY GNEISS			
30.0	MODERATELY HARD TO SOFT BROWN AND GRAY FEATHERED GNEISS	83 RQD =0	NX 1619	CONTAINS NUMEROUS M SEAMS
38.0	HARD TO VERY HARD DARK GRAY GNEISS	84 RQD =3	1609	
59.0	CORING TERMINATED	40 RQD =60	1599
