engineers | scientists | innovators

LAKE PETIT DAM

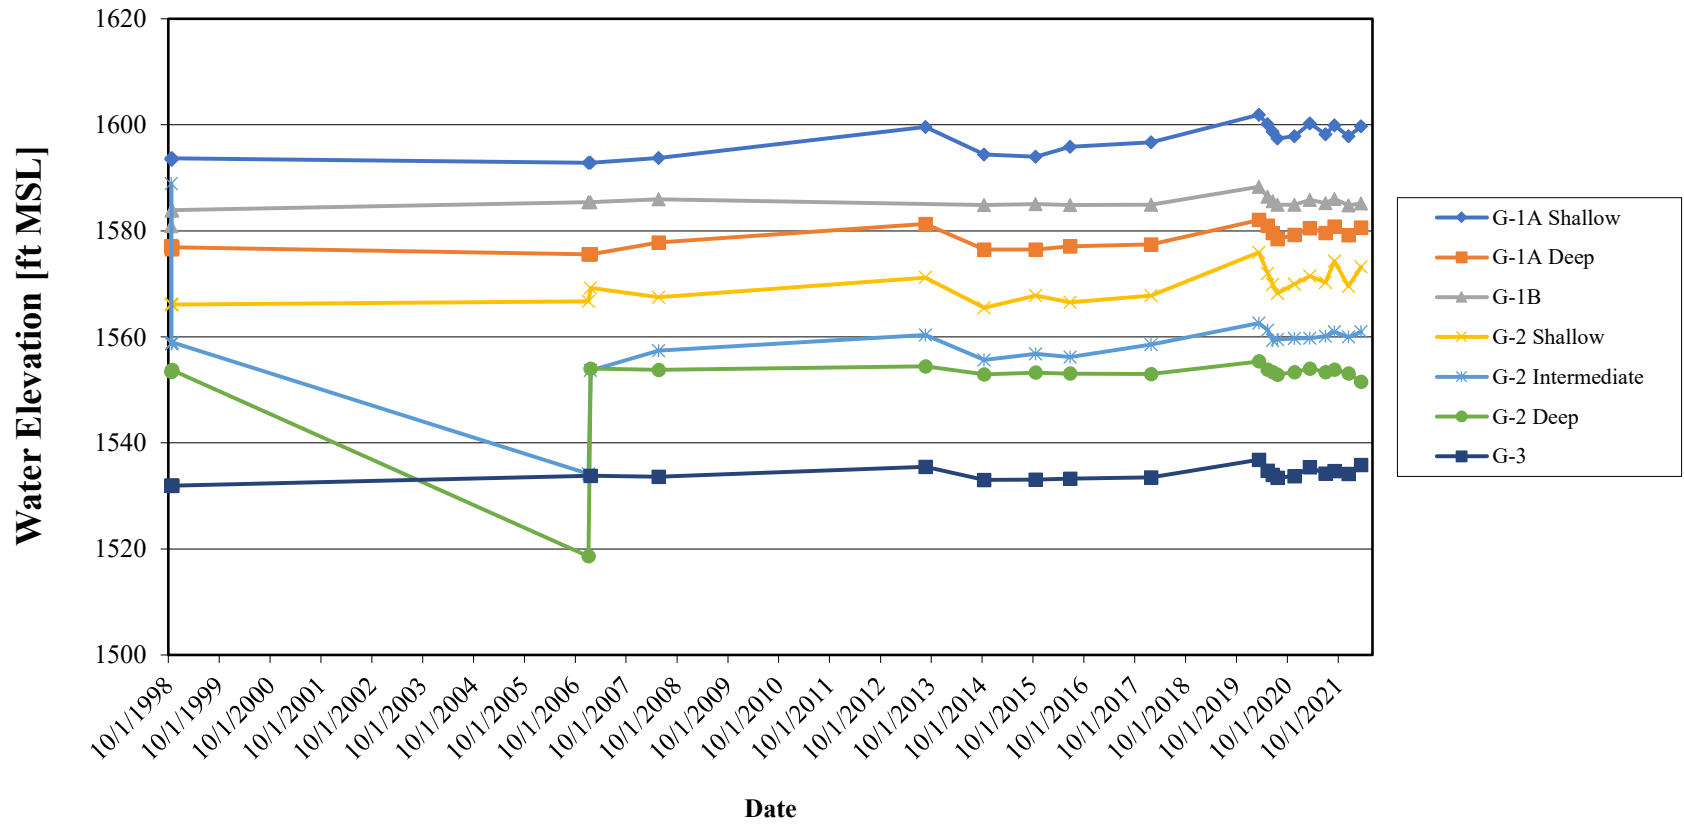
Note: G-2 water levels noted as anomolous on 3 Jan 2007. Re-measured 19 Jan 2007, and levels more consistent with previous readings.

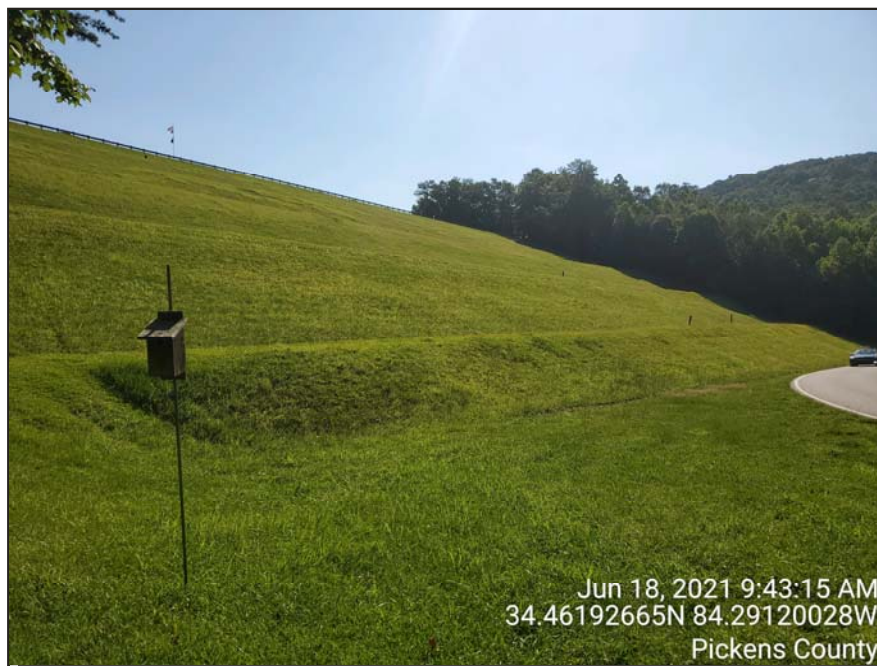
Photograph 2: Downstream Face, Jun. 2021 – overview of downstream face in good condition

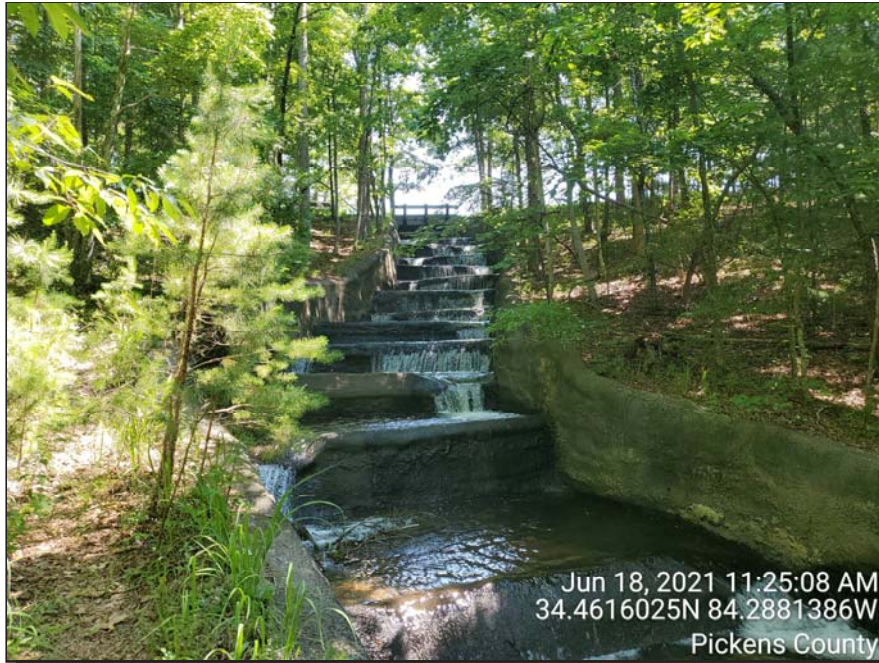
Photograph 3: Spillway, Jun. 2021 – general view of stepped spillway with moderate flow. Downed trees previously identified across or within the spillway were observed to have been removed.

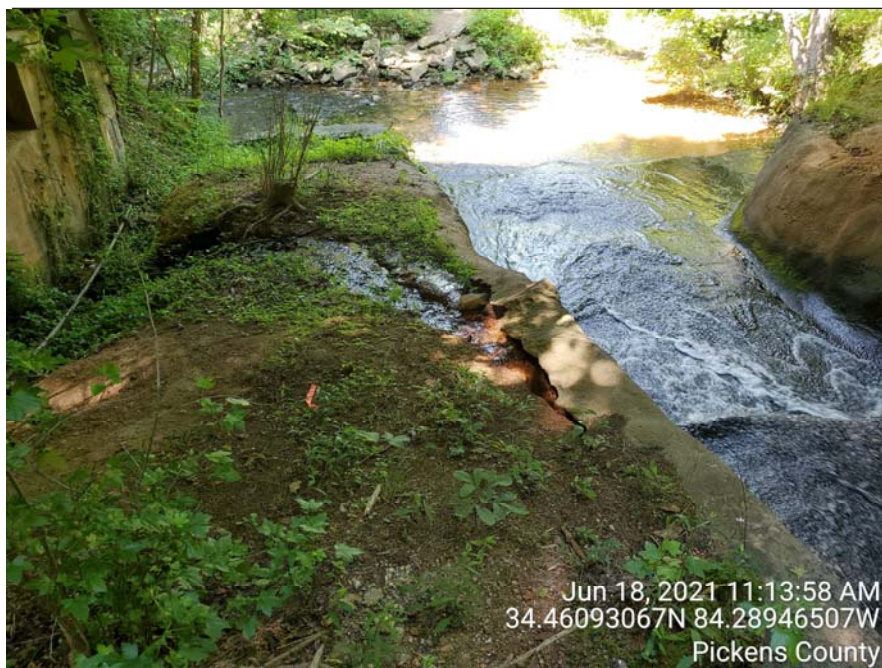
Photograph 4: Spillway, Jun. 2021 – Area of previously identified water flow behind concrete lined channel. Water flow was observed to continue and daylighted at surface in depicted location.

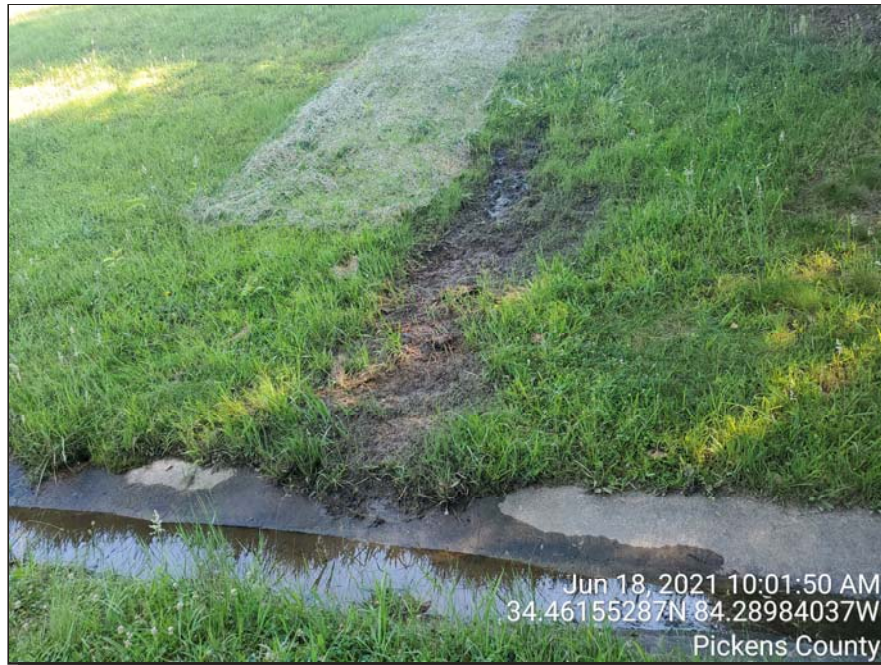
Photograph 5: Downstream face, Jun. 2021 – Previously identified wet area above Bench No. 1 at the left abutment observed to have increased water flow and diminished vegetation from the previous inspection.

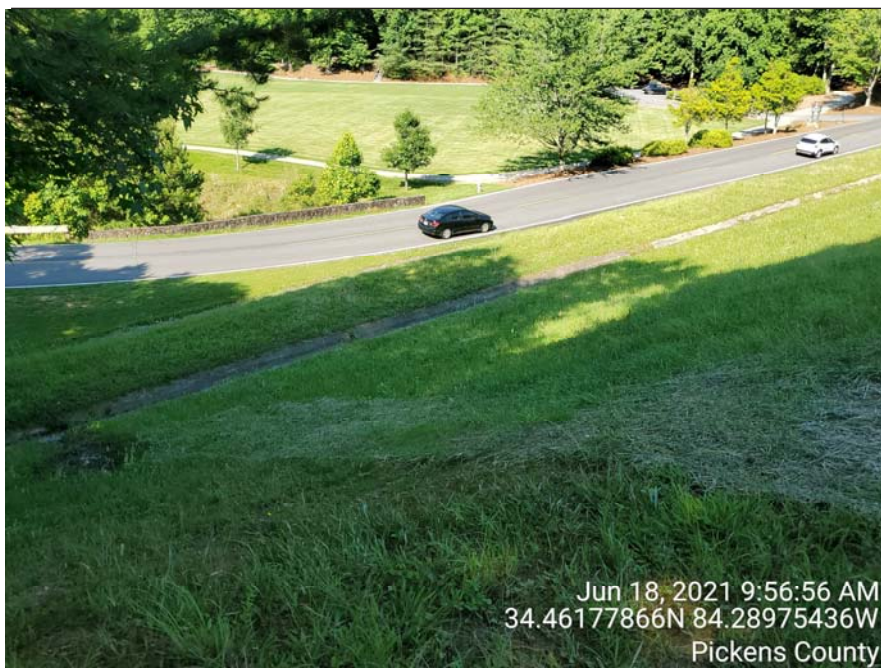
Photograph 6: Downstream face, Jun. 2021 – A minor depression previously identified at Bench No. 2 at the left abutment was observed to have been backfilled and covered with a mat of new grass .

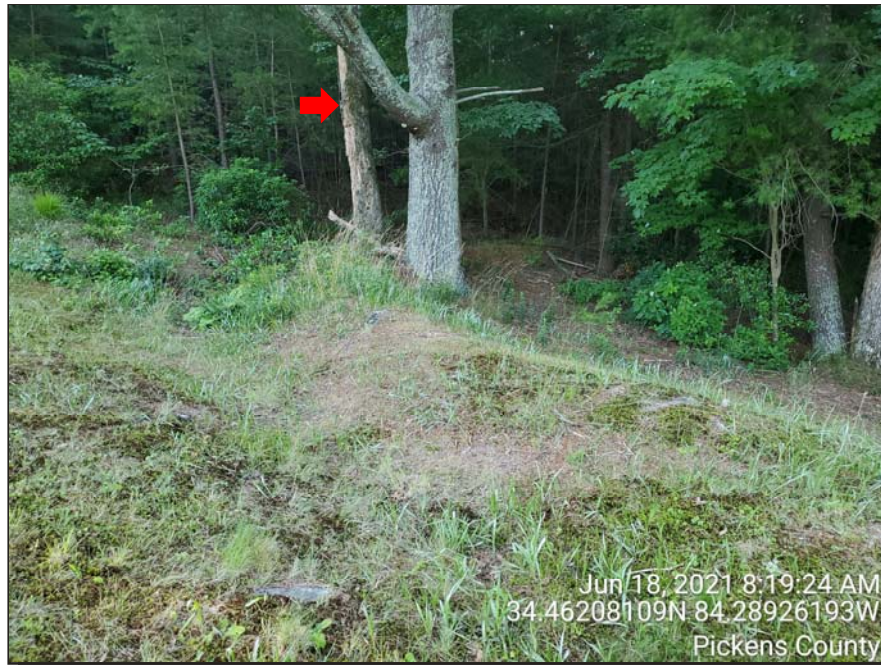
Photograph 7: Downstream face, Jun. 2021 – Surficial erosion with shallow channels developed at Bench No. 4 left abutment. Large dead tree identified during the previous inspection observed in the background.

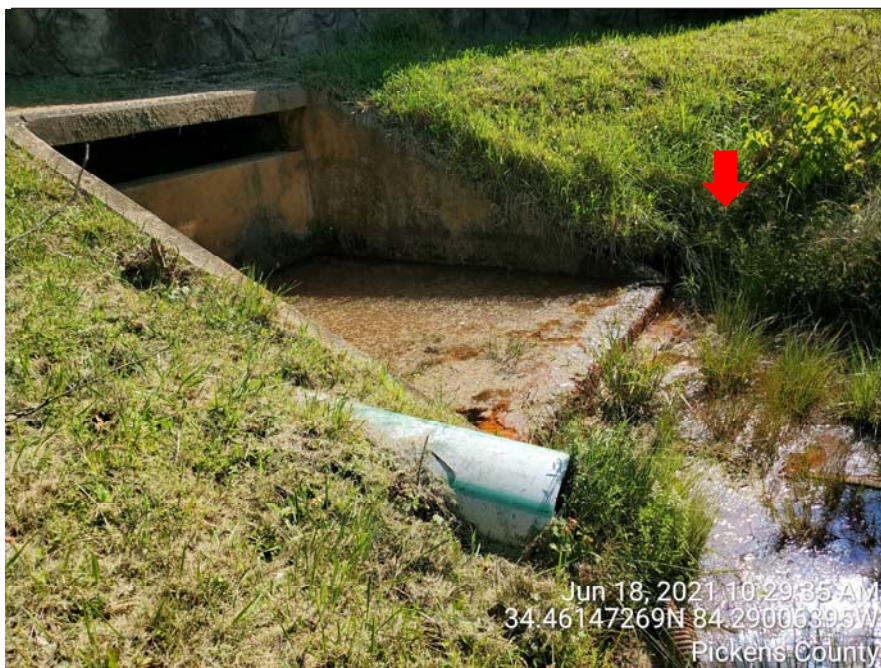
Photograph 8: Downstream outlet structure, Jun. 2021 – Normal flow observed exiting drainpipes from the impact-style stilling basin. Clear flow observed from a drainpipe at the lower right of photo (not visible). Other pipes adjacent to and downstream could not be observed due to overgrown vegetation.

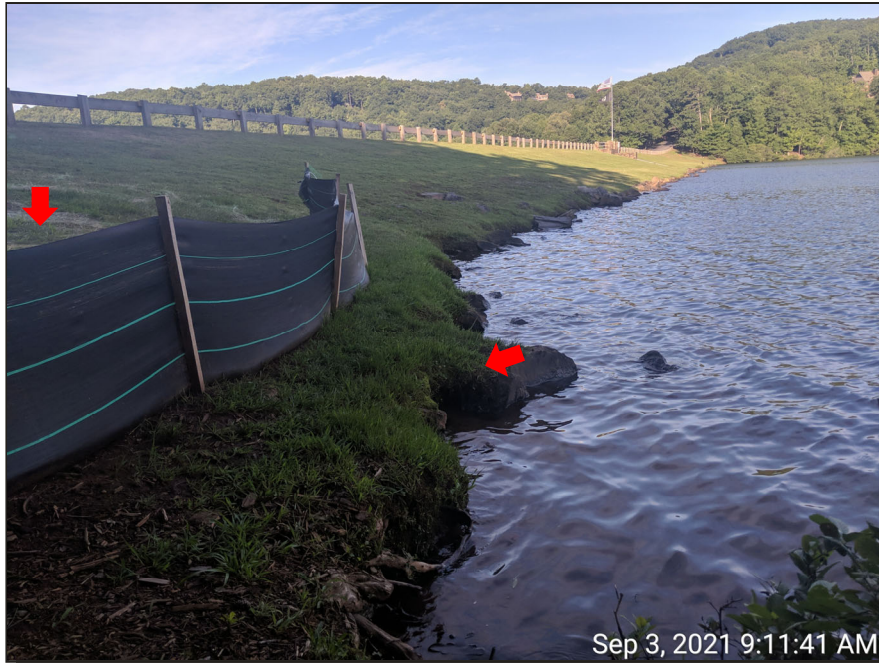
Photograph 1: Upstream Face, Sept. 2021 – localized areas of erosion repaired; beaching observed along shoreline.

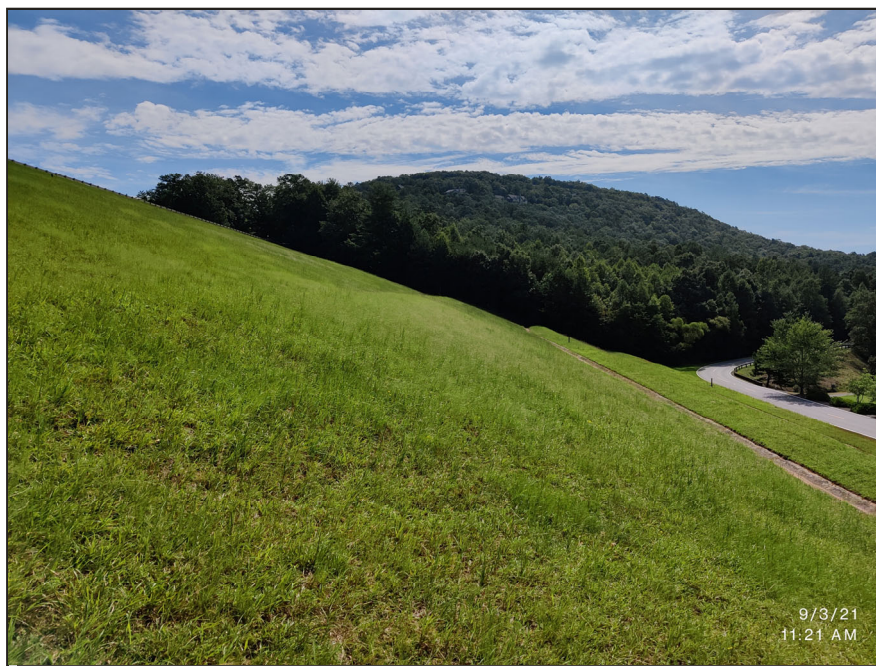
Photograph 2: Downstream Face, Sept. 2021 – overview of downstream face in good condition

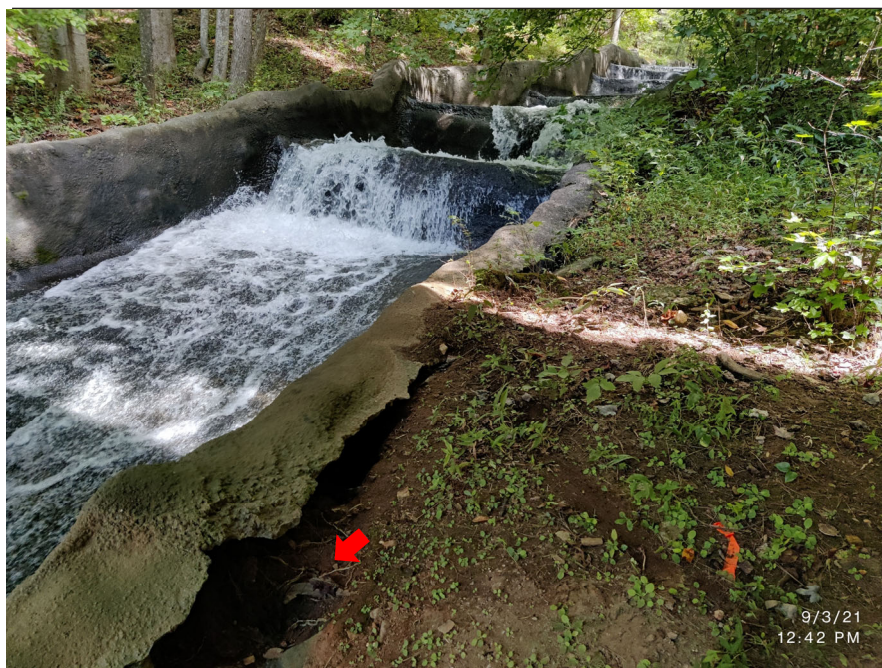
Photograph 4: Spillway, Sept. 2021 – Area of previously identified water flow behind concrete lined channel. Water flow was observed to continue.

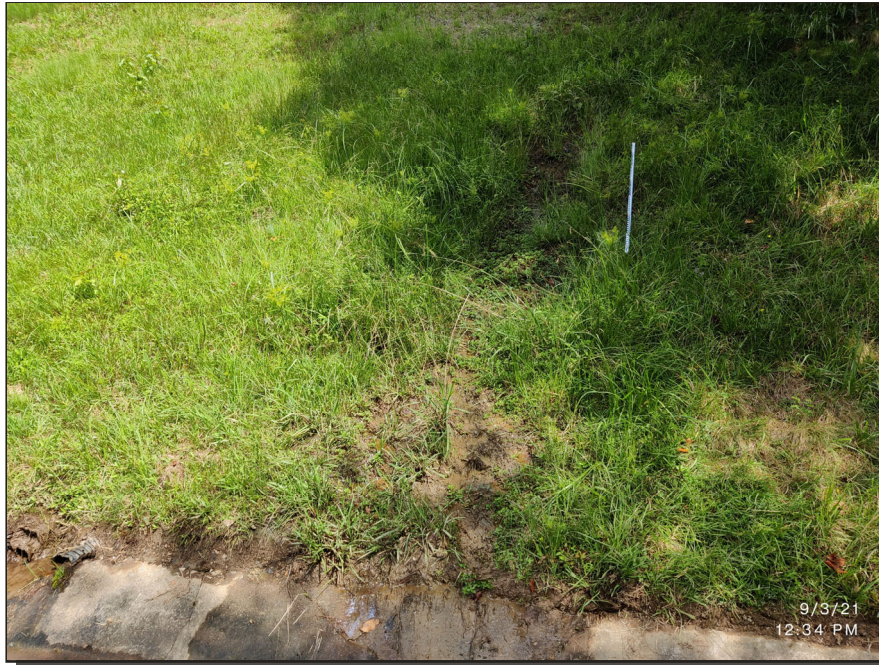
Photograph 5: Downstream face, Sept. 2021 – Previously identified wet area above Bench No. 1 at the left abutment observed to have increased water flow and diminished vegetation from the previous inspection.

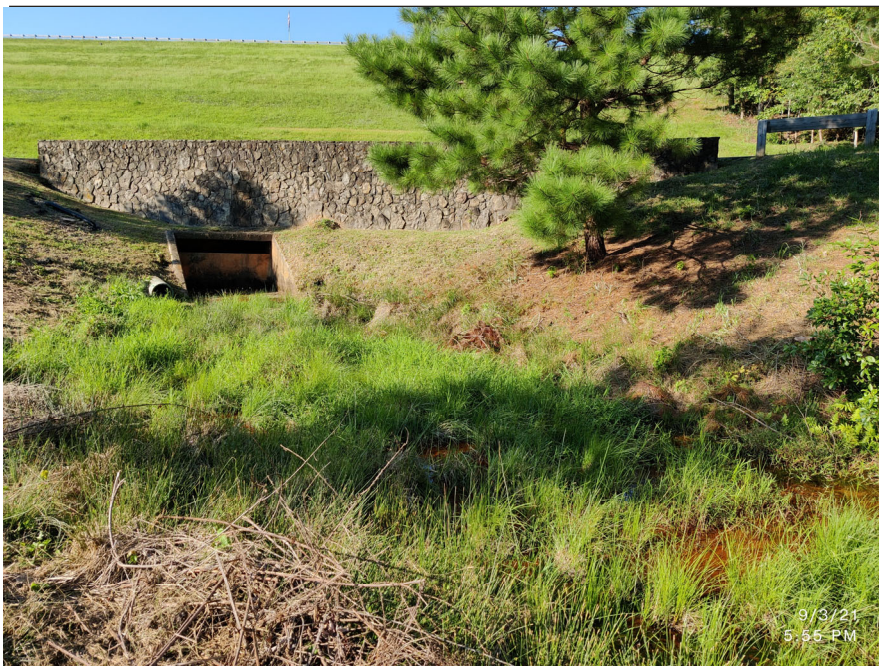
Photograph 6: Concrete distilling basin, Sept. 2021 – Vegetation clearing was conducted along the left and right banks.

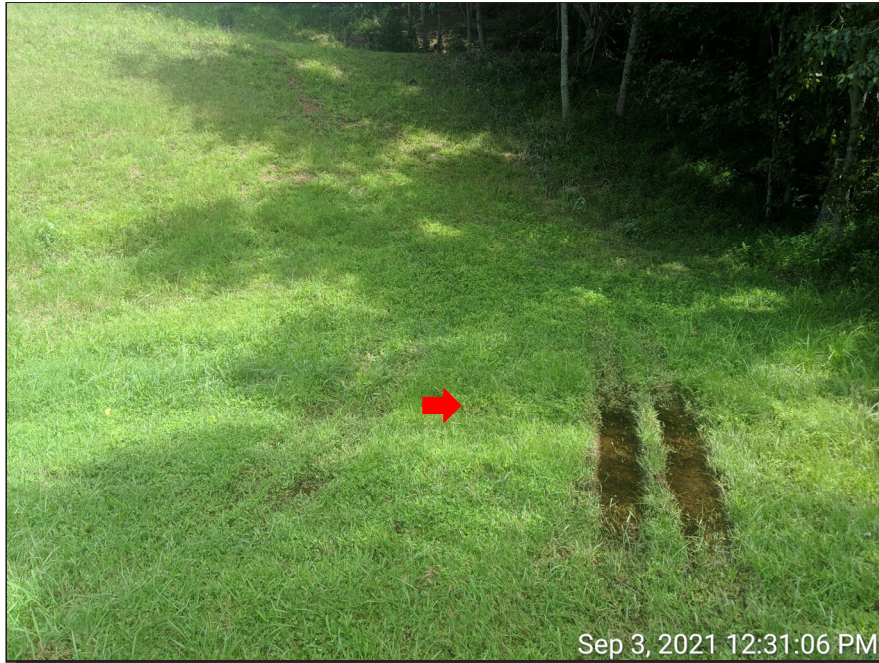
Photograph 7: Downstream toe, Sept. 2021 – Wet area observed at the downstream toe of the dam. The water ponding in the area is believed to be water discharging from the left weir on Bench No. 1.

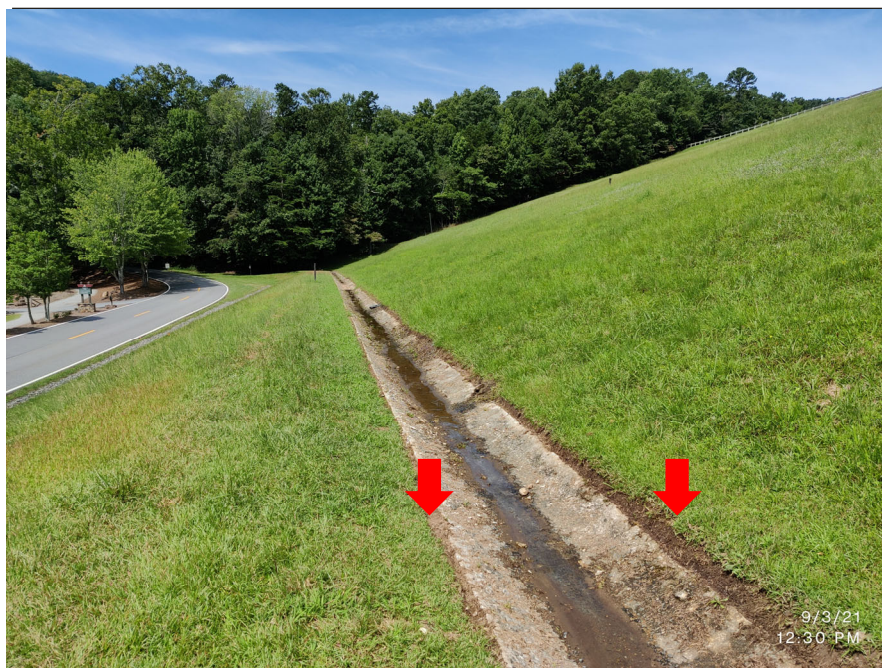
Photograph 8: Edging performed on the concrete channels located on Bench No.1 and Bench No.2

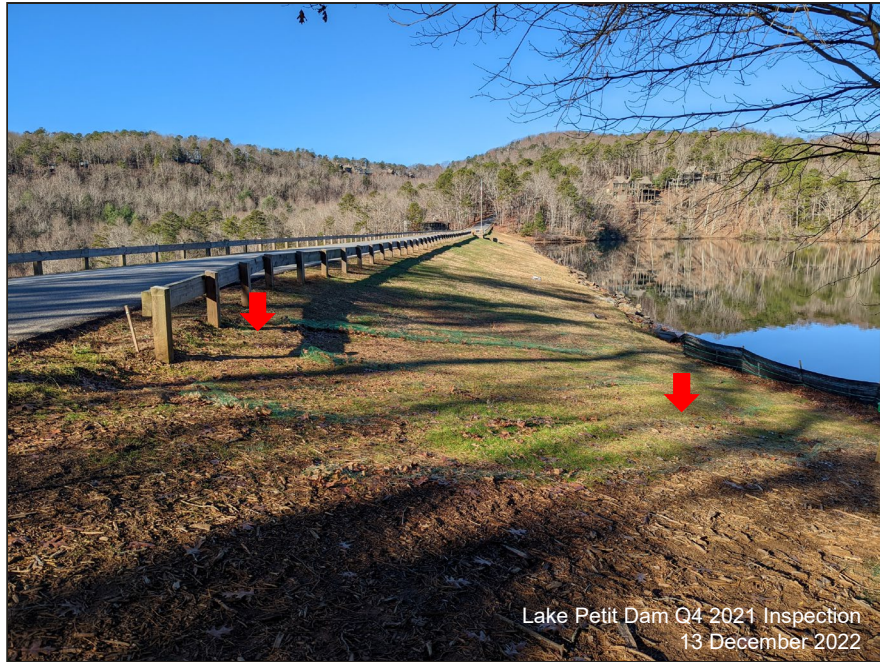
Photograph 1: Upstream Face, Dec. 2021 – Localized areas of surficial erosion previously repaired which require upkeep due to pedestrian traffic.

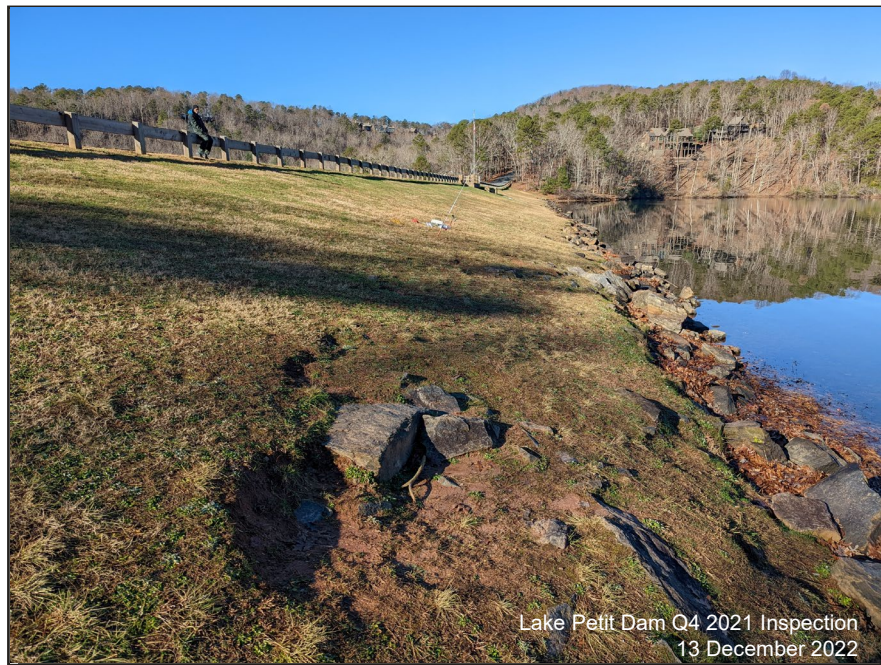
Photograph 2: Upstream Face, Dec. 2021 – Riprap along the bottom of the upstream face is more exposed than previous inspections – shoreline protection repairs are scheduled for early 2022.

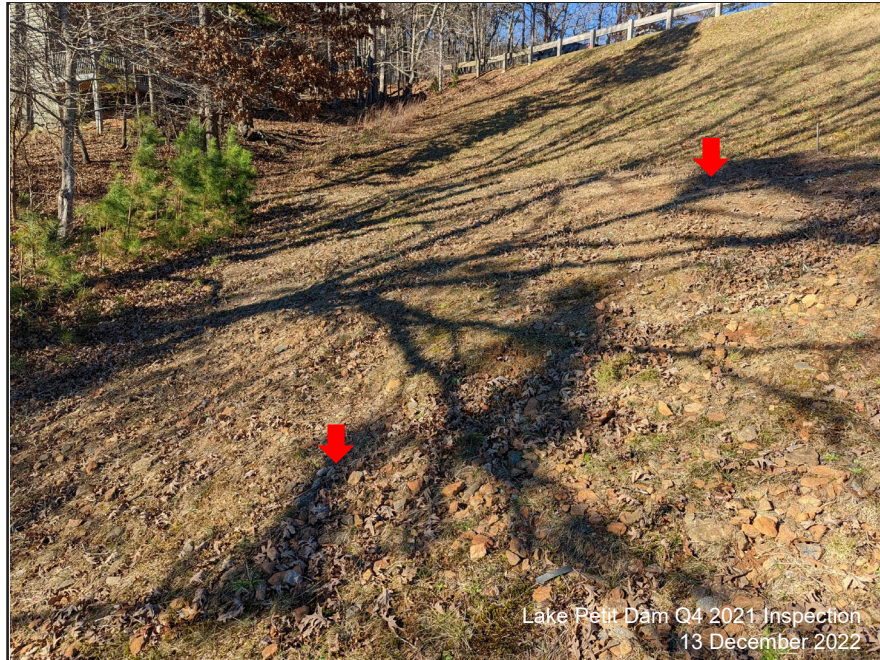
Photograph 3: Downstream Face, Dec. 2021 – Surfacial erosion observed between Bench No.4 and No.5 on the right side of the downstream face.

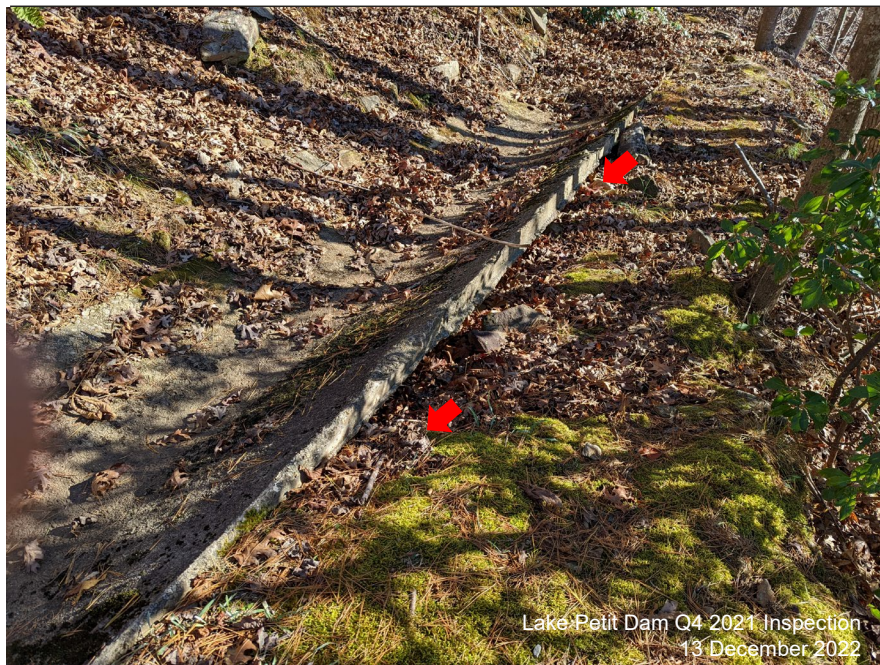
Photograph 4: Left Rim, Dec. 2021 – Foundation material under the concrete channel on Bench No.2 has eroded away, and should be replaced.

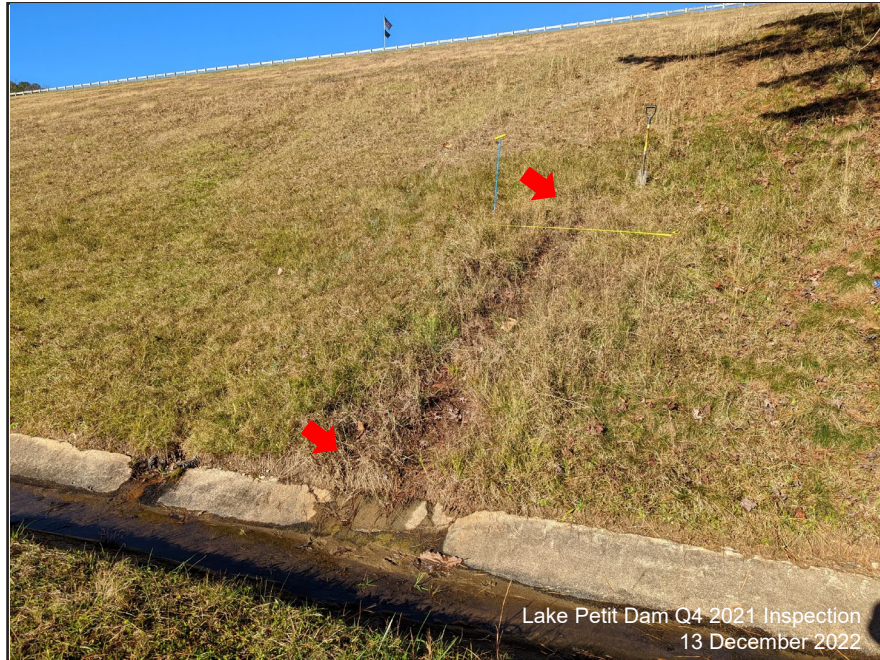
Photograph 5: Downstream Face, Dec. 2021 – Previously identified wet area above Bench No. 1. No changes observed in the wet spot.

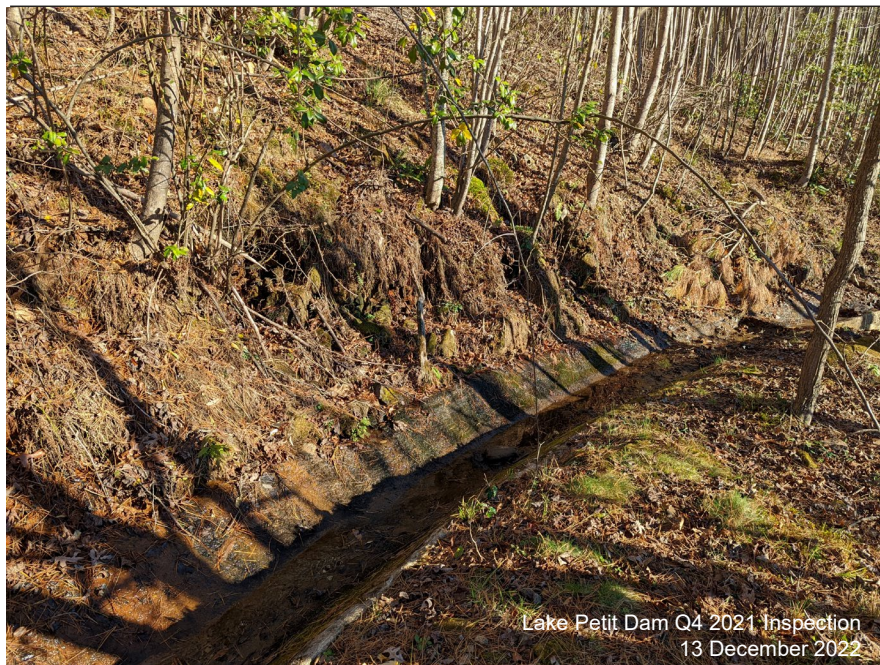
Photograph 6: Downstream Face, Dec. 2021 – Surficial erosion observed on the left abutment, which leads to sediment built in the left weir.

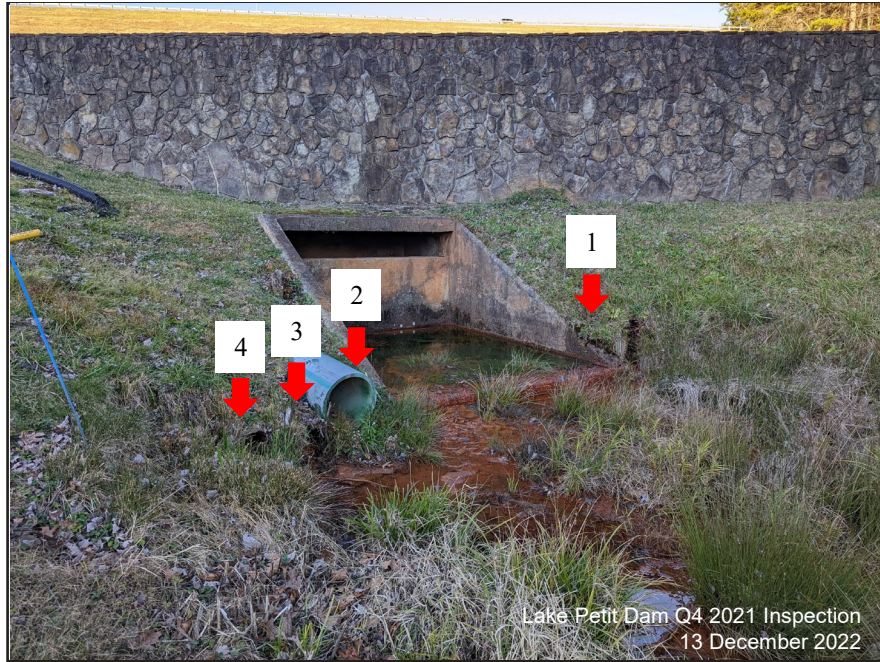
Photograph 7: Concrete Stilling Basin, Dec. 2021 – Flow observed and measured at the drain left of the concrete stilling basin (1), and the two corrugated pipes on the right (3 and 4).

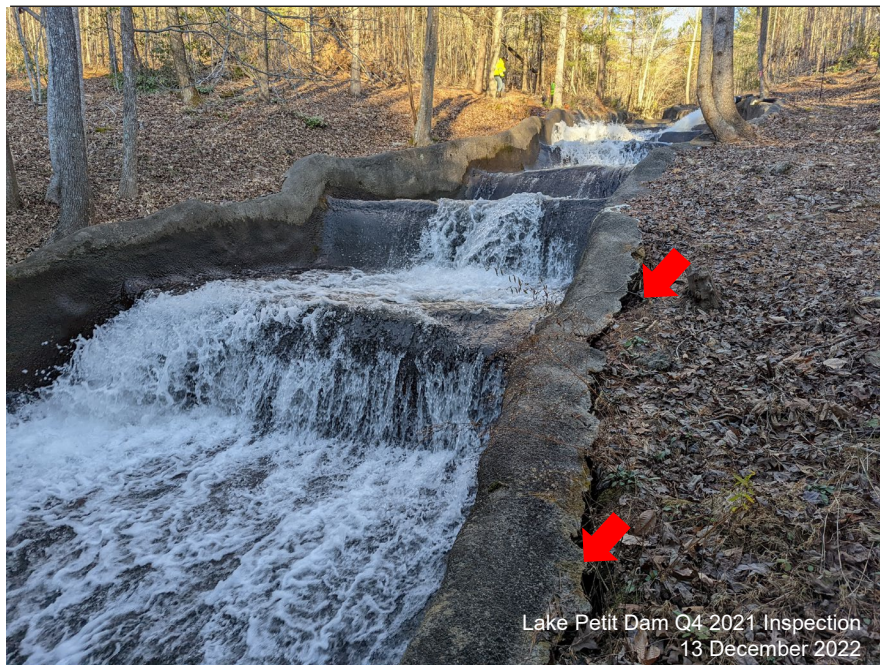
Photograph 8: Spillway, Dec. 2021 – Erosion observed behind the left side of the spillway near the bridge on Wolfscratch Drive. Water was being released via a bypass line operated by Big Canoe to lower the reservoir to conduct a spillway inspection. Maintenance on the spillway is scheduled for early 2022.

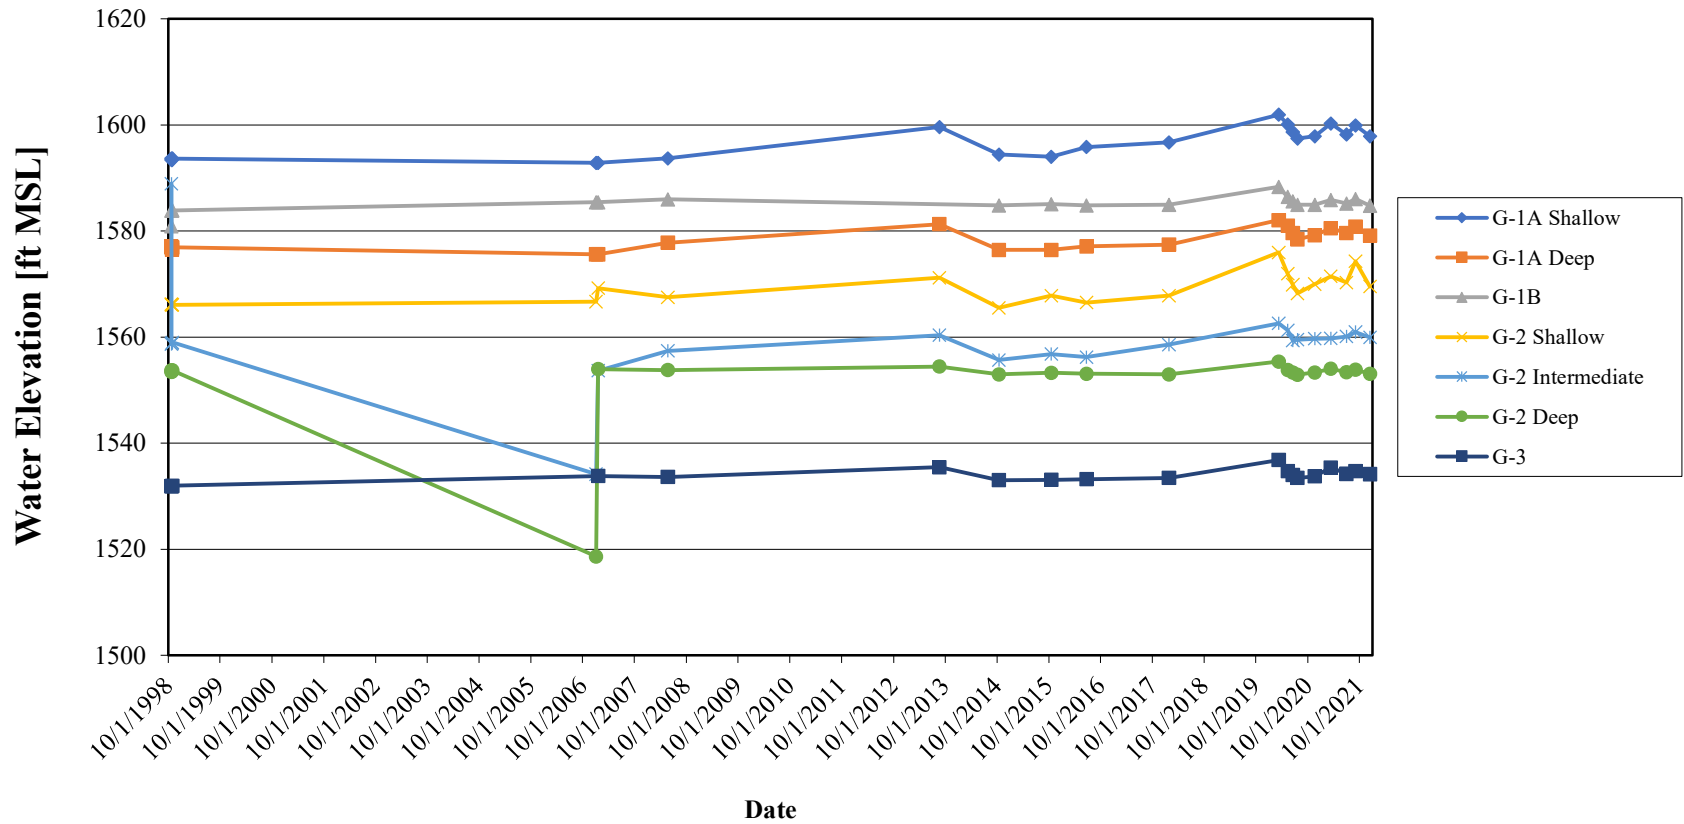
Note: G-2 Shallow water levels noted as anomolous on 3 Jan 2007. Re-measured 19 Jan 2007, and levels more consistent with previous readings.

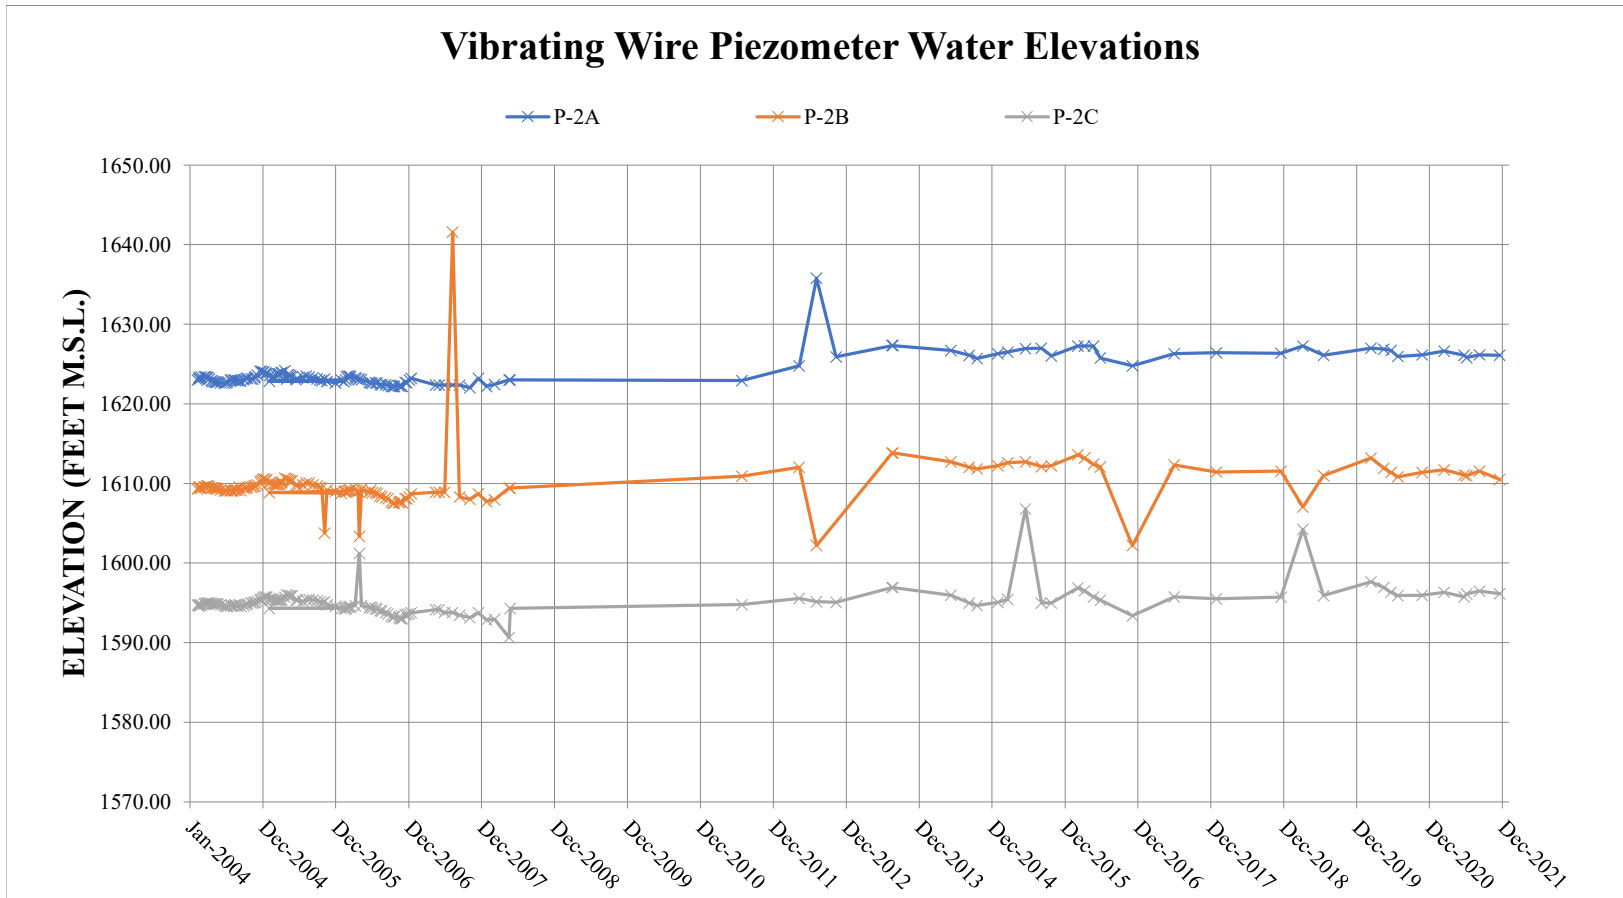
Note: Historical data anomalies generally appear to be the result of transcription errors.

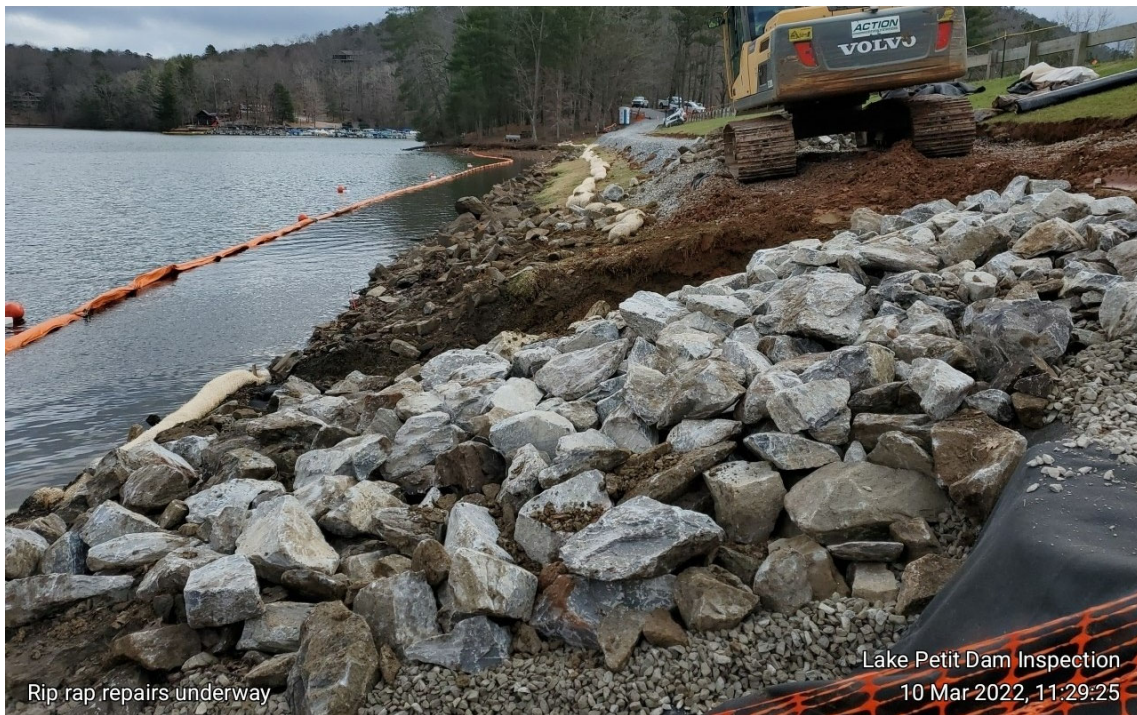
Photograph 1: Beginning of shoreline protection repairs (looking toward left abutment)

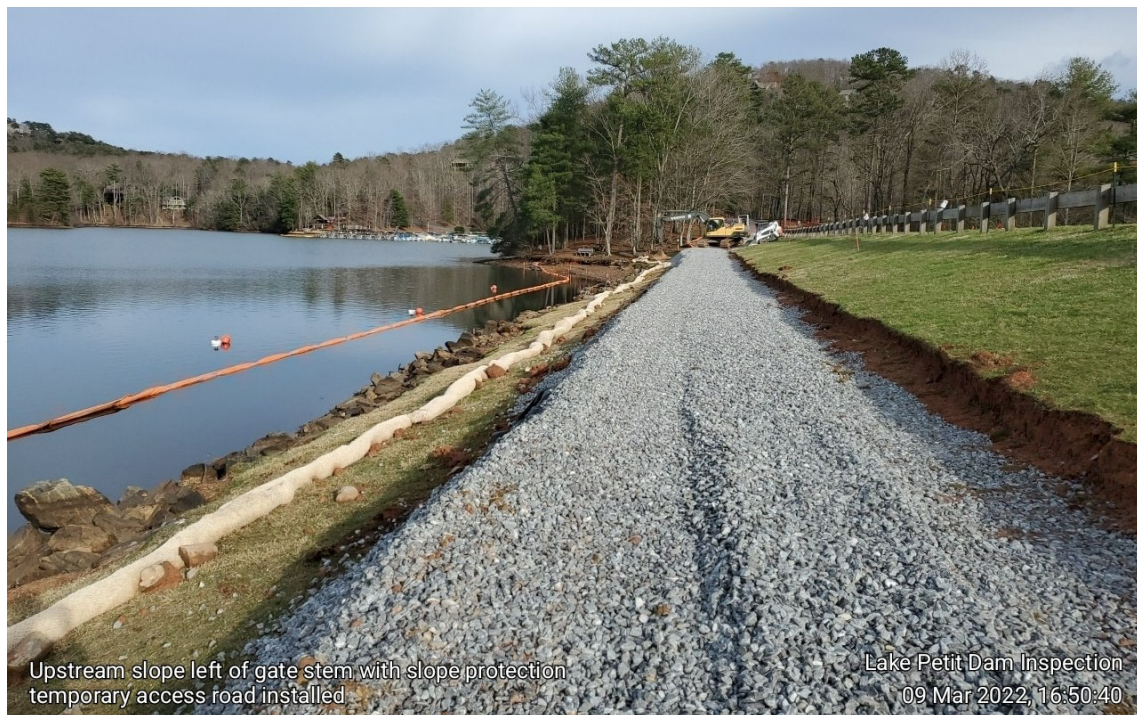
Photograph 2: Temporary access road for shoreline protection repairs

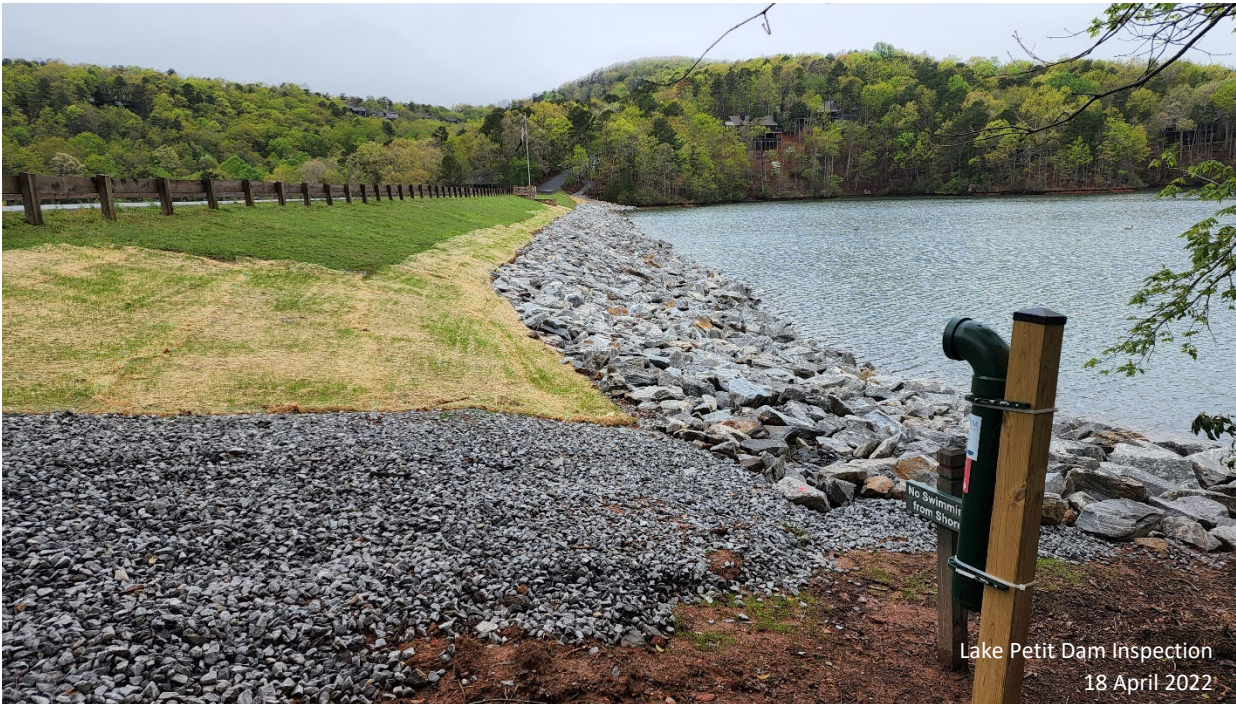
Photograph 3: Shoreline protection repairs completed (looking toward right abutment)

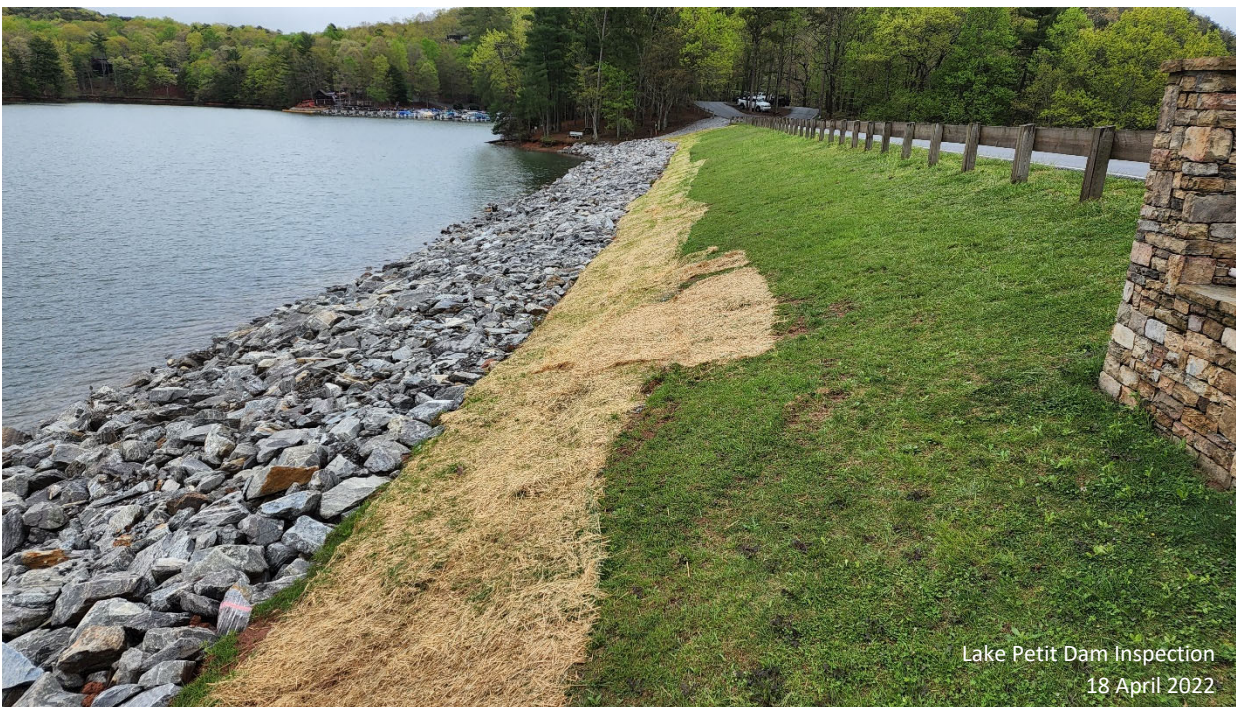
Photograph 4: Shoreline protection repairs completed (looking toward left abutment)

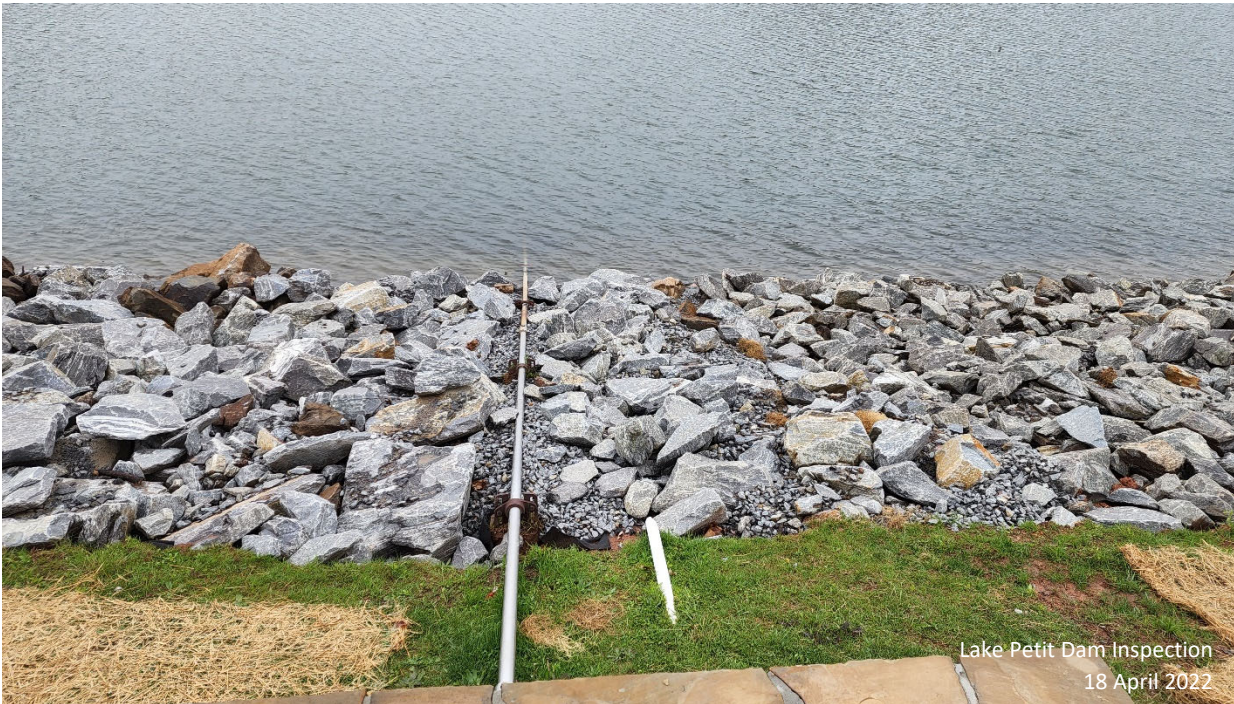
Photograph 5: Shoreline protection repairs completed (looking down alignment of gate stem)
