engineers | scientists | innovators

LAKE PETIT DAM

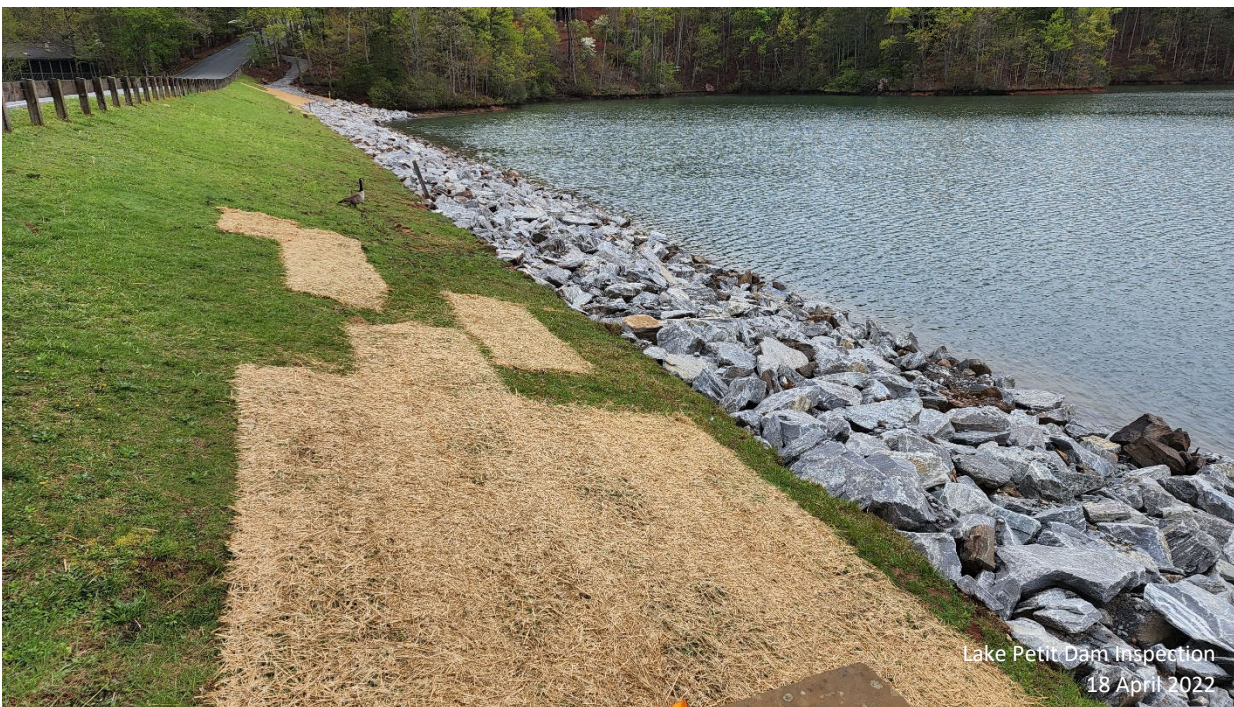
Photograph 6: Shoreline protection repairs completed (looking toward right abutment)

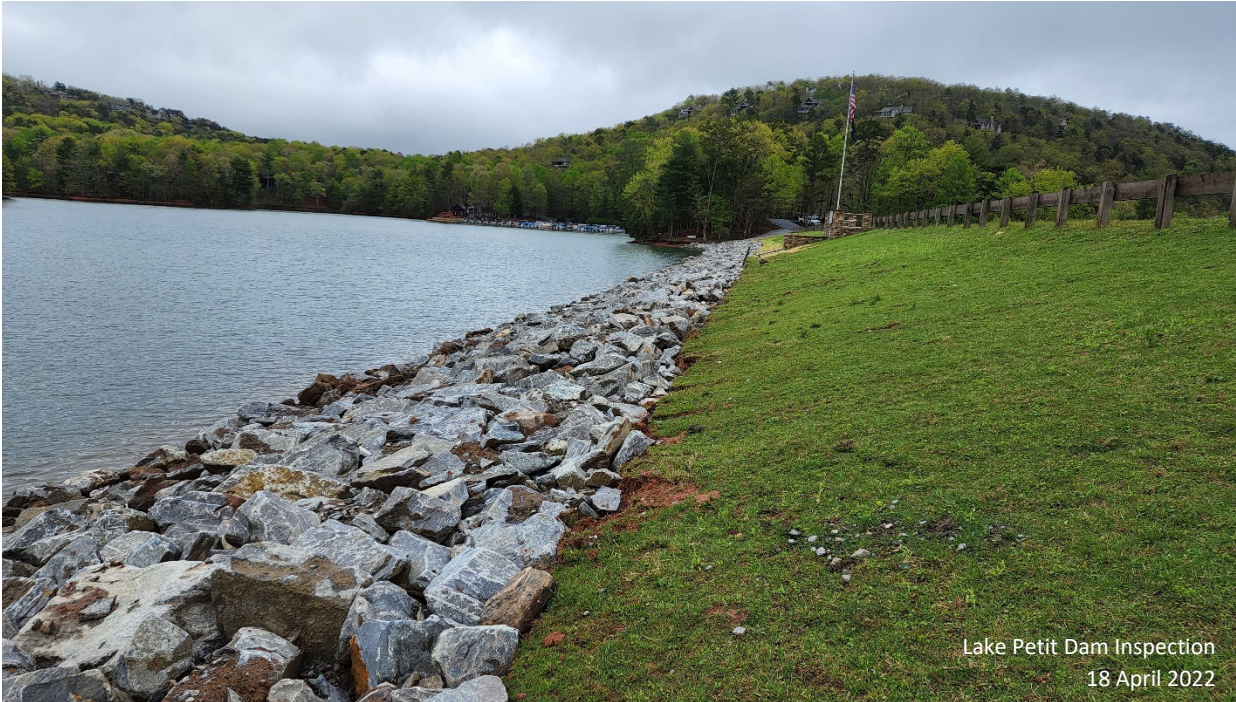
Photograph 7: Shoreline protection repairs completed (looking toward left abutment)

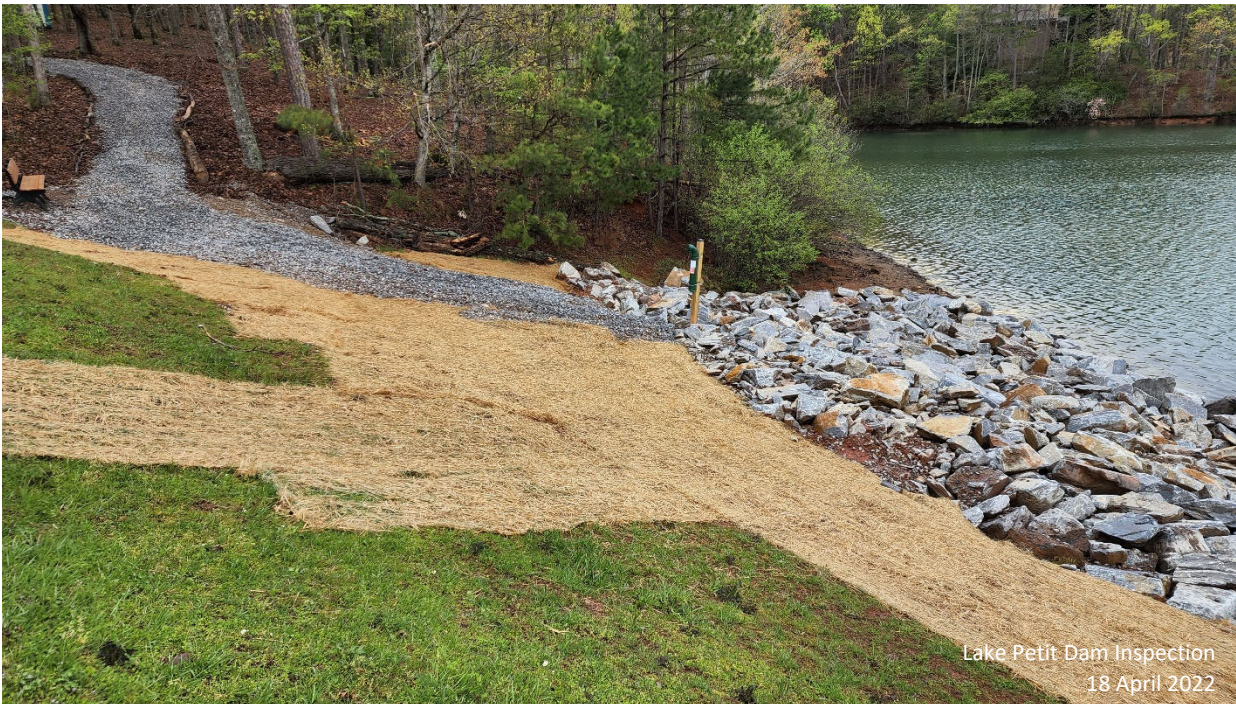
Photograph 8: Shoreline protection repairs and new pedestrian access on right abutment

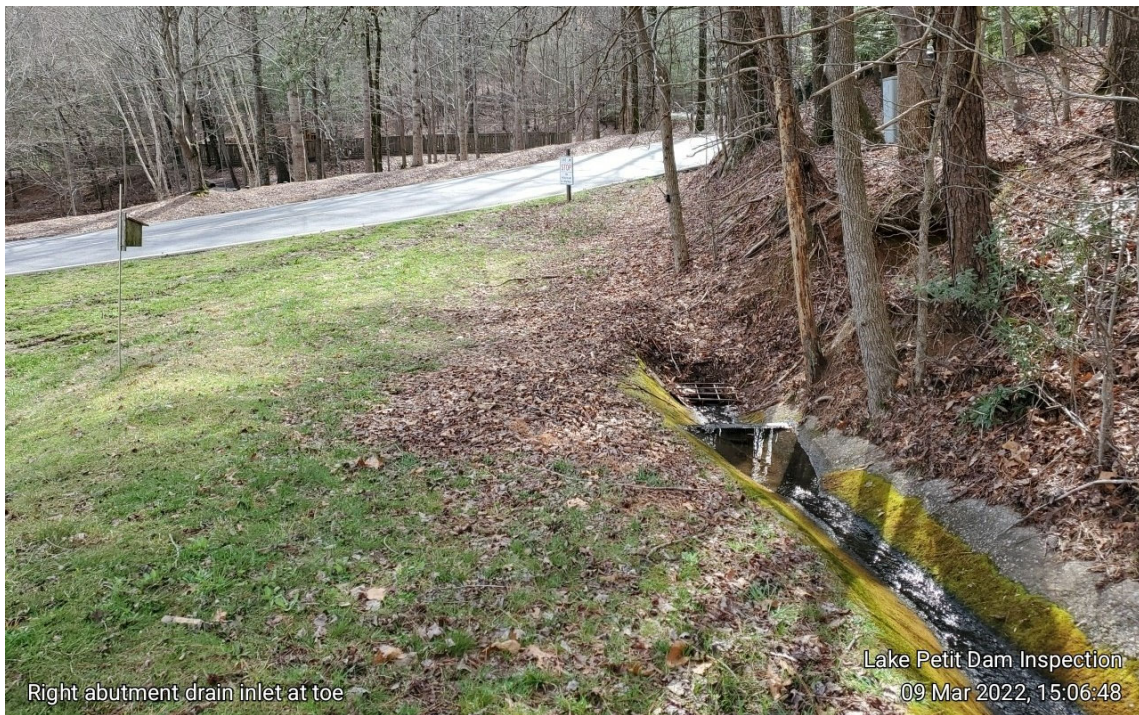
Photograph 9: Right abutment weir

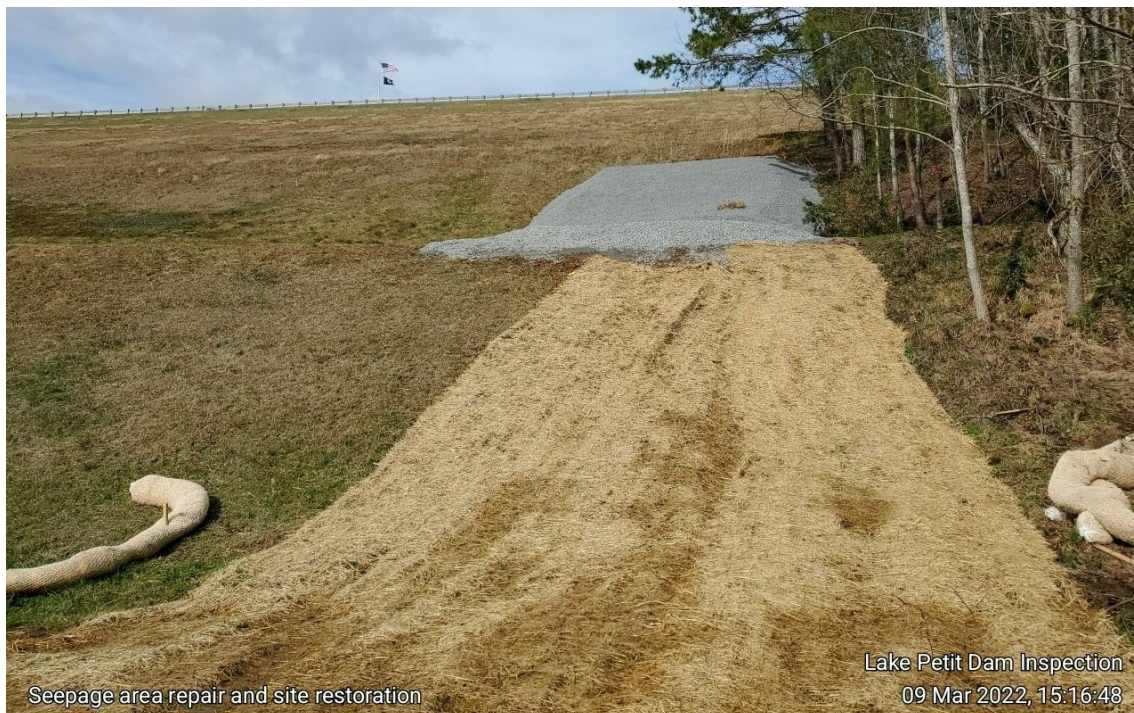
Photograph 14: Seepage area repair and site restoration

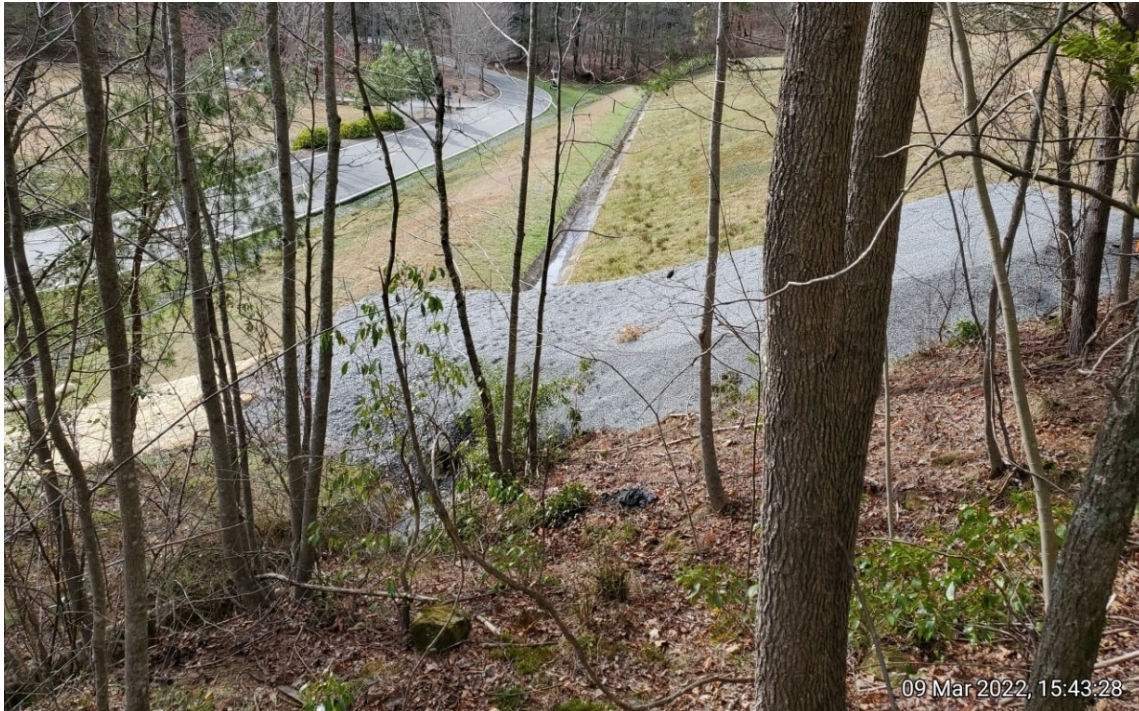
Photograph 15: Seepage area repair from left abutment

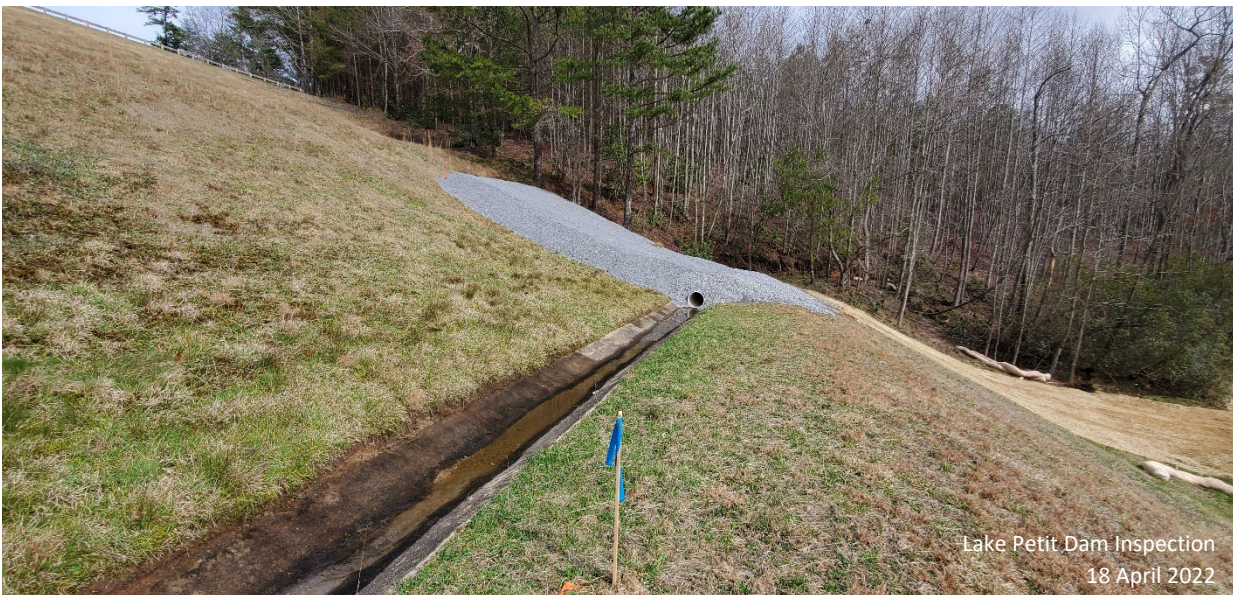
Photograph 16: Seepage Area Repair between Bench 1 (El. 1544) and Bench 2 (El. 1562)

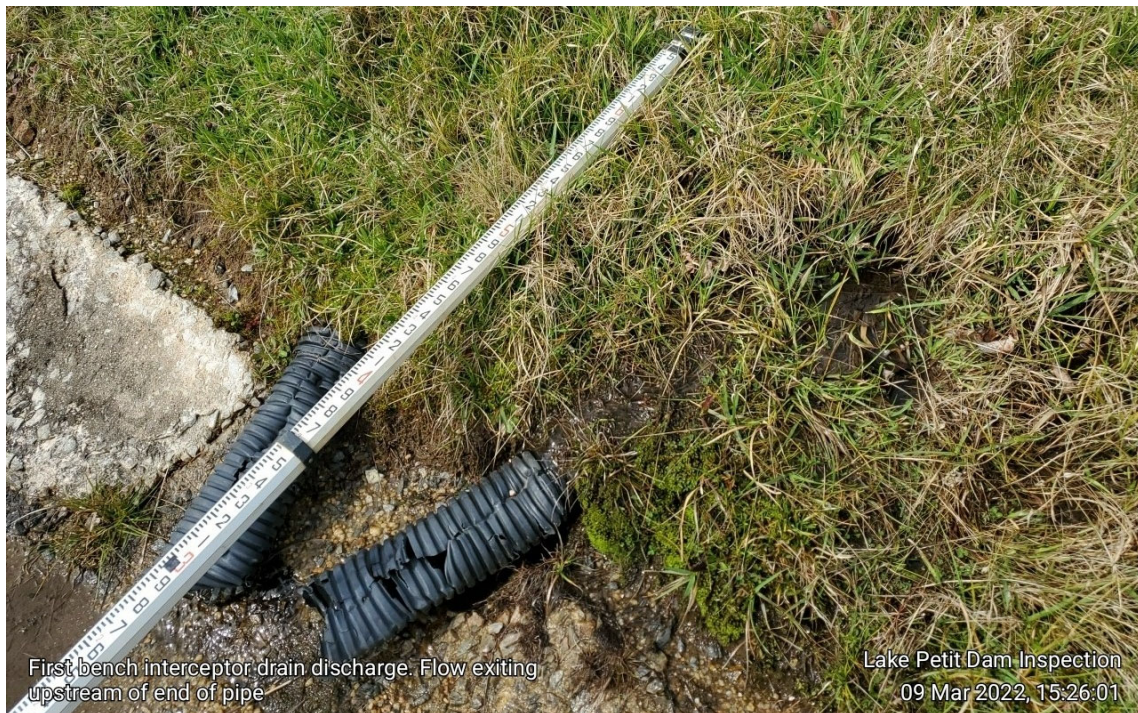
Photograph 17: Interceptor drains 9 and 10 discharge above end of pipe

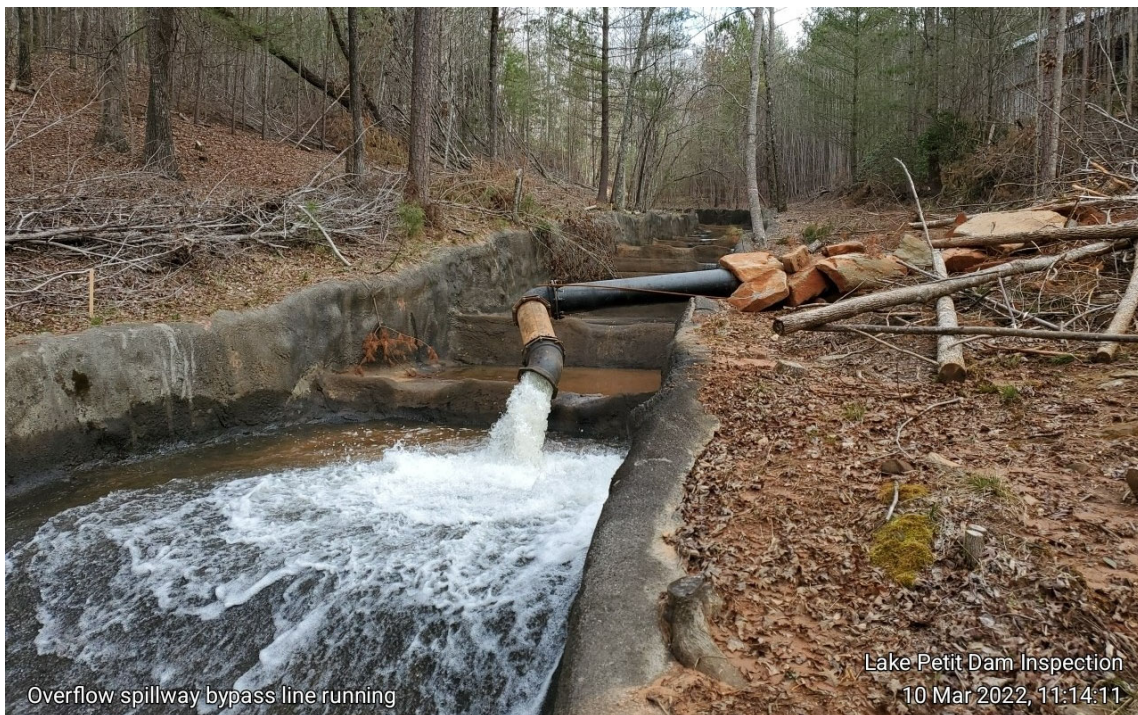
Photograph 28: Spillway bypass line in operation to lower reservoir level for maintenance repairs

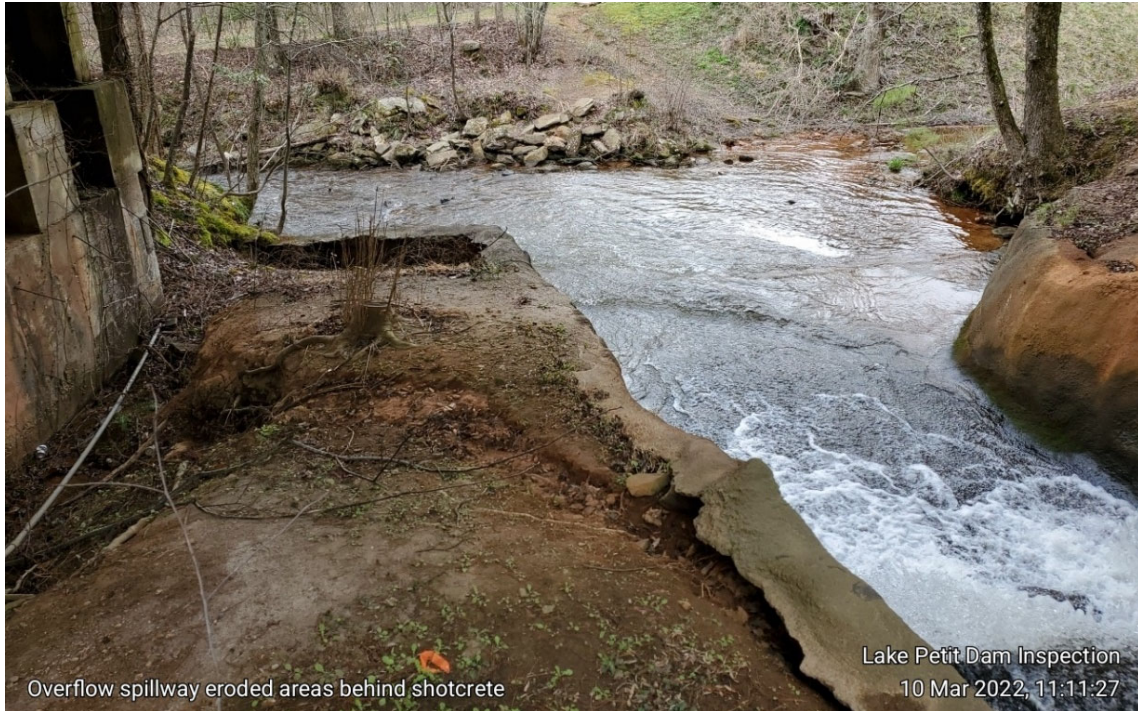
Photograph 29: Eroded areas behind spillway concrete

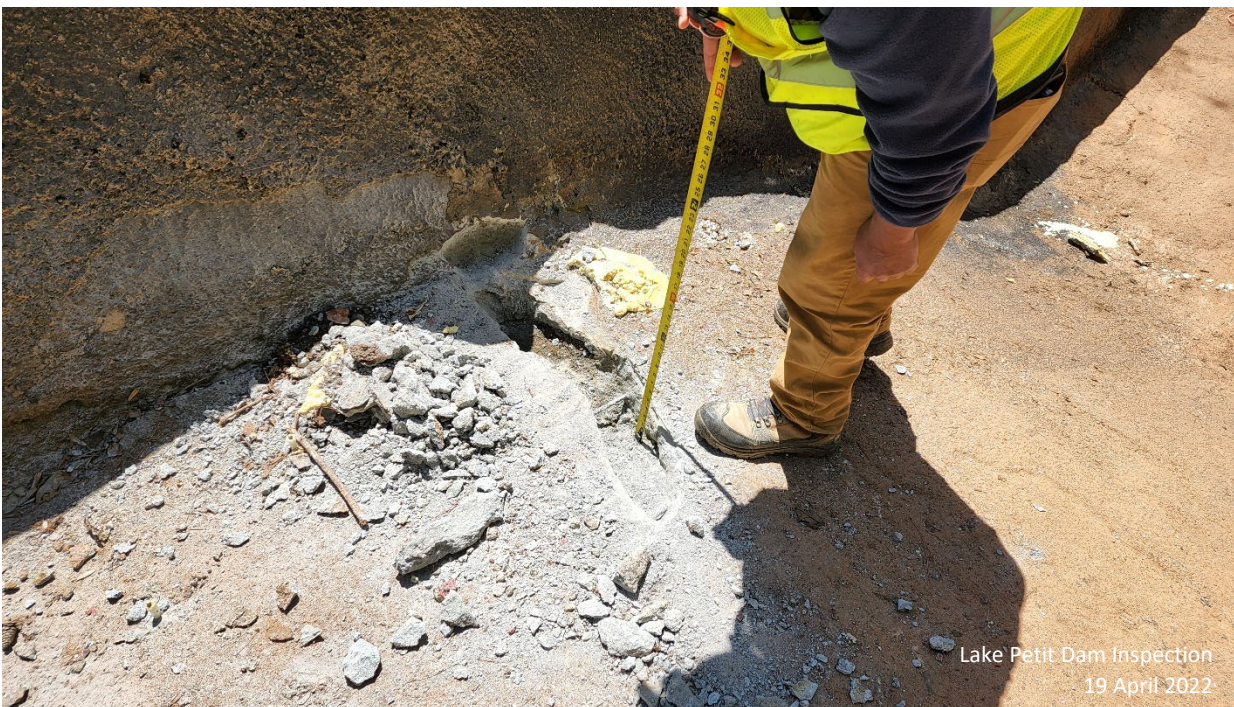
Photograph 34: Cracked area chipped out for patching

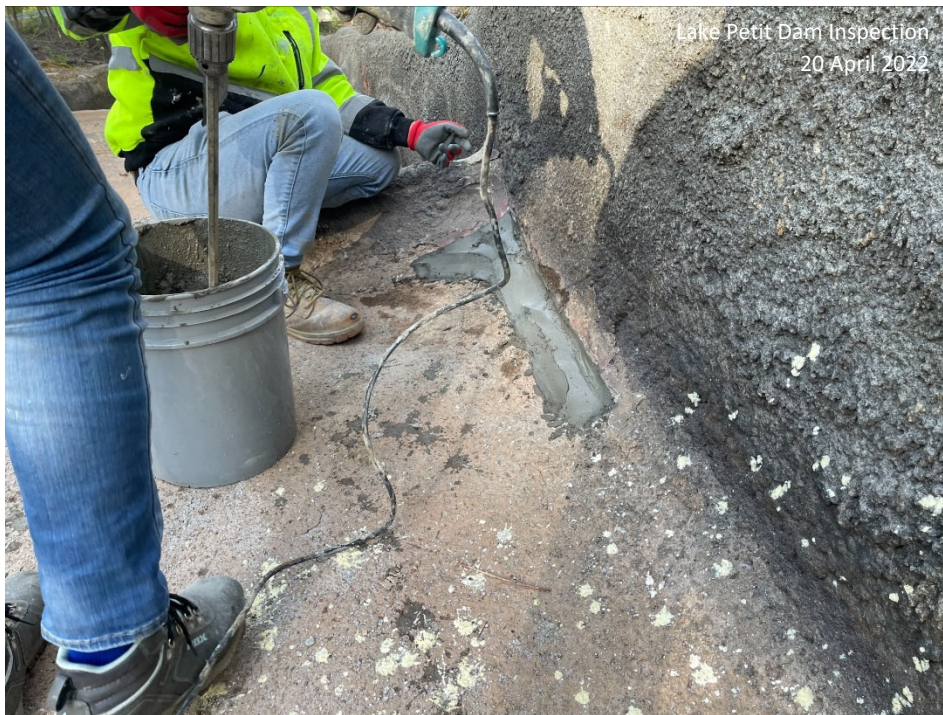
Photograph 35: Cracked area patched

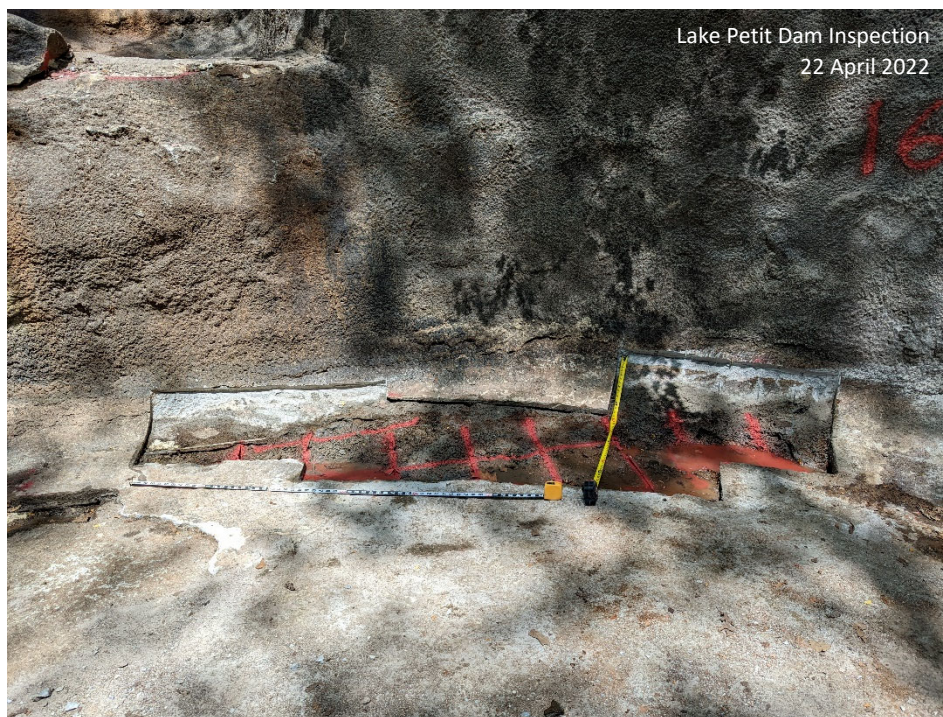
Photograph 36: Repair at Step 16 – removal of damaged gunite section

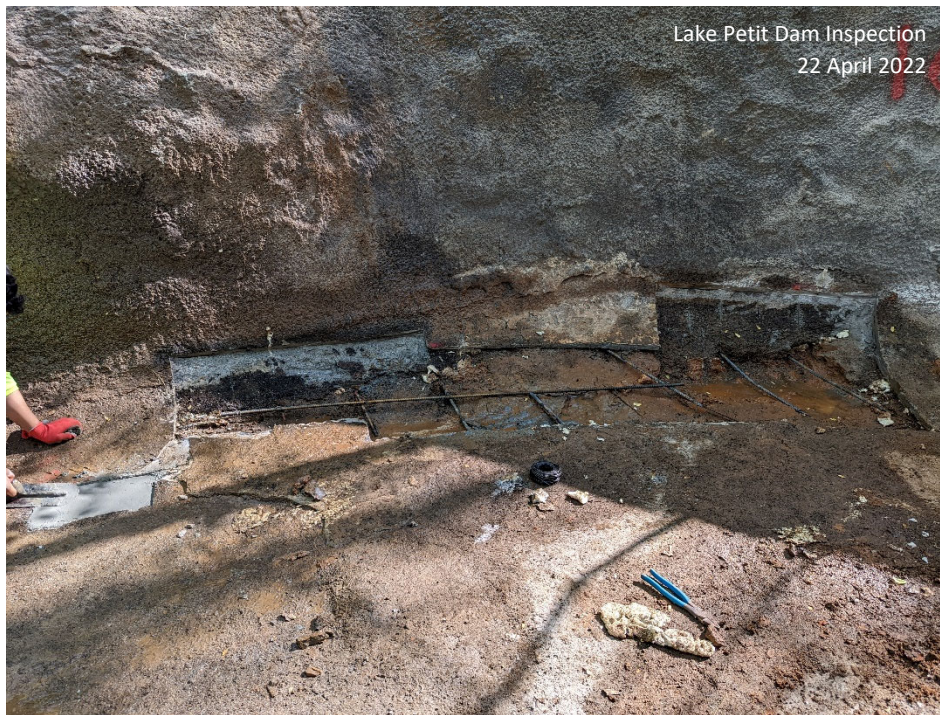
Photograph 37: Repair at Step 16 – rebar installation

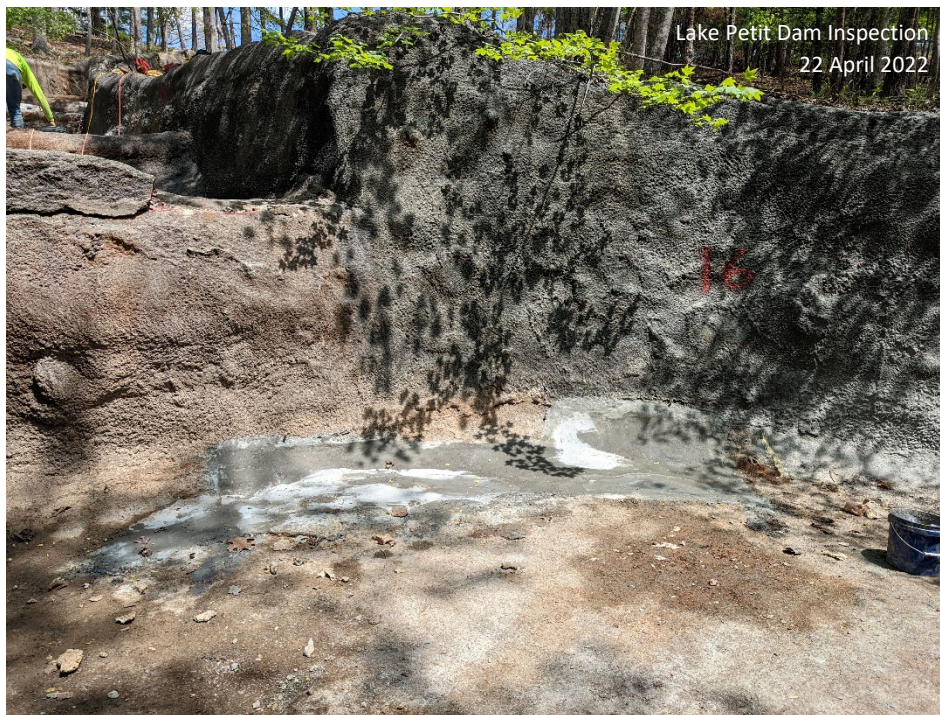
Photograph 38: Repair at Step 16 – repair complete
