**Subject: Owner Quarterly Inspection Reports 2022/2023 (Quarters 2, 3, and 4 of 2022 and Quarter 1 of 2023)
Lake Petit Dam (ID Number (No.) 112-009-00462), Pickens County**

Embankment (Earth) Dam Inspection Form

Name of Dam: Lake Petit Dam Date: 06 June 2022
Location of Dam (County): Pickens County Weather: Sunny, 82 degrees F
Inspected by (Print Name): Edisson O. Avila, E.I.

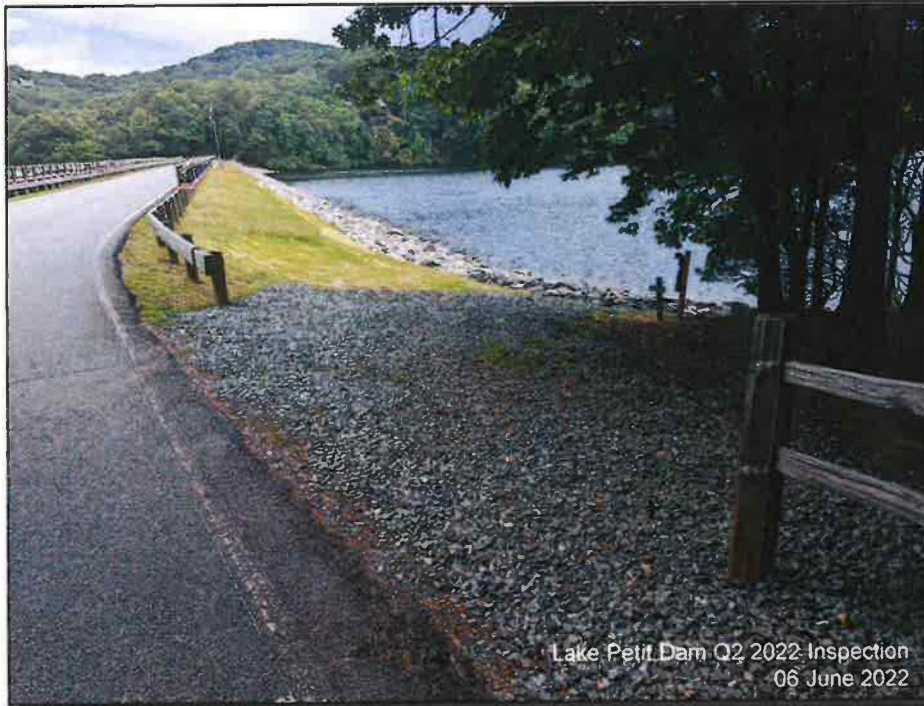
Photograph 1: Upstream Face, June 2022 – GDOT No. 4 aggregate was placed along the left and right groin (not in Photograph 1) to assist with historical surficial erosion observed on the groins.

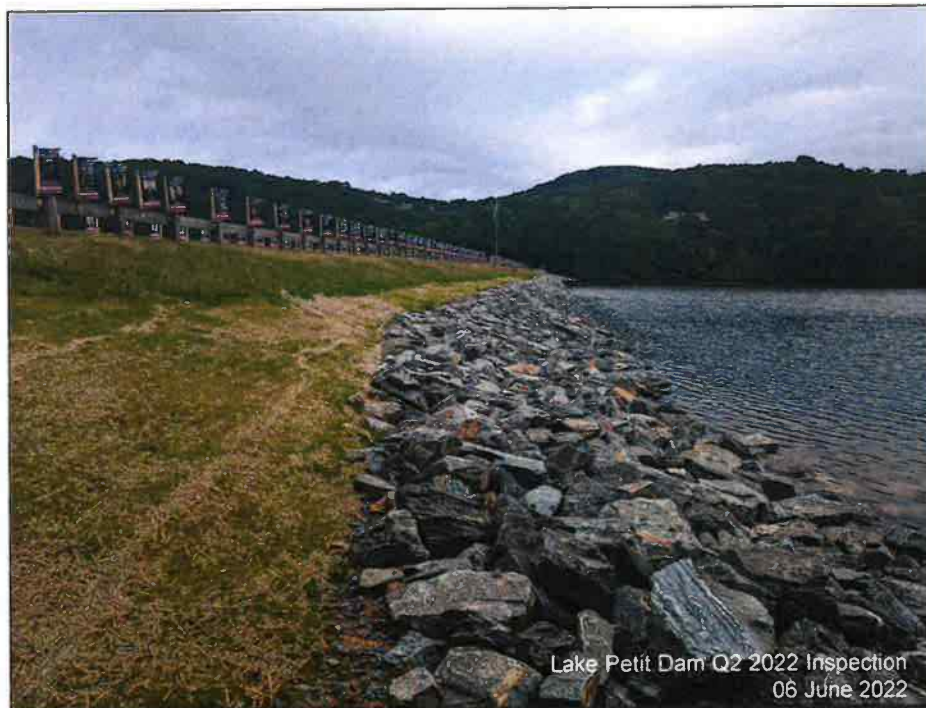
Photograph 2: Upstream Face, June 2022 – Shoreline protection repair conducted in March 2022. No changes were observed on the recently placed rip rap.

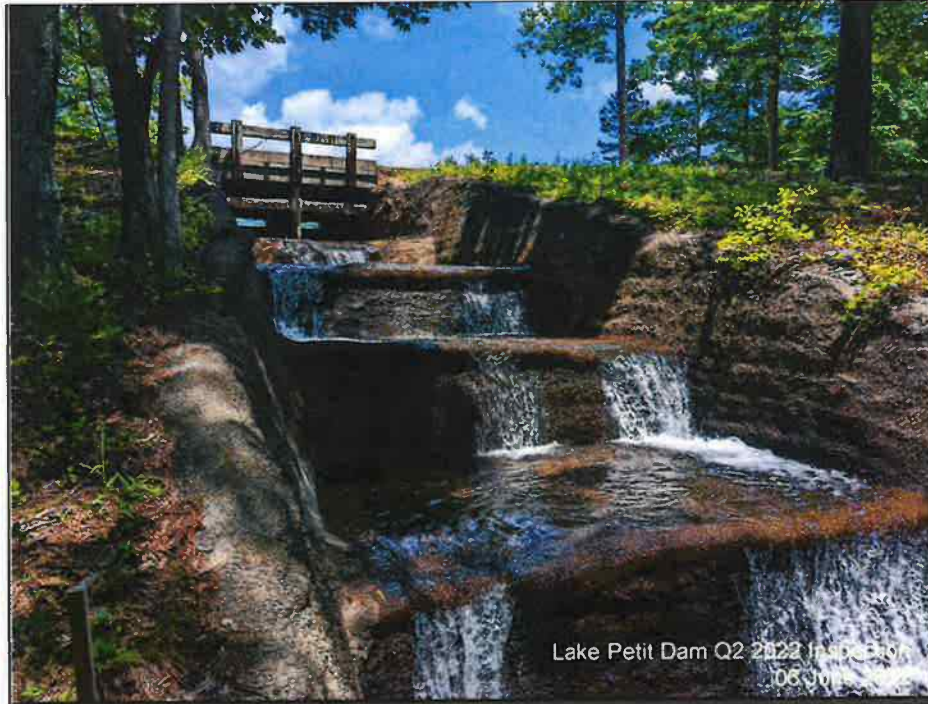
Photograph 3: Overflow Spillway, June 2022 – Flow restored to the spillway after the completion of spillway repairs completed in April 2022. Small leaves were observed in the spillway.

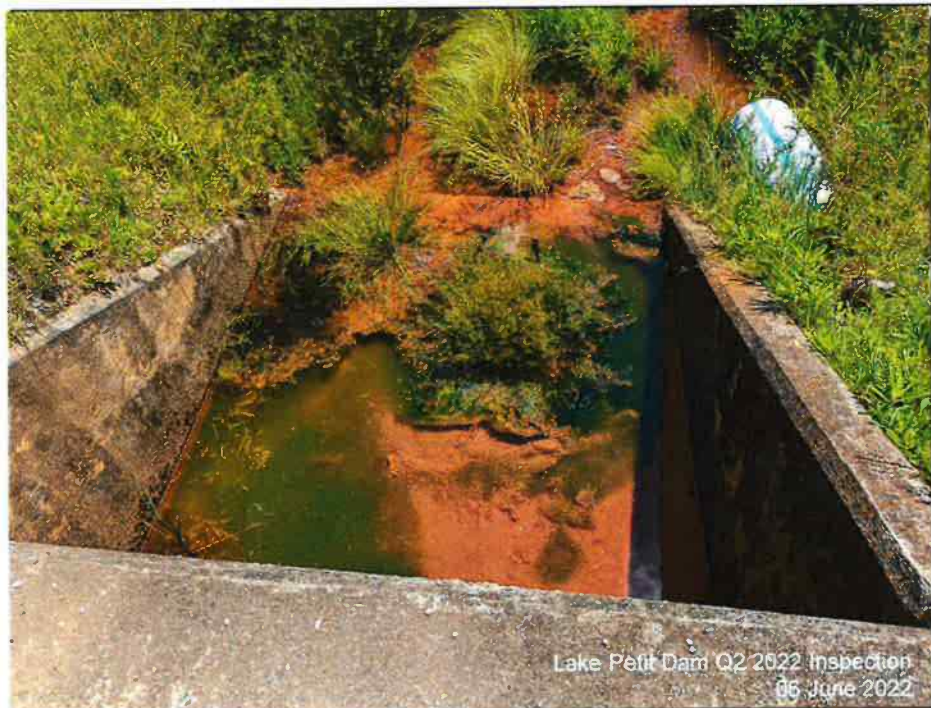
Photograph 4: Impact Stilling Basin, June 2022 – Bacterial growth observed in the instilling basin.

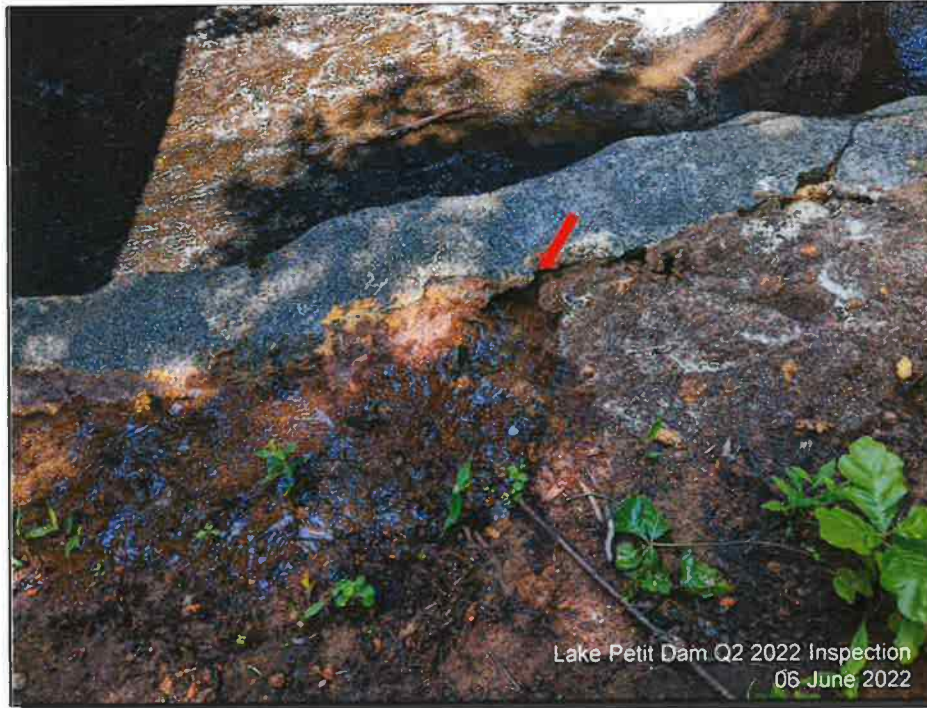
15. Other observations on the spillways/Corrective Action: An 8 in. bypass siphon line was used to control reservoir levels and dewater the spillway for the repairs conducted in April 2022. The bypass siphon line is recharged via a valve in a manhole at the left side of the spillway, near Wilderness Parkway. For the spillway repairs conducted in April 2022, the left side of Bay 45 was repaired by excavating loose soils and debris behind the walls of the spillway. The areas were then backfilled against and under the walls with granular soils, and grouted with polyurethane resin to prevent the areas from eroding. As of this inspection, the repaired areas were stable with no visible signs of erosion, however, water flow was observed to daylight over the recently repaired areas. The source of the water flow is currently being investigated.

Photograph 5: Spillway, June 2022 – Flow observed on top of the recent repairs conducted in April 2022. The source of the flow is currently being investigated.

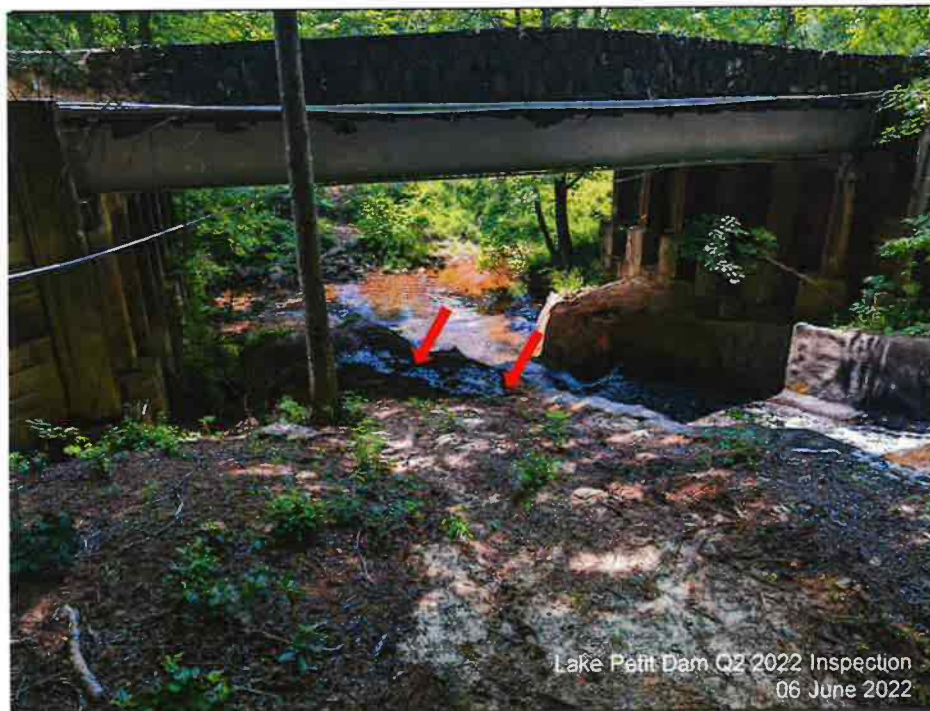
Photograph 6: Spillway, June 2022 – A wide shot photo documenting the same flow as in Photograph 5.

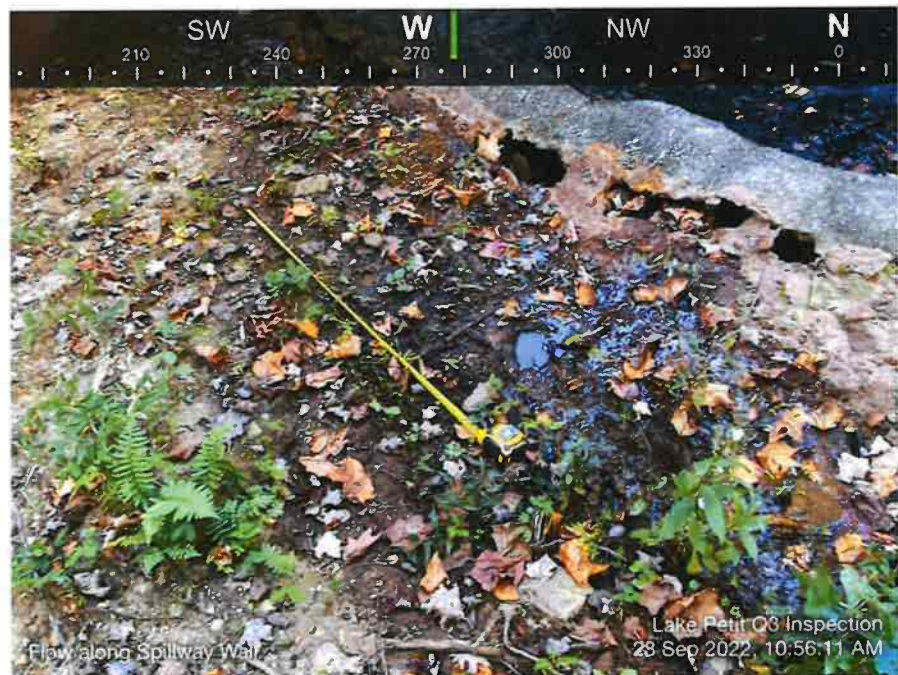
Photograph 4

Comments: Overflow Spillway - Flow observed along the left wall of the overflow spillway. Flow appears to daylight near the downstream end of the overflow spillway.

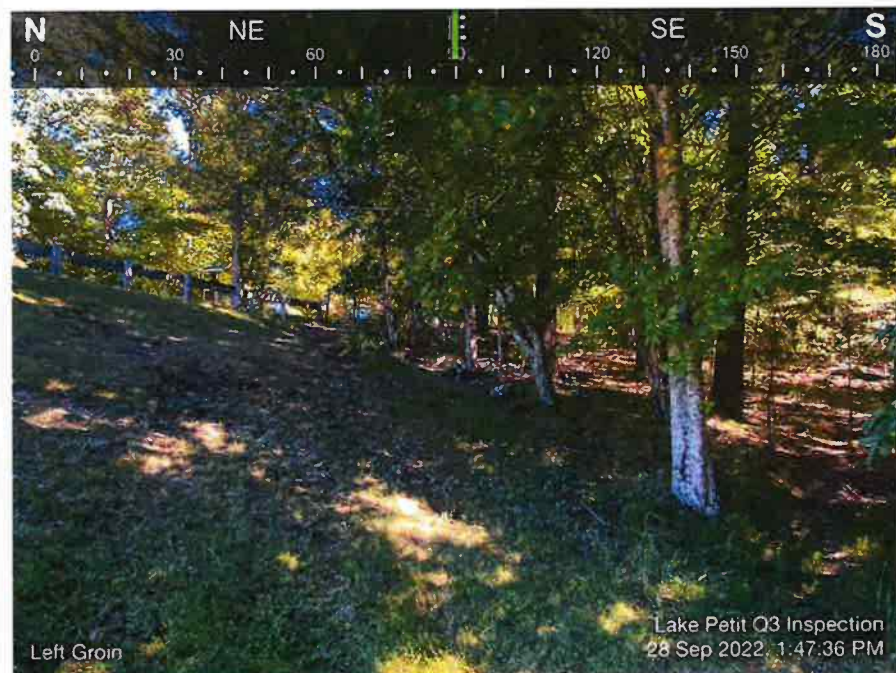
Photograph 6

Comments: Downstream Slope - View of minor, surficial erosion observed along the left, downstream groin area. It is assumed that erosion is caused by stormwater flow during rain events.

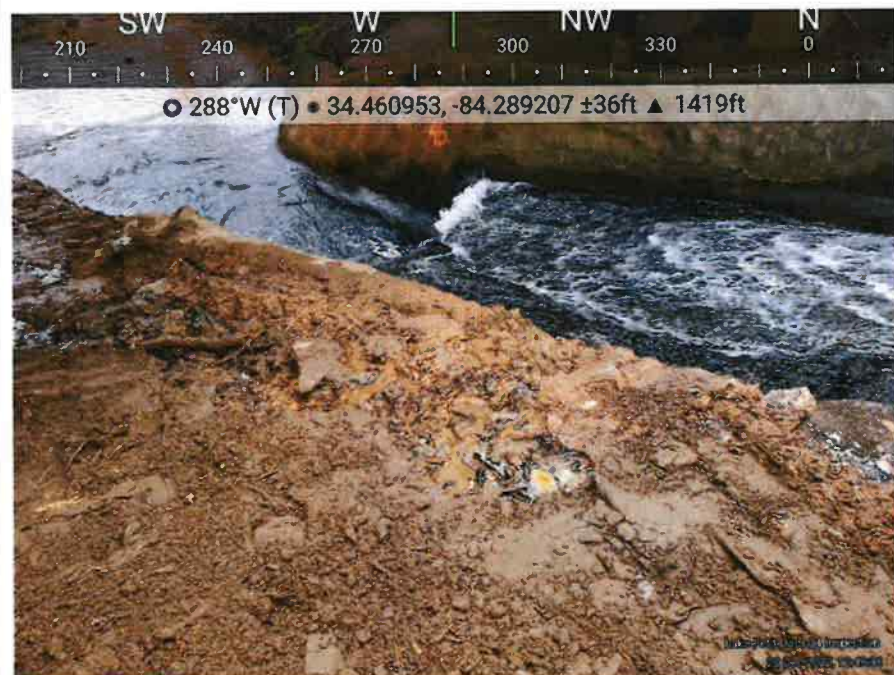
Photograph 4

Comments: Overflow Spillway – Previously repaired (backfilled and grouted) area behind the left spillway wall at the bridge abutment. Repaired area was stable with no signs of erosion. Flow observed to daylight over previously repaired areas.

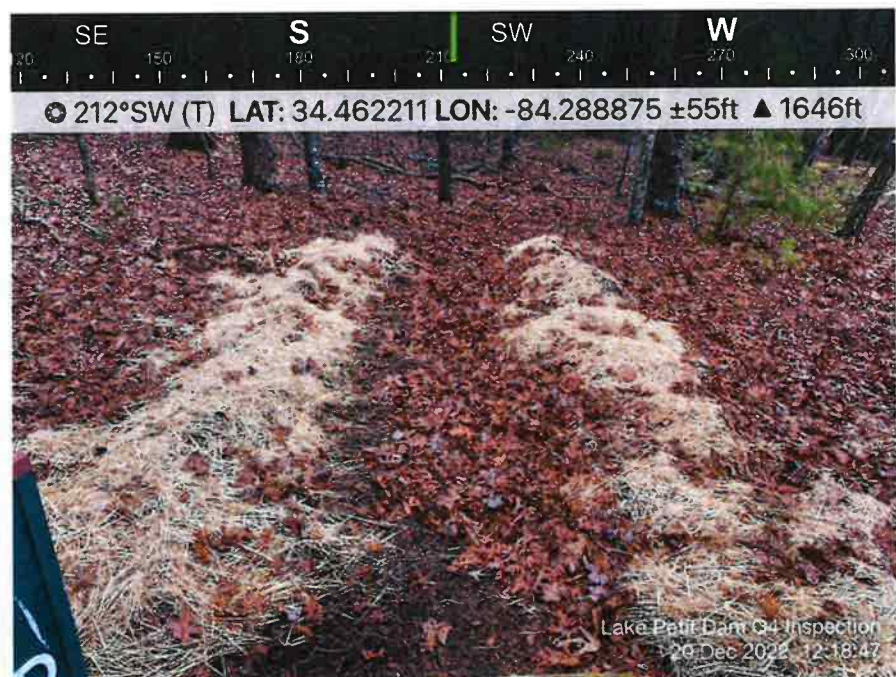
Photograph 6

Comments: Downstream Slope - View of soil swales installed near the road to convey water into the wooded left abutment, downstream groin area.

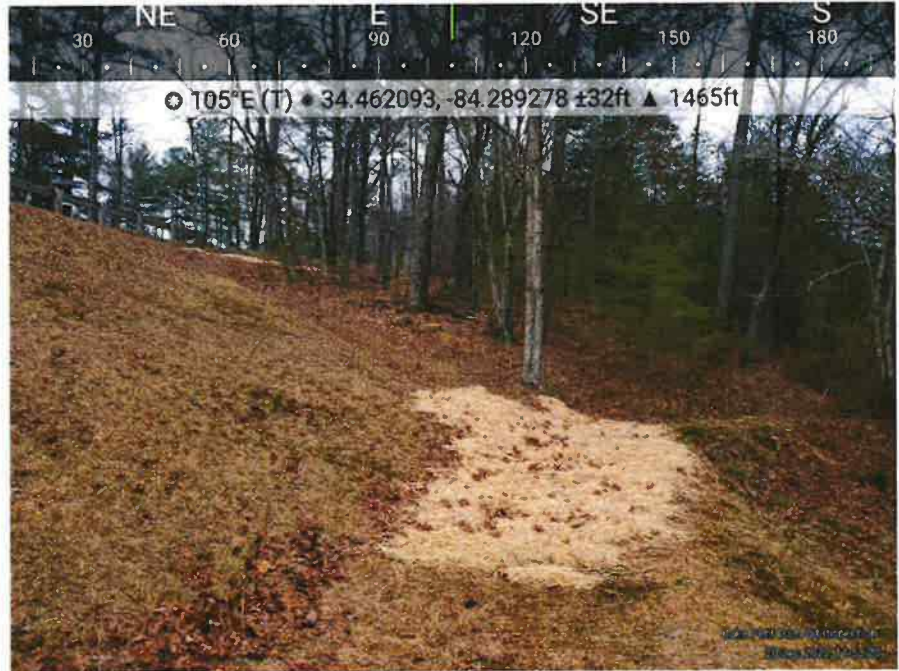
Comments: Downstream Slope - View of maintenance repairs to Bench No. 5 to mitigate surficial erosion along the left, downstream groin area.

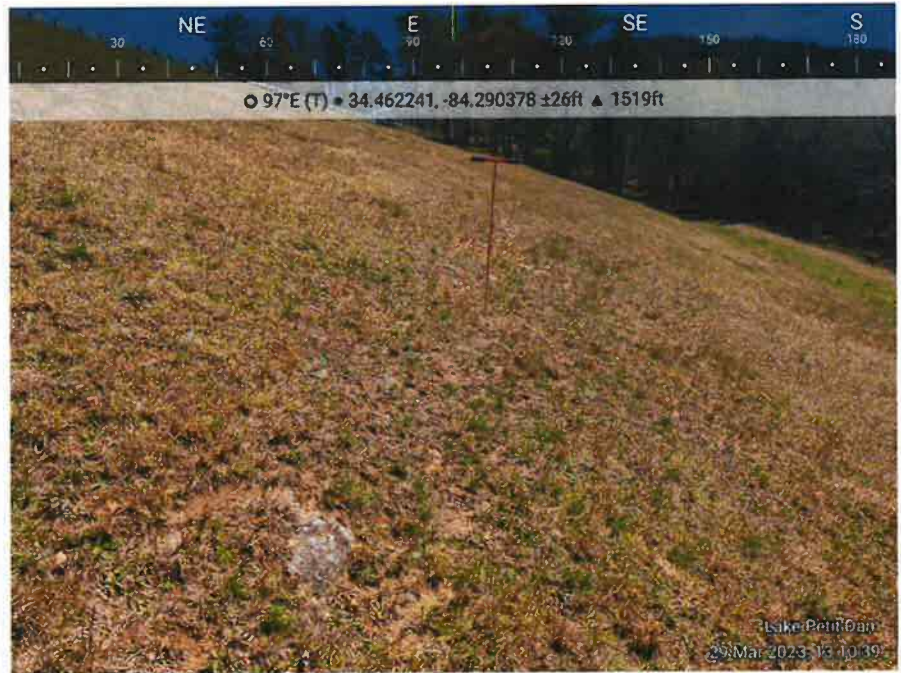
Comments: Downstream Slope - View of typical erosion/area of sparse vegetation (near right abutment between Benches 4 and 5).

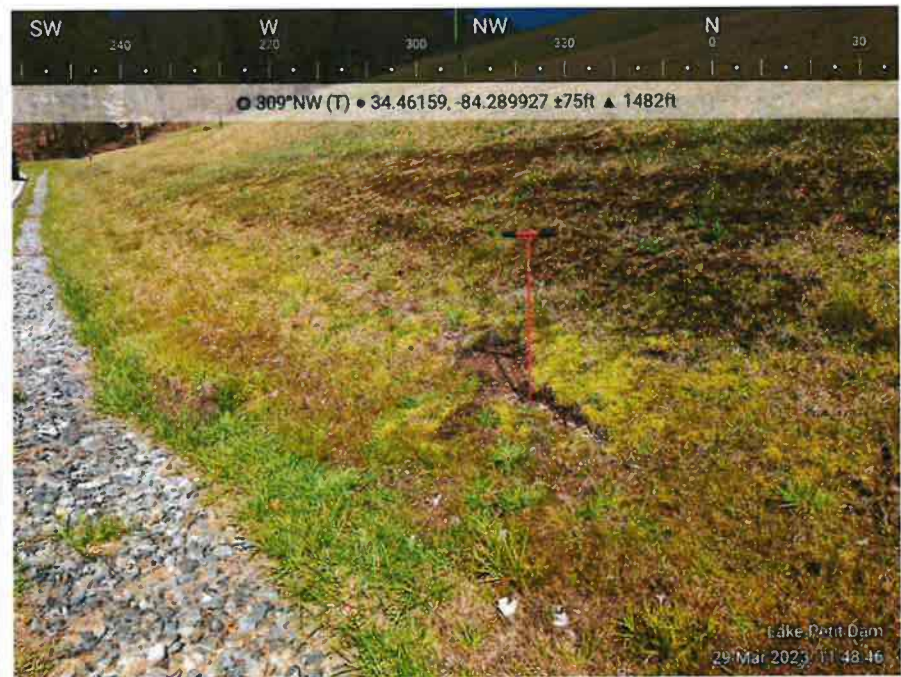
Photograph 4

Comments: Downstream Slope - Wet area on left side of the slope between the road and Bench No.1, approximately 10 ft up the slope and 20 ft along the slope

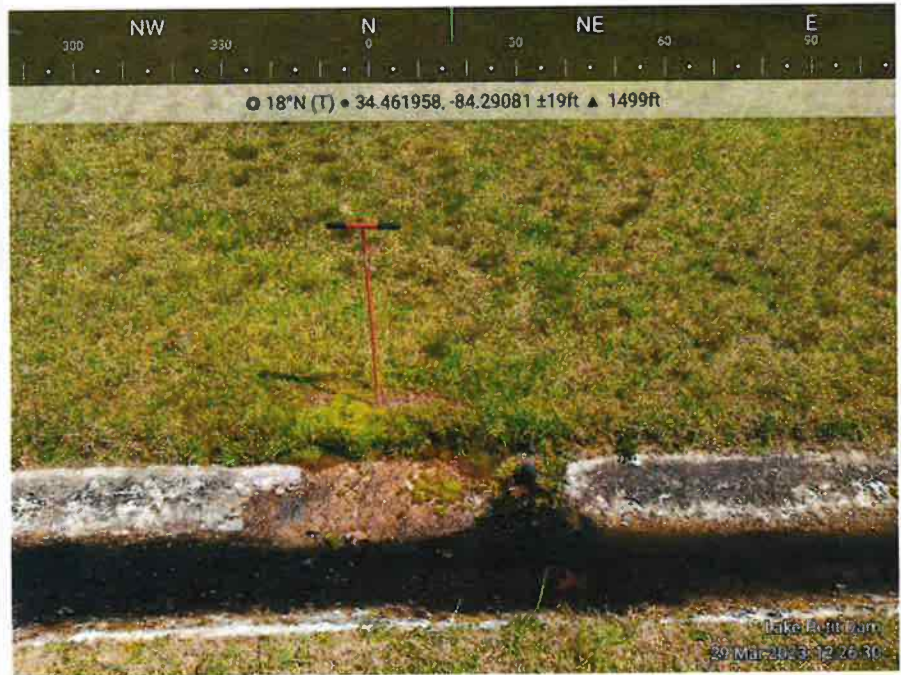
Comments: Downstream Slope - Wet area to the right of interceptor drain No. 5 at Bench No. 1, approximately 2 ft up the slope and 5 ft along the slope

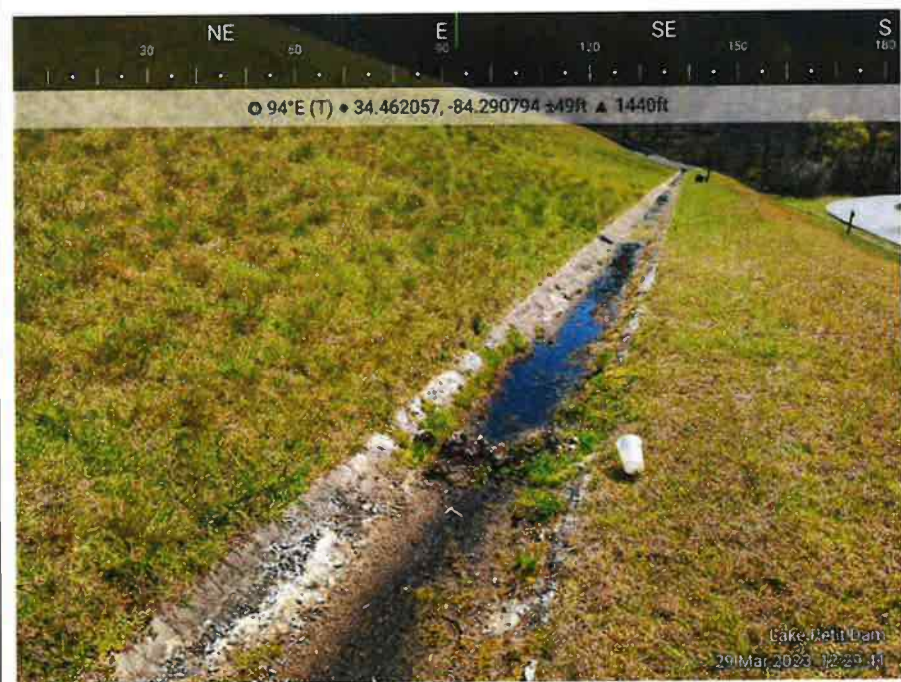
Photograph 6

Comments: Downstream Slope - View of the sediment and vegetation build-up at the concrete channel located on Bench No. 1.

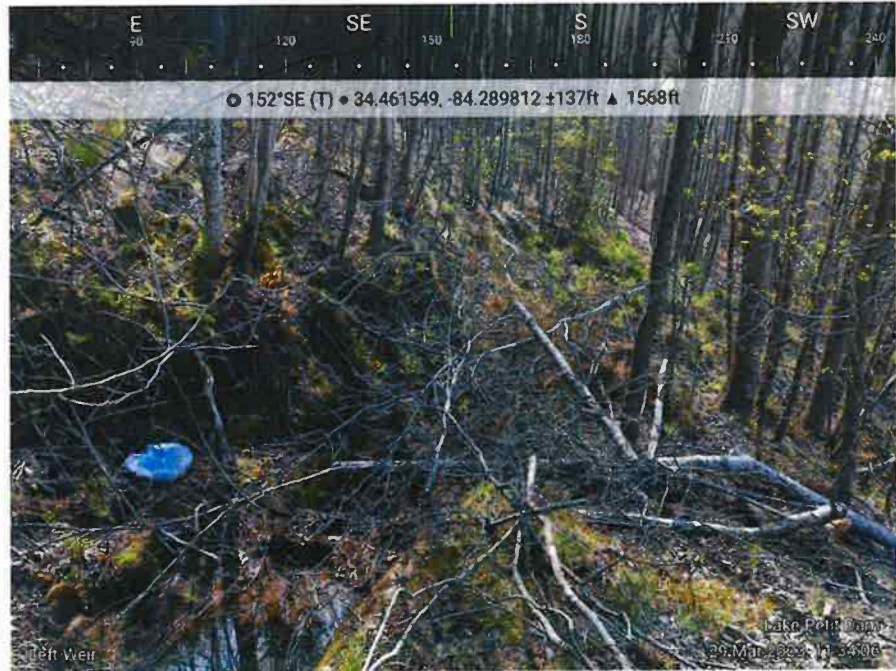
**Comments: Downstream
 Slope - Cut down trees
 and vegetation
 obstructing flow on the
 left weir, located on
 Bench No. 1.**

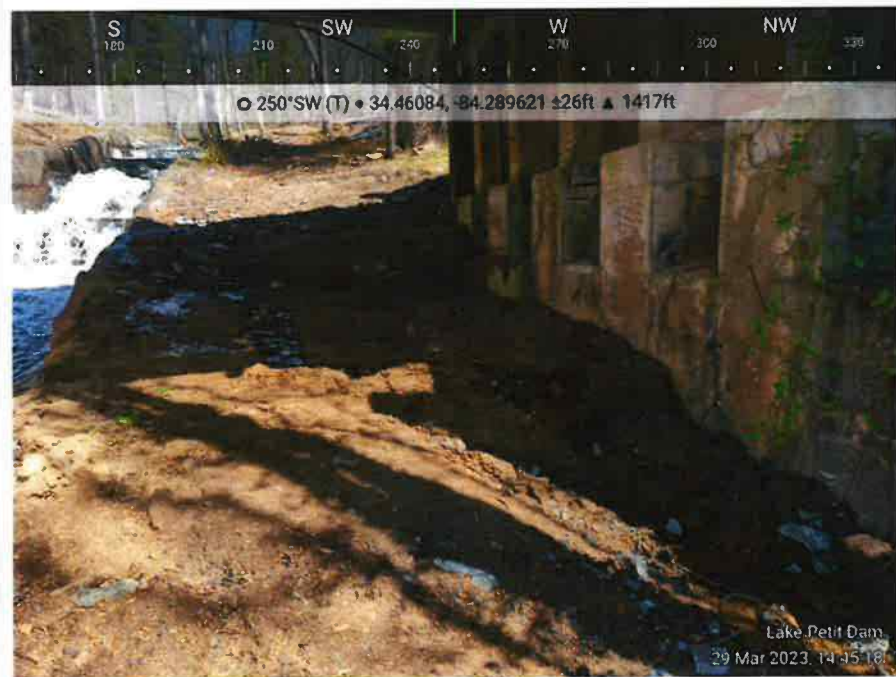
Photograph 8

**Comments: Spillway -
 Surficial flow was
 observed on the left side
 of Step 45 of the spillway.**
