Inspection Report

Date of Inspection: 02/22/2023

Name of Dam: Lake Petit Dam County: Pickens

ID#: 112-009-00462 weather: partly cloudy, ~70°

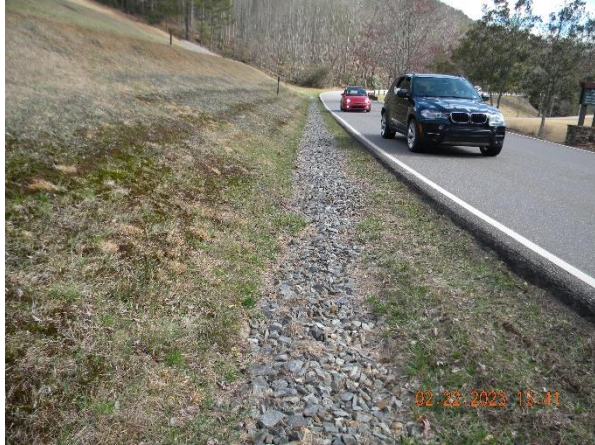
Looking left from near the right abutment at lower downstream slope and toe

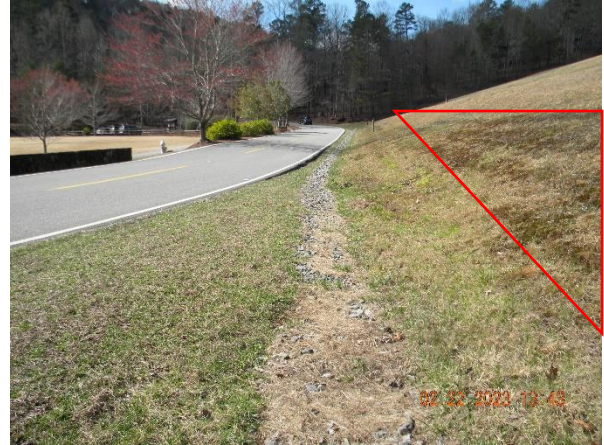
Looking right from near the left abutment at lower downstream slope and toe with saturated area

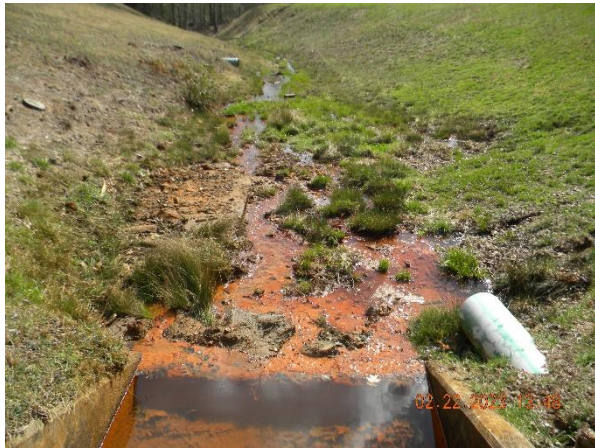
Looking downstream from the low-level outlet with orange ochre in the outlet channel as in past inspections

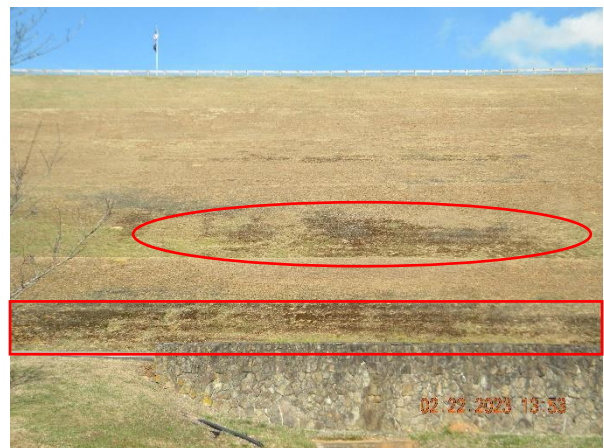
Looking from the right side of the low-level outlet channel at the left downstream slope with saturated areas
