## Monthly Construction Progress Report

Date: 14 February 2025

Subject: Lake Petit Dam Seepage Collection System Modifications CQA, Revision 1

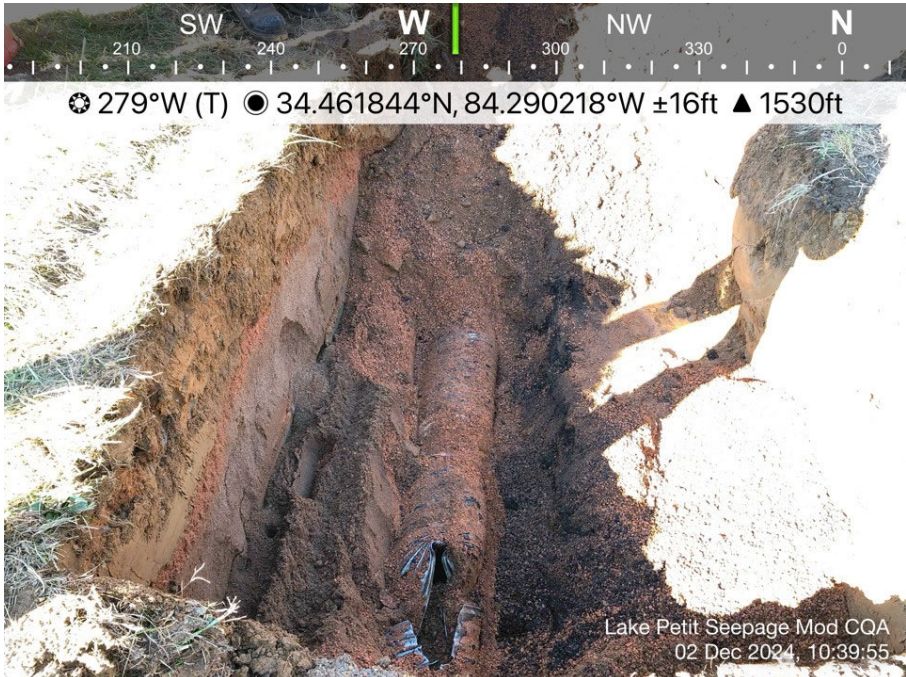
Excavation of the embankment began on 02 December 2024. A 10-in. diameter, CMP was encountered approximately 3 ft below the ground surface (bgs), at approximately Station 3+00 (near proposed CB2). This CMP was not noted in historical construction records of the Dam. A short section of the CMP was exposed, removed, and inspected by the engineering team. The CMP contained perforations and appeared to be part of a previously installed and undocumented internal drainage system. Additionally, the CMP appeared to be approaching the end of its service life. Note, water was not visually observed to be flowing within this section of pipe.

<p>Photograph No. 02</p> <p>Description: View of existing perforated CMP drain underlaying previously removed concrete drain.</p>

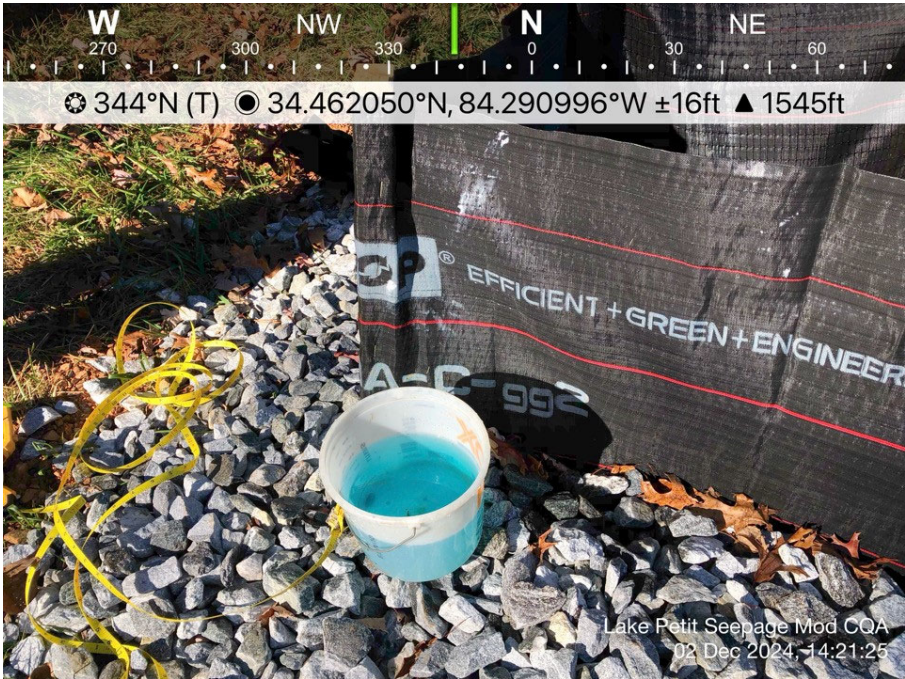
A CCTV drain camera was pushed approximately 80 ft towards the left and right. A couple inches of stagnant water was observed through the camera. The camera could not be pushed further due to an apparent obstruction or joint in the pipe. The Engineer conducted a dye test to determine the locations of the CMP outlets. Water with blue indicator dye was poured into the side of the CMP draining towards the right abutment. The blue indicator dye was observed flowing into DI2. The process was repeated along the side of the CMP draining towards the left abutment. However, the discharge was not identified, as blue indicator dye was not observed at any known outlets.

PHOTOGRAPH LOG		
PROJECT AND SITE INFORMATION		
PROJECT: Lake Petit Dam Seepage Collection CQA	DATE: December 2024 Reporting Period	
DESCRIPTION: Seepage Collection System Modification	PROJECT NO.: TCG11100	TASK NO.: 01/02
Photograph No. 03  Description: View of indicator dye.

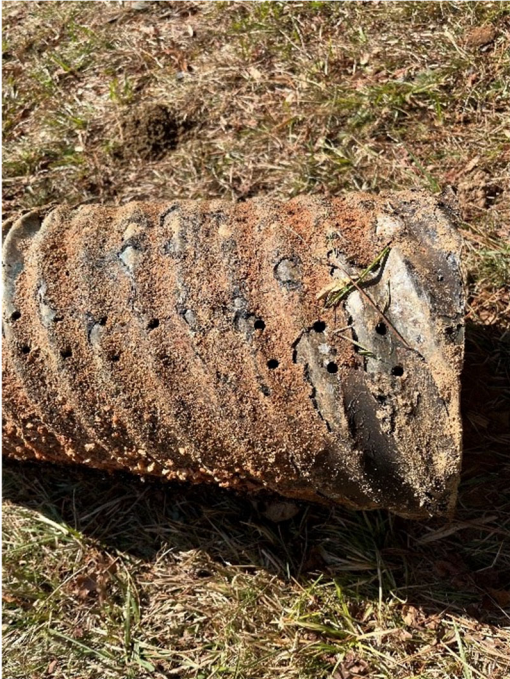
Photograph No. 04  Description: View of the removed CMP near Station 3+00. Note perforations in pipe.

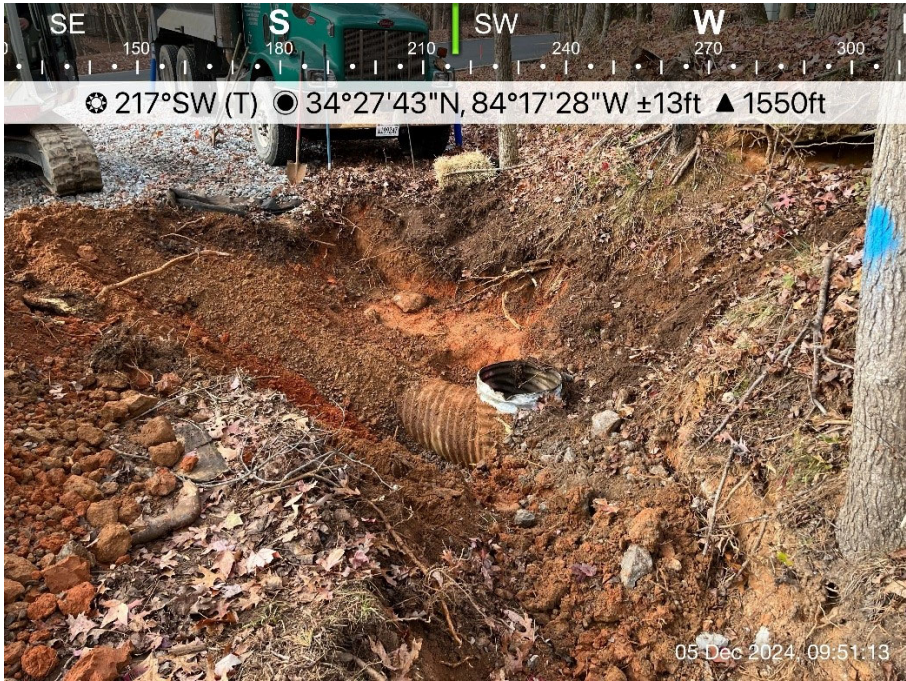
PHOTOGRAPH LOG		
PROJECT AND SITE INFORMATION		
<b>PROJECT:</b> Lake Petit Dam Seepage Collection CQA	<b>DATE:</b> December 2024 Reporting Period	
<b>DESCRIPTION:</b> Seepage Collection System Modification	<b>PROJECT NO.:</b> TCG11100	<b>TASK NO.:</b> 01/02
Photograph No. 05  Description: View of existing DI3 and CMP at the location of proposed CB4.

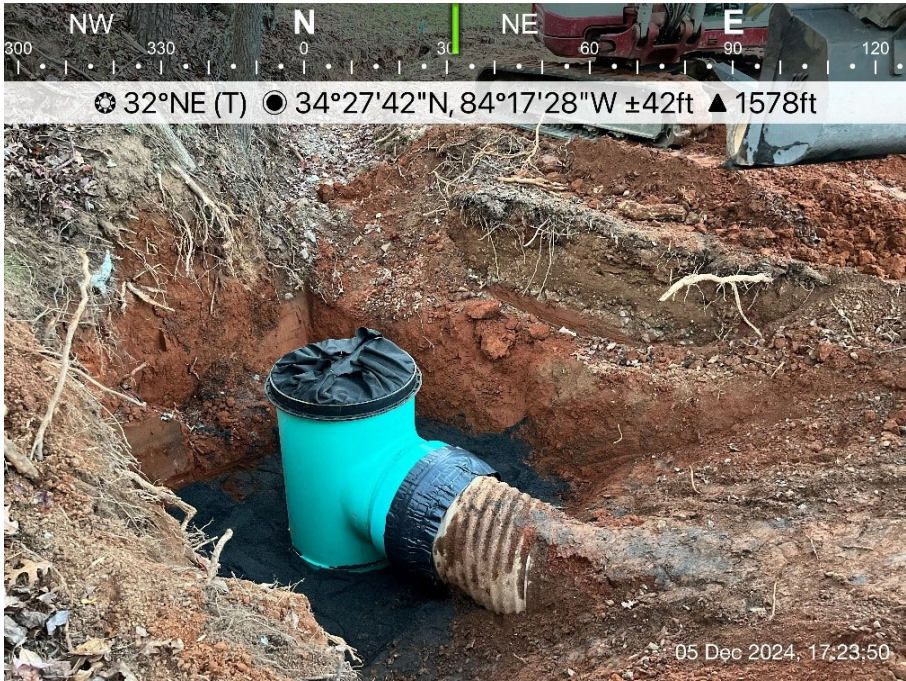
The Contractor excavated at approximately Station 0+12 (05 December 2024) and 0+51 (07 December 2024) for the installation of CB4 and CB1, respectively. Existing embankment material was stockpiled, for use as backfill after the installation. The Contractor performed a hand excavation around the existing 24-in. CMP at CB4. After the subgrade elevation was reached, the Contractor prepared the subgrade using the smooth edge of the excavator bucket. The Contractor placed two lifts of sand bedding within the excavated trench. The lifts consisted of approximately 3-in. of bucket-compacted SM10 Sand. The sand bedding was leveled and CB4 was installed. Per

Photograph No. 06  Description: View of the installed CB4.

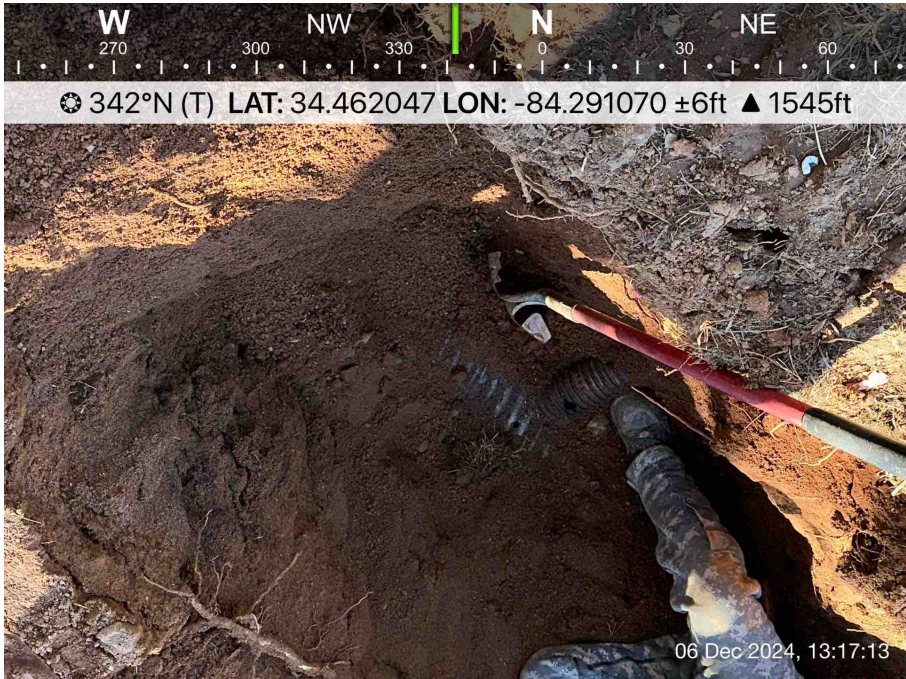
An existing 4-in. HDPE tee fitting and perforated pipe, located east of CB1 near Station 0+62, was connected to the existing CMP from the north. Due to the depth of the HDPE pipe, the Engineer directed the Contractor to remove the tee fitting and trim the HDPE pipe to daylight into the backfill to allow any discharge from the right abutment to flow into the new bench drain.

PHOTOGRAPH LOG			
PROJECT AND SITE INFORMATION			
<b>PROJECT:</b> Lake Petit Dam Seepage Collection CQA		<b>DATE:</b> December 2024 Reporting Period	
<b>DESCRIPTION:</b> Seepage Collection System Modification		<b>PROJECT NO.:</b> TCG11100	<b>TASK NO.:</b> 01/02
Photograph No. 07  Tee fitting connecting an existing 4-in. HDPE to the 10-in. CMP, located east of CB1.

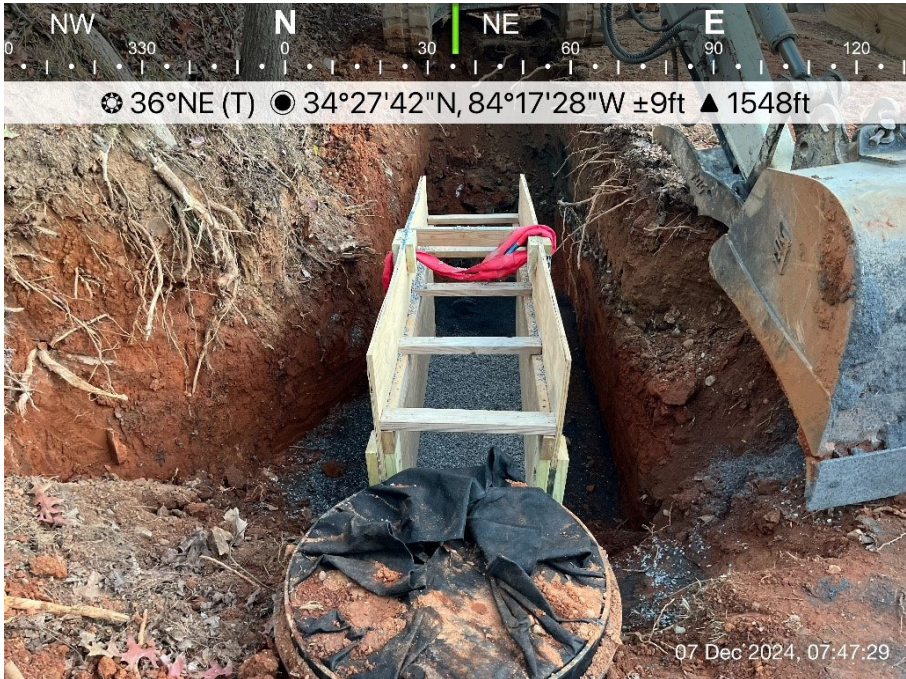
Photograph No. 08  Description: View trench template being used to control the placement of No. 89 stone over the 10-in. ADS N-12 pipe at CB4.
