## Monthly Construction Progress Report

Date: 14 February 2025

Subject: Lake Petit Dam Seepage Collection System Modifications CQA

## Lake Petit Seepage Collection CQA: Monthly Construction Progress Report January 2025

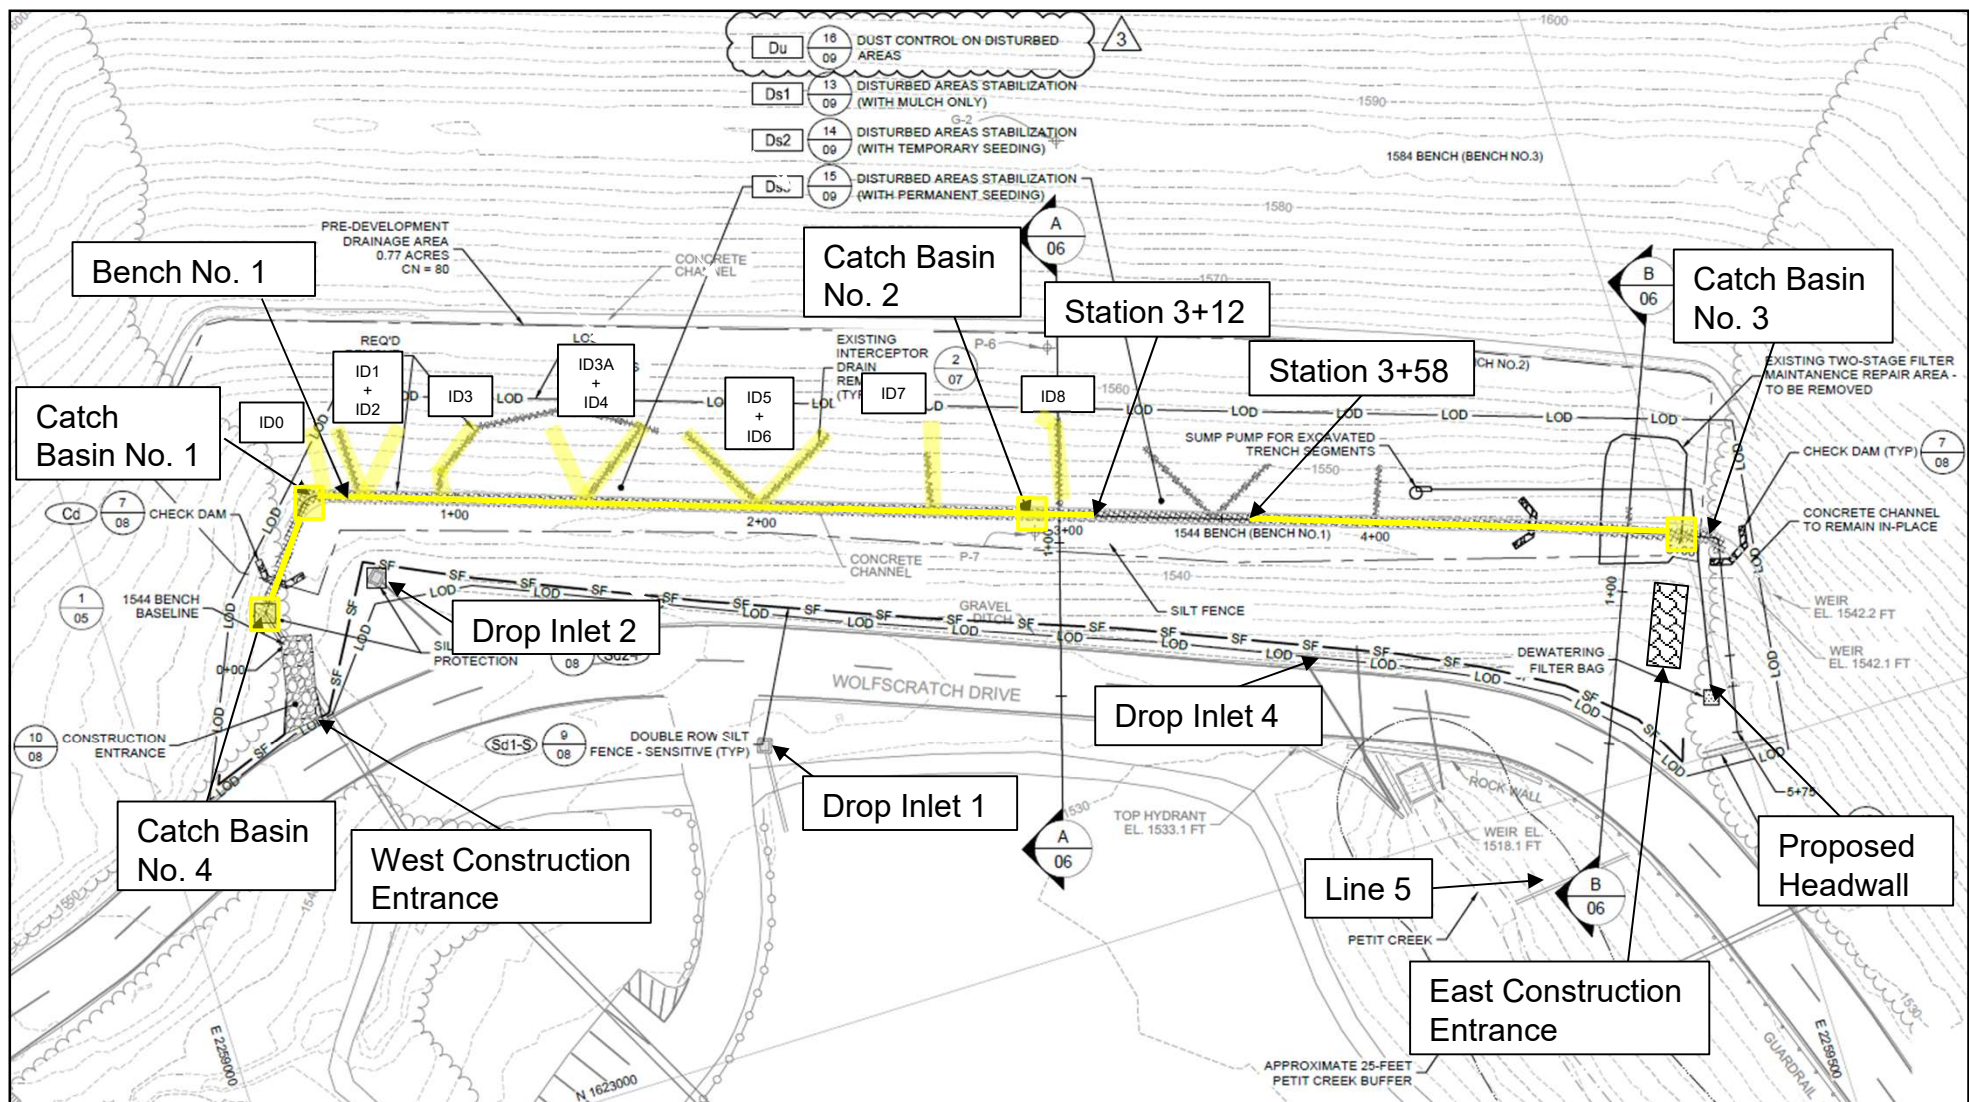
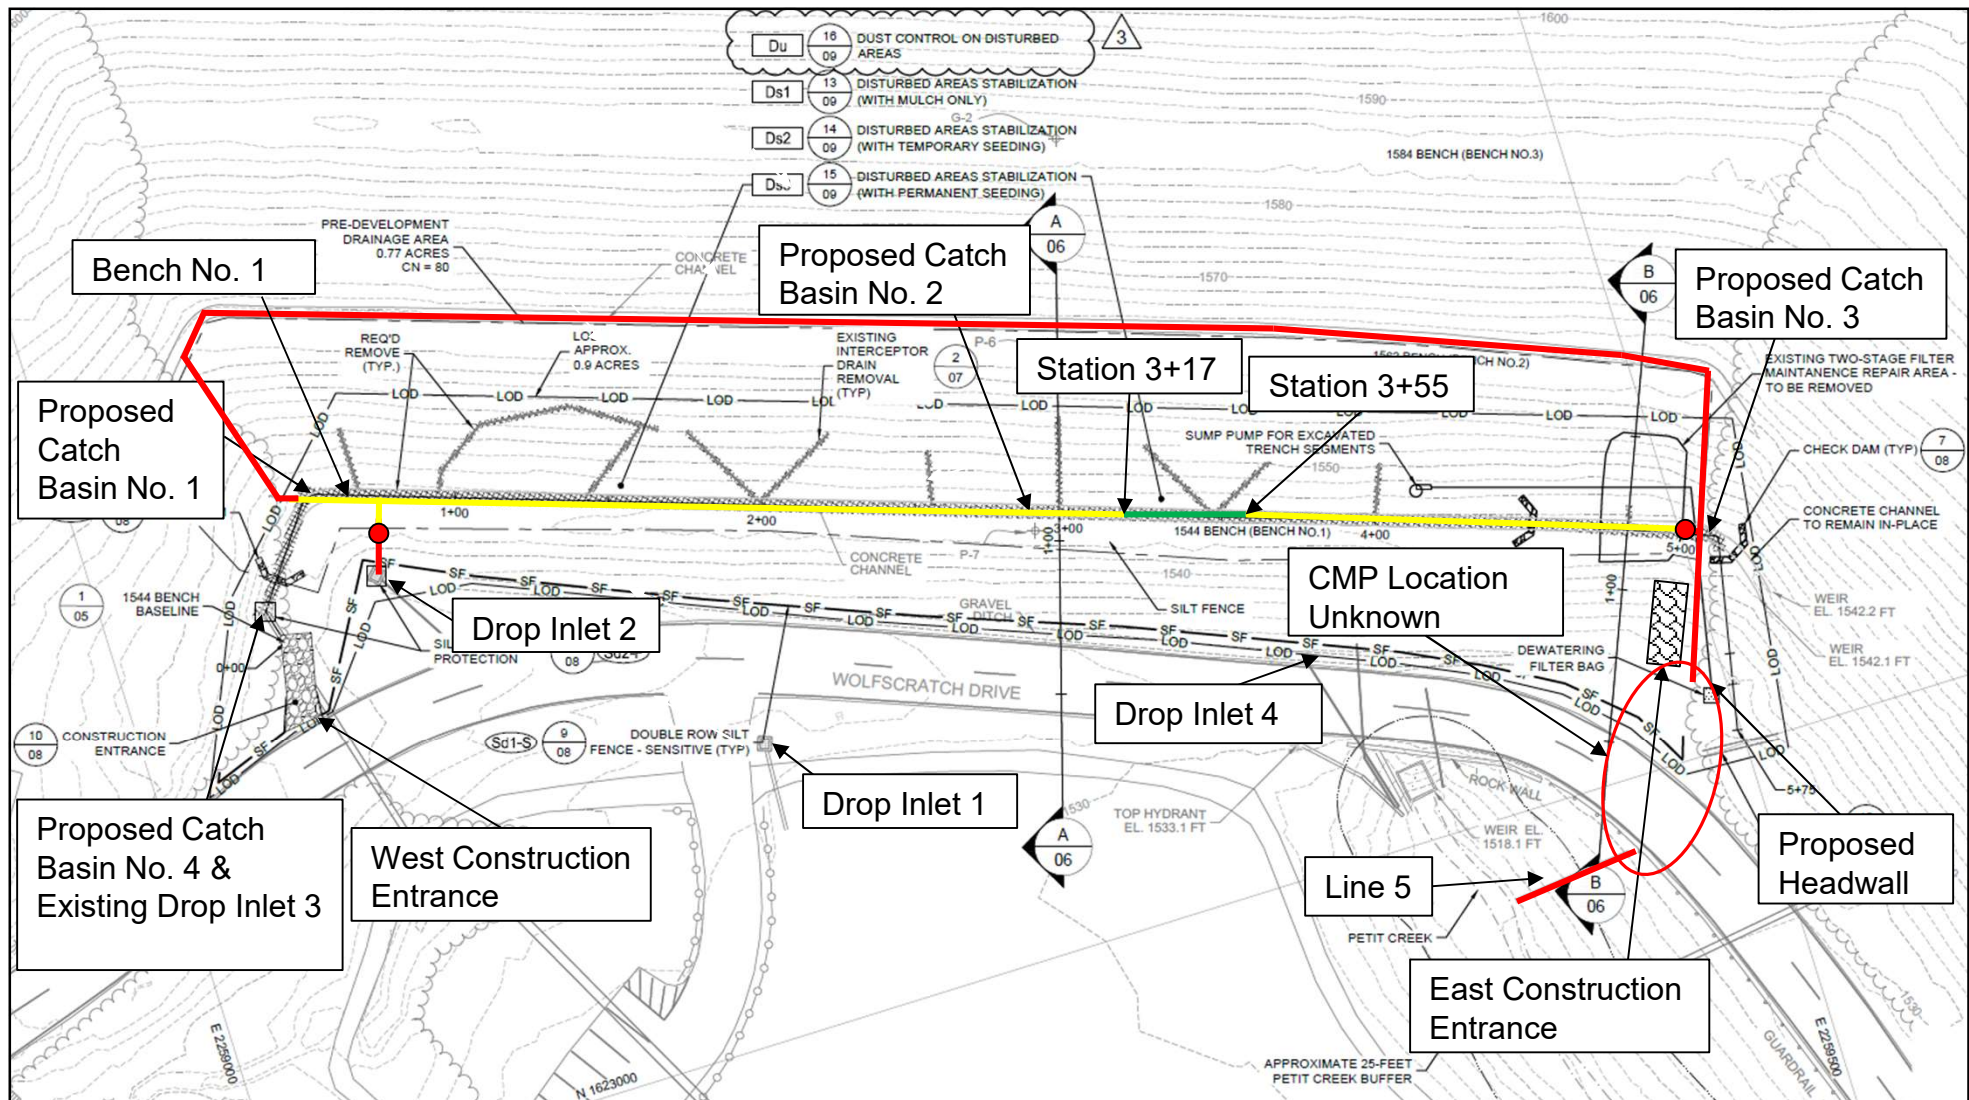
#### FIGURE 2. SITE LAYOUT

GPRS did not observe the 10-in. CMP extending upstream along the abutments beyond Bench No. 2 (i.e., up to Bench Nos. 3, 4, or 5). GPRS marked the locations of the CMP in the field and the Contractor's as-built survey will document these locations. See Figure 2 for approximate locations of the CMP.

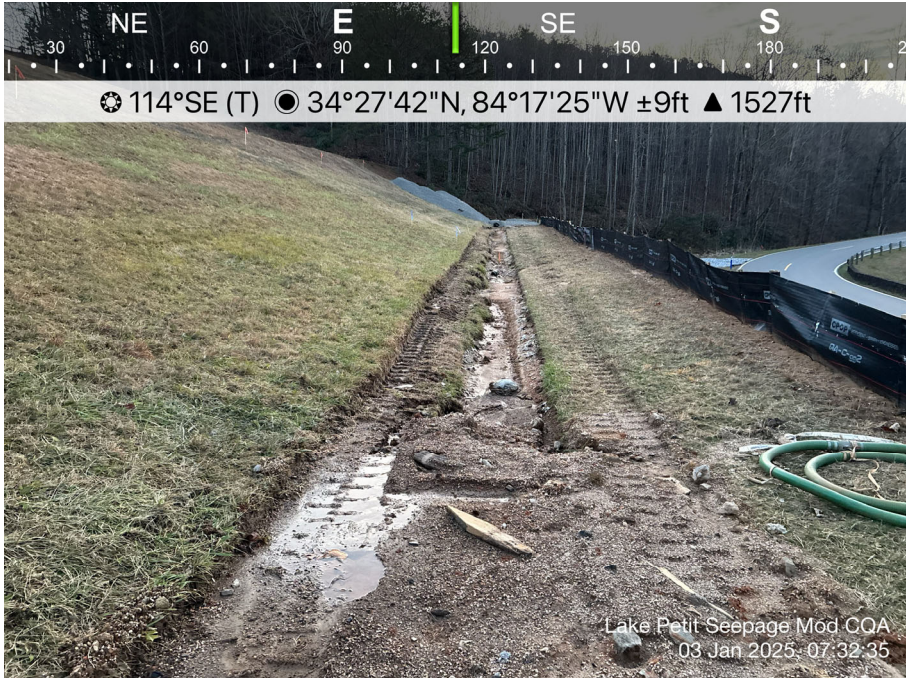
| PHOTOGRAPH LOG | | |
|---|---|---|
| <p>Photograph No. 01</p> <p>Description: Site conditions prior to start of excavation on 03 January 2025. Photo taken from center of Bench No. 1 (facing east).</p> | | |

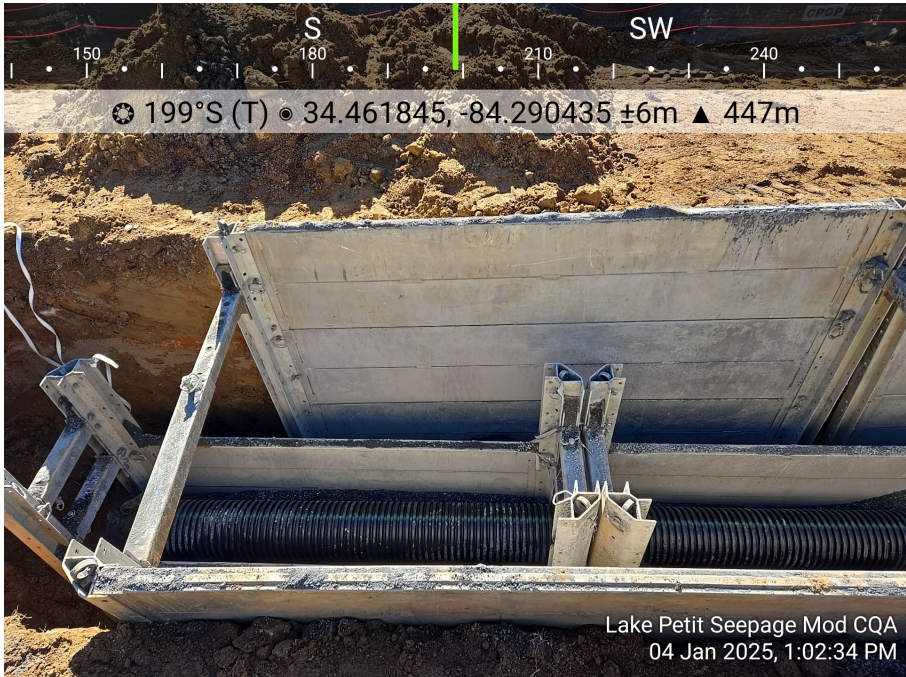
| PHOTOGRAPH LOG | | |
|---|---|---|
| <p>Photograph No. 02</p> <p>Description: View of installed ADS N-12 pipe from approximately Station 2+52 to 2+72.</p> | | |

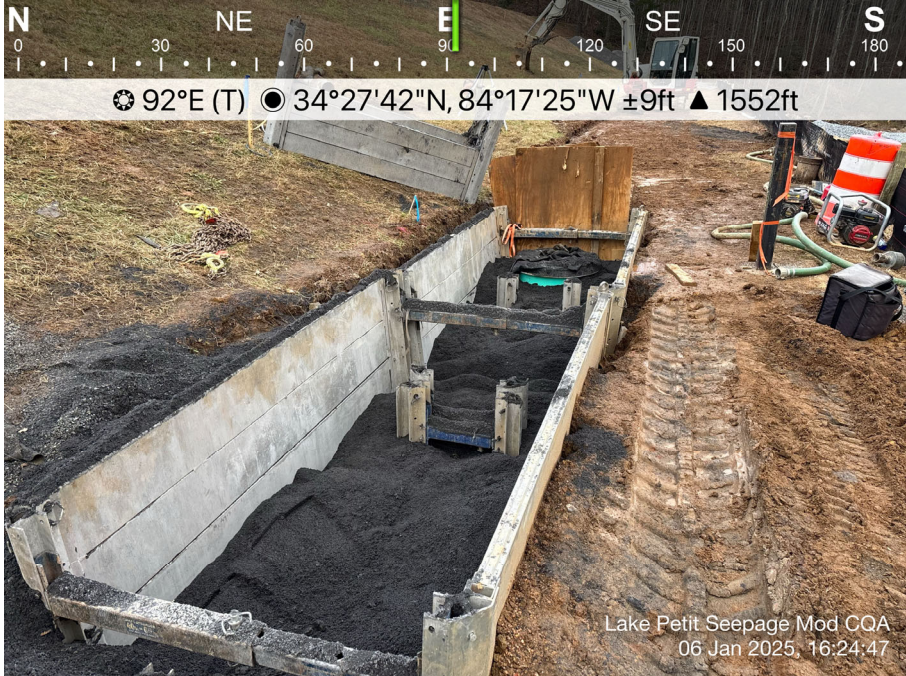
| PHOTOGRAPH LOG | | |
|---|---|---|
| Photograph No. 03<br><br>Description: View of installation and backfilling of CB3. | <p>Lake Petit Seepage Mod CQA<br/>06 Jan 2025, 16:24:47</p> | |

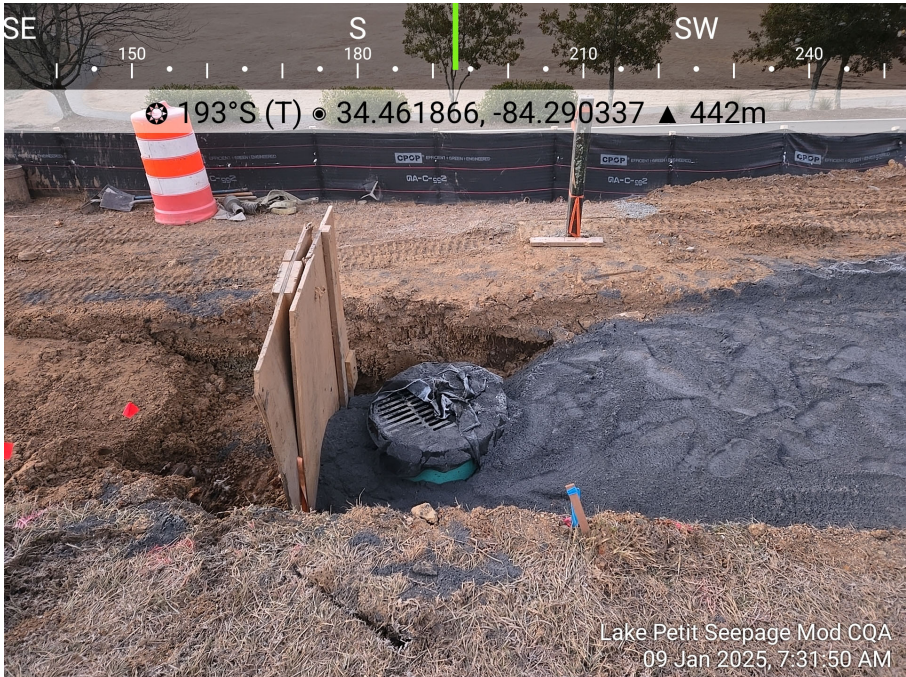
| PHOTOGRAPH LOG | | |
|---|---|---|
| Photograph No. 04<br><br>Description: View of installed CB3. | <p>Lake Petit Seepage Mod CQA<br/>09 Jan 2025, 7:31:50 AM</p> | |

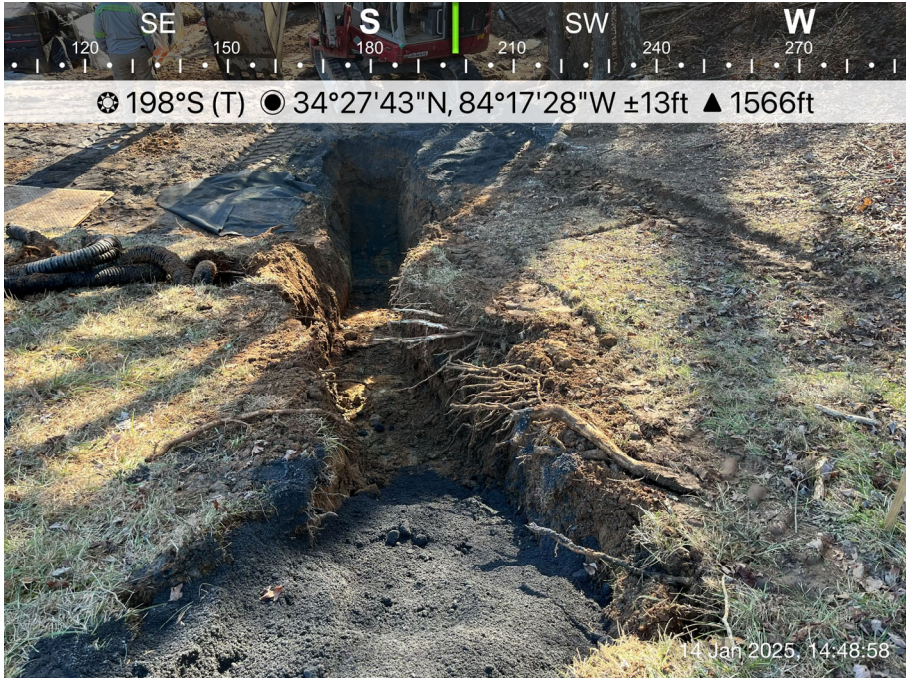
| PHOTOGRAPH LOG | | |
|---|---|---|
| Photograph No. 05<br><br>Description: View of replacement of ID0. | | |

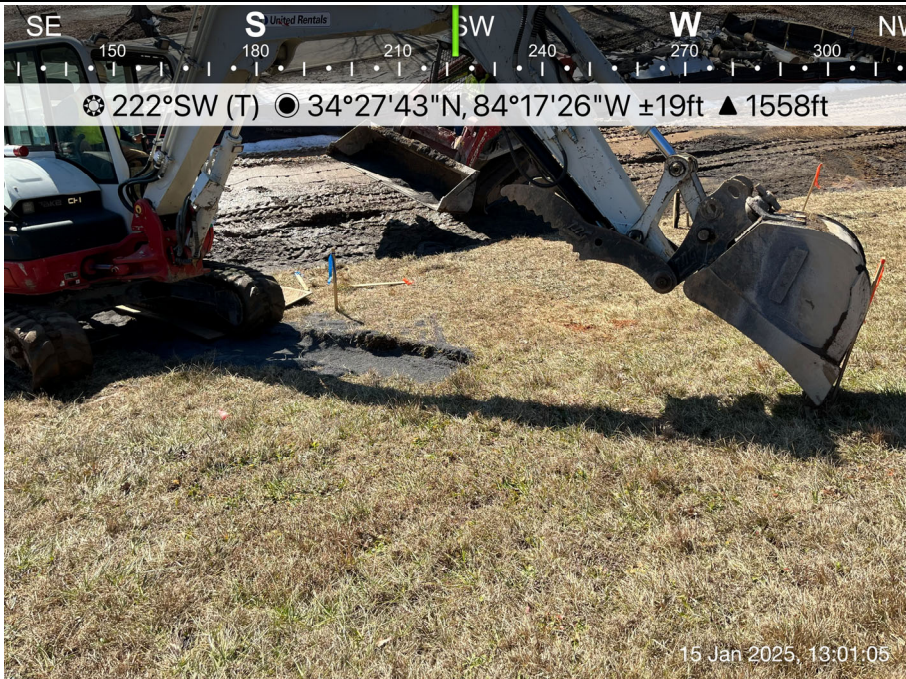
| PHOTOGRAPH LOG | | |
|---|---|---|
| Photograph No. 06<br><br>Description: View of ID3A excavation. | | |

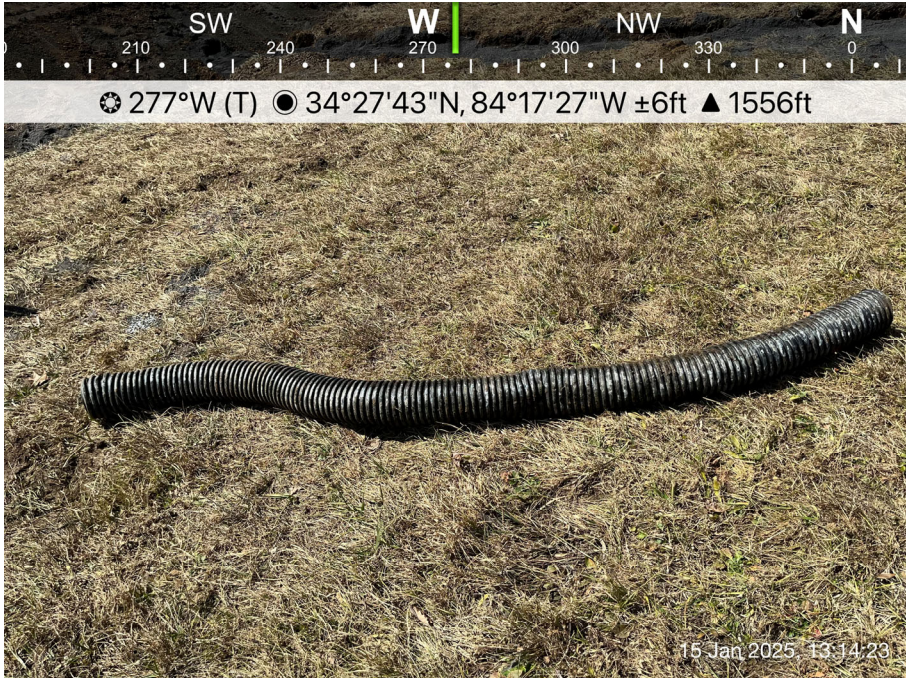
| PHOTOGRAPH LOG | | |
|---|---|---|
| Photograph No. 07<br><br>Description: View of removed section of 4-in. HDPE pipe from ID. | | |

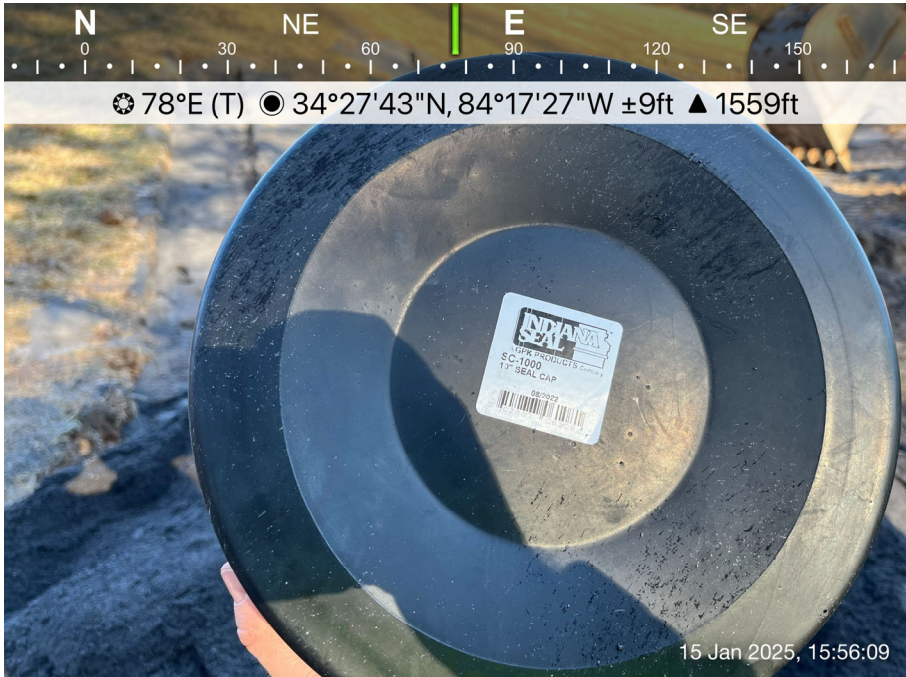
The Contractor capped the existing 10-in. CMP that is planned to remain in place using Fernco caps, attached to the CMP with a clamp, at the following locations: (i) approximately Station 0+75, where the CMP connects to DI2 (15 January 2025) and (ii) immediately east of CB3 (21 January 2025). When capping the CMP near Station 0+75, the Contractor removed an additional 4-ft of the CMP and backfilled with excavated embankment material. The material was placed in approximately 6- to 8-in. lifts and compacted with the excavator bucket. When backfilling near CB3, SM10 Sand was placed in approximately 6-in. thick lifts and compacted with the excavator bucket. The CMP that was left in place immediately west of CB1 will be capped and backfilled at a later date.

| PHOTOGRAPH LOG | | |
|---|---|---|
| Photograph No. 08<br><br>Description: View of Fernco cap used to cap existing CMP into DI2 (typical for the three CMP caps). | | |

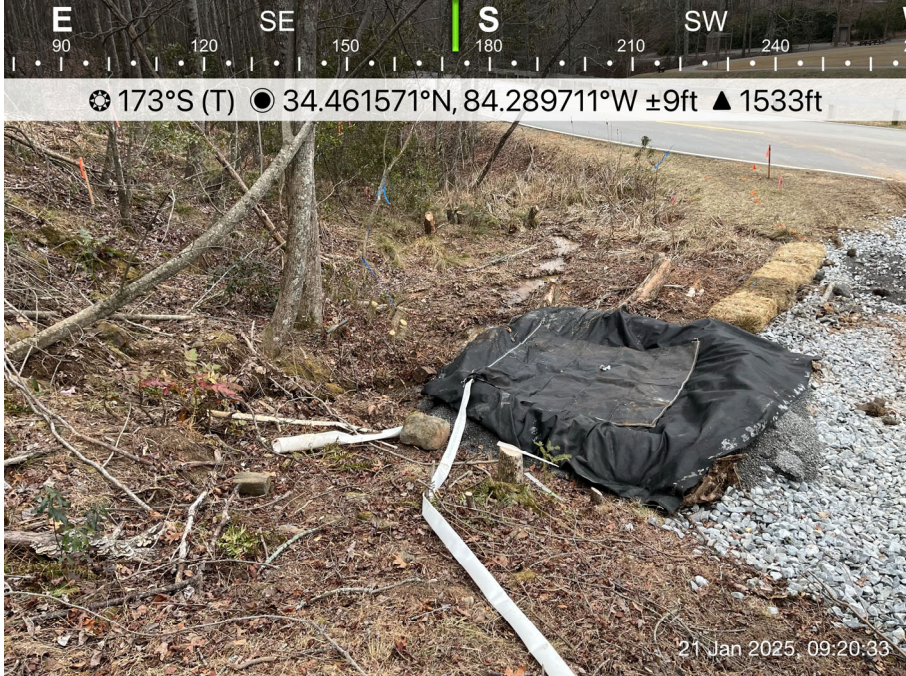
The Contractor also installed a second sedimentation basin consisting of a filter bag overlaying No. 89 Stone at the left abutment, east of CB3, within the existing concrete drainage swale. No. 89 Stone and hay bales were also placed east of the sedimentation basin to control turbidity. A 4-in. diesel pump was used to pump water collected in a sump installed directly west of CB3. This pump was operated as-needed, including overnight, to collect flow entering the area from the left abutment and preventing pooling within the open trench.

| PHOTOGRAPH LOG | | | |
|---|---|---|---|
| Photograph No. 13<br><br>Description: View of constructed sedimentation basin at left toe of the Dam. | | | |

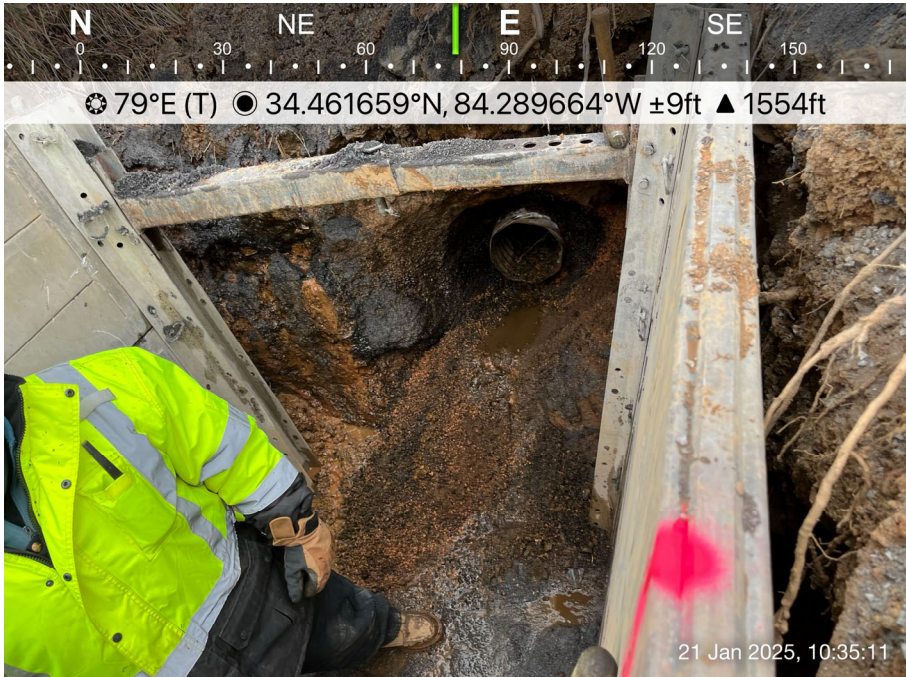
| PHOTOGRAPH LOG | | | |
|---|---|---|---|
| Photograph No. 14<br><br>Description: View of existing 10-in. CMP at the left abutment tee where pipe runs north and south. | | | |

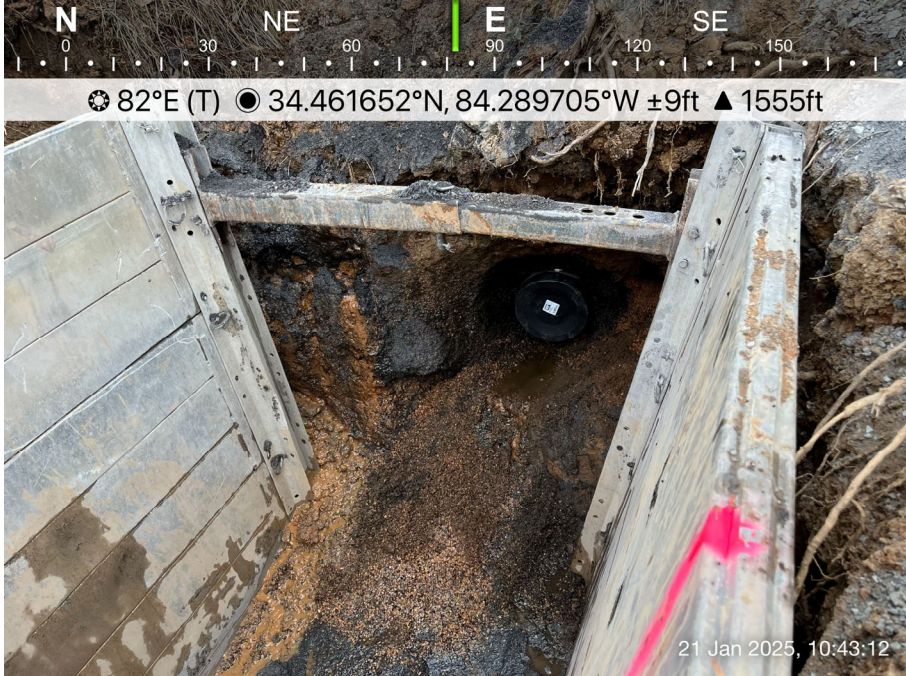
| PHOTOGRAPH LOG | | |
|---|---|---|
| <p>Photograph No. 15</p> <p>Description: View of capped 10-in. CMP at the left abutment.</p> | | |

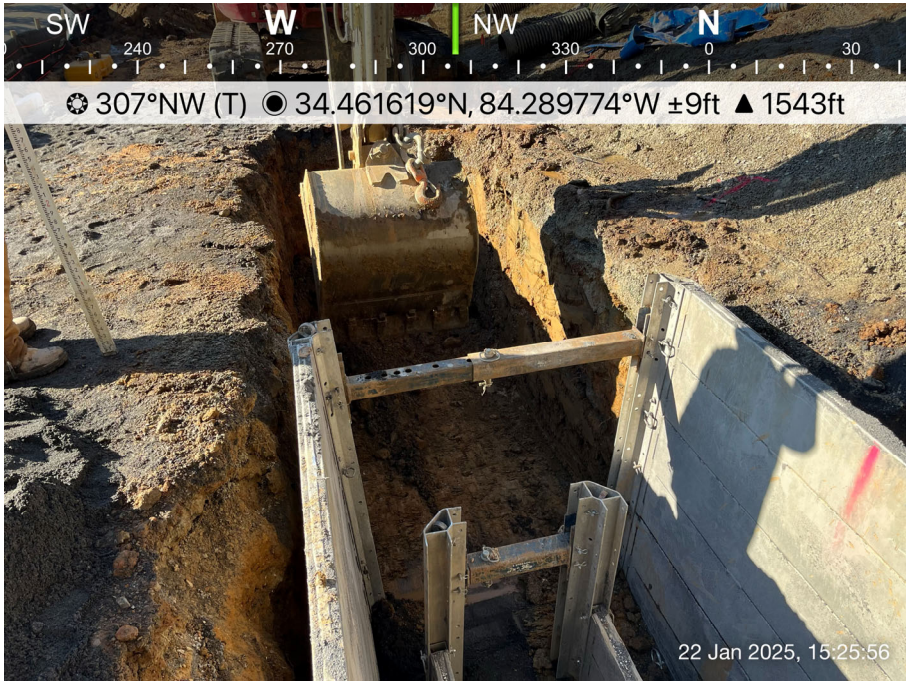
| PHOTOGRAPH LOG | | |
|---|---|---|
| <p>Photograph No. 16</p> <p>Description: View of subgrade preparation at approximately Station 4+88, heading west.</p> | | |

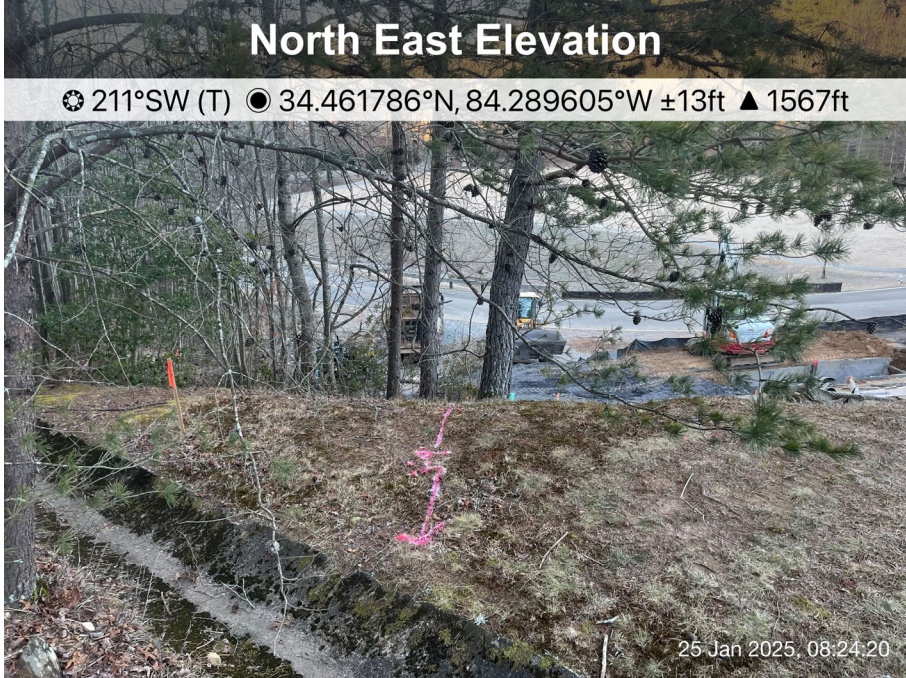
GPRS then attached their EM equipment to the existing (capped) 10-in. CMP immediately east of CB3. GPRS was able to observe that the CMP ran: (i) downstream to Wolfscratch Drive for approximately 50-ft and then the signal was lost; and (ii) upstream to Bench No. 2 and then under the existing concrete drainage channel running west along Bench No. 2. GPRS then relocated to the right abutment, entering the existing (capped) 10-in. CMP immediately west of CB1. GPRS confirmed the 10-in. CMP on the right abutment also continued up to Bench No. 2, then under the existing concrete drainage channel running east along Bench No. 2.

| PHOTOGRAPH LOG | | |
|---|---|---|
| Photograph No. 17<br><br>Description: View of the orientation of the 10-in. CMP at the left abutment (located using GPR and EM methods). | <div> <p><b>North East Elevation</b></p> <p>☼ 211°SW (T) ● 34.461786°N, 84.289605°W ±13ft ▲ 1567ft</p> <p>25 Jan 2025, 08:24:20</p> </div> | |

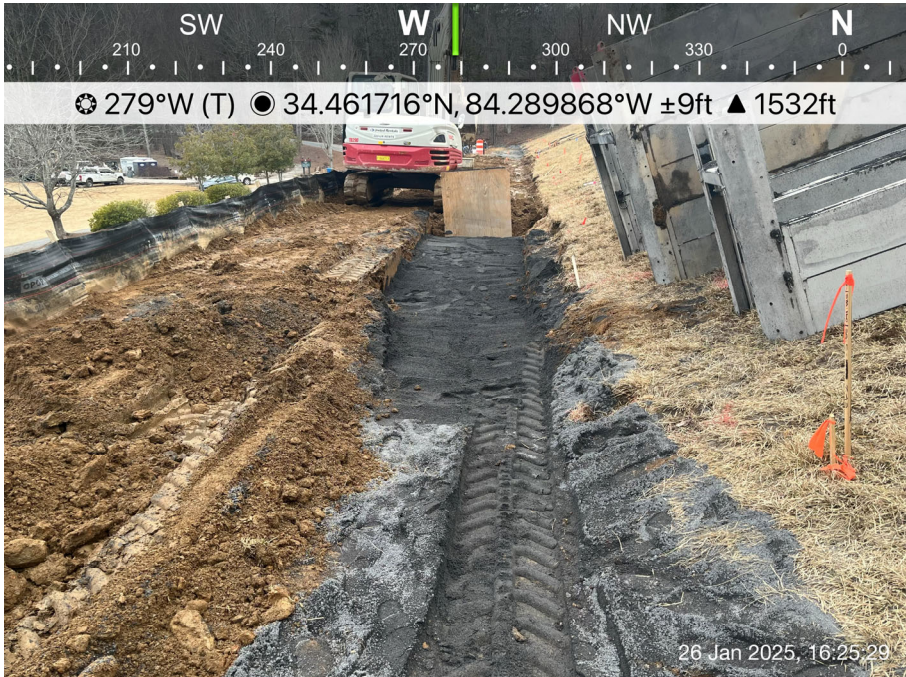
| PHOTOGRAPH LOG | | |
|---|---|---|
| Photograph No. 18<br><br>Description: View of installed and backfilled bench drain from approximately Station 4+18 to 3+78. | <div> <p>SW W NW N</p> <p>210 240 270 300 330 0</p> <p>☼ 279°W (T) ● 34.461716°N, 84.289868°W ±9ft ▲ 1532ft</p> <p>26 Jan 2025, 16:25:29</p> </div> | |

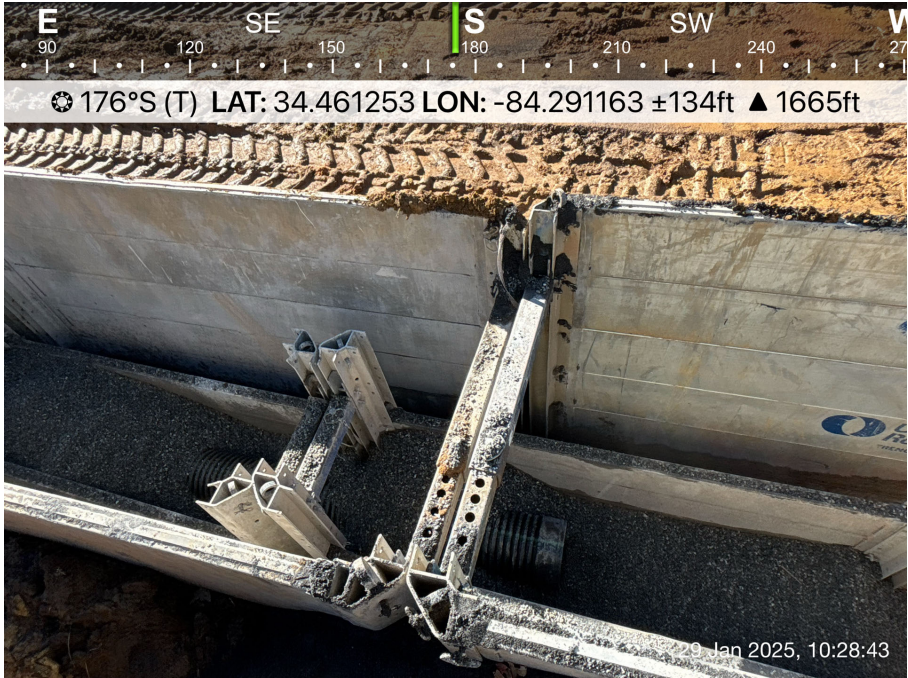
| PHOTOGRAPH LOG | | | |
|---|---|---|---|
| Photograph No. 19<br><br>Description: View of Action placing stone to the top of the aluminum forms between approximately Stations 4+18 and 4+00. | | | |

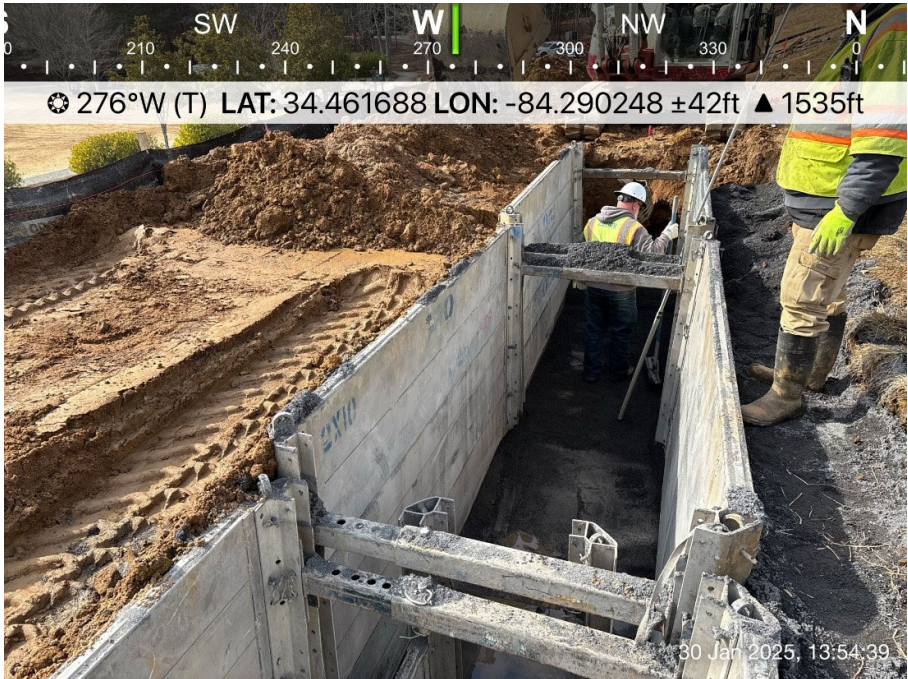
| PHOTOGRAPH LOG | | | |
|---|---|---|---|
| Photograph No. 20<br><br>Description: View of sand bedding being prepared to approximately Station 3+78 to 3+58. | | | |
