Monthly Construction Progress Report

Subject: Lake Petit Dam Seepage Collection System Modifications CQA

Lake Petit Seepage Collection CQA: Monthly Construction Progress Report November 2024

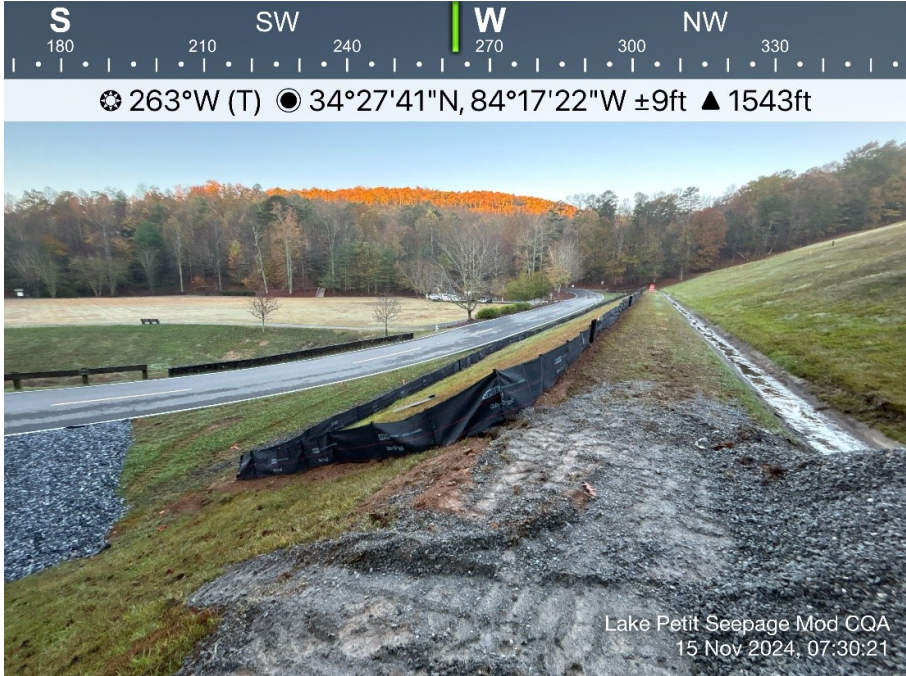
PHOTOGRAPH LOG		
PROJECT AND SITE INFORMATION		
PROJECT: Lake Petit Dam Seepage Collection CQA	DATE: November 2024 Reporting Period	
DESCRIPTION: Seepage Collection System Modification	PROJECT NO.: TCG11100	TASK NO.: 01/02
<p>Photograph No. 03</p> <p>Description: Site conditions at the beginning of the workday, taken from the left abutment. Note installation of silt fence along Bench No. 1 and at toe.</p>

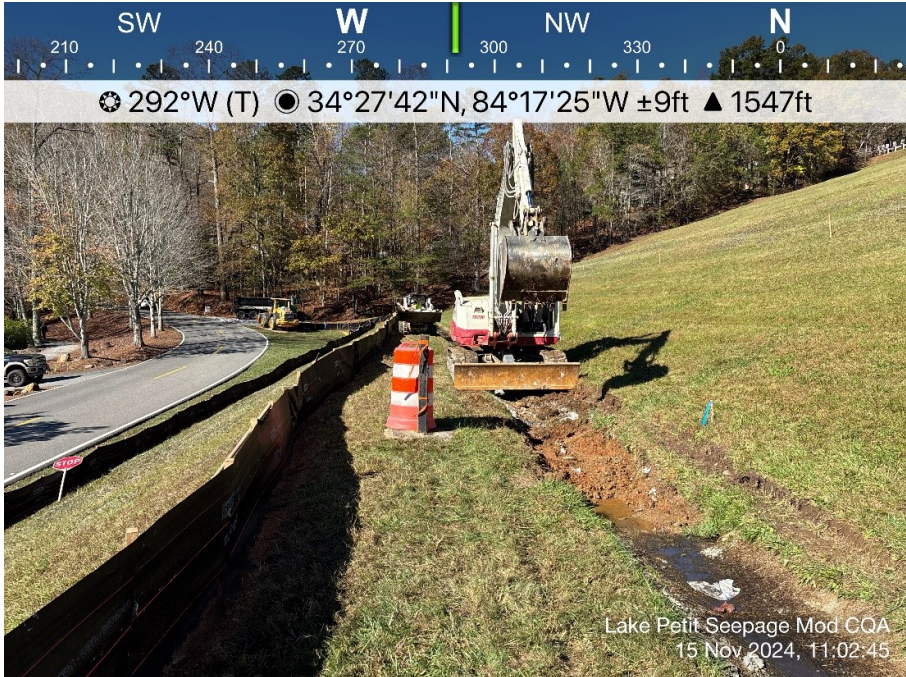
<p>Lake Petit Seepage Mod CQA 15 Nov 2024, 07:30:21</p>	
<p>Photograph No. 04</p> <p>Description: Excavator being used to remove the concrete drainage channel.</p>

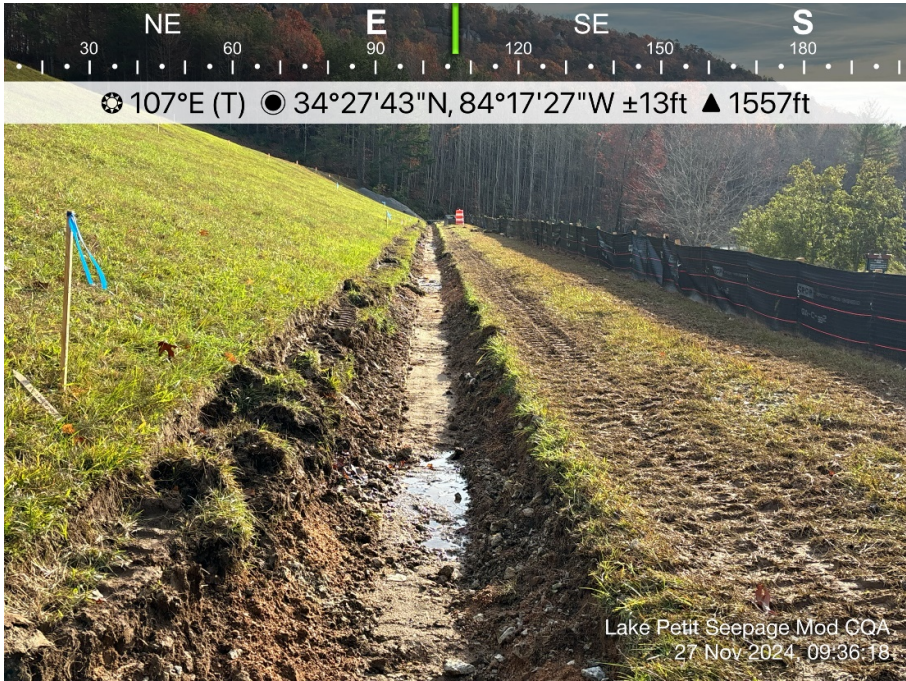
PHOTOGRAPH LOG		
PROJECT AND SITE INFORMATION		
PROJECT: Lake Petit Dam Seepage Collection CQA	DATE: November 2024 Reporting Period	
DESCRIPTION: Seepage Collection System Modification	PROJECT NO.: TCG11100	TASK NO.: 01/02
Photograph No. 07 Description: View of general condition of the drainage channel.

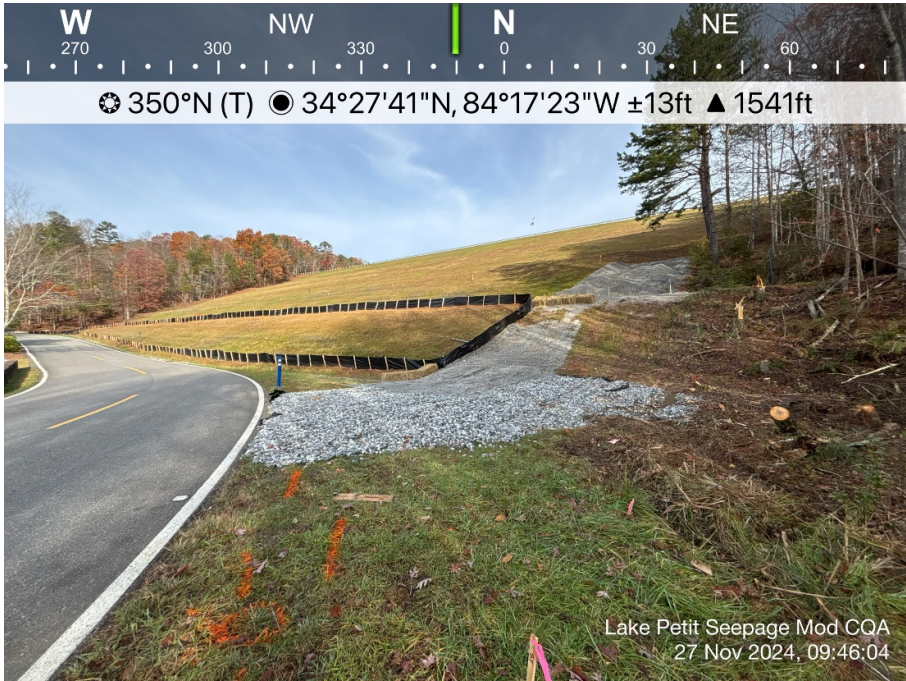
<p> 107°E (T) 34°27'43"N, 84°17'27"W ±13ft ▲ 1557ft </p> <p>Lake Petit Seepage Mod CQA 27 Nov 2024, 09:36:18</p>	
Photograph No. 08 Date 27 Nov 2024 Description: Site conditions as viewed from the left abutment.

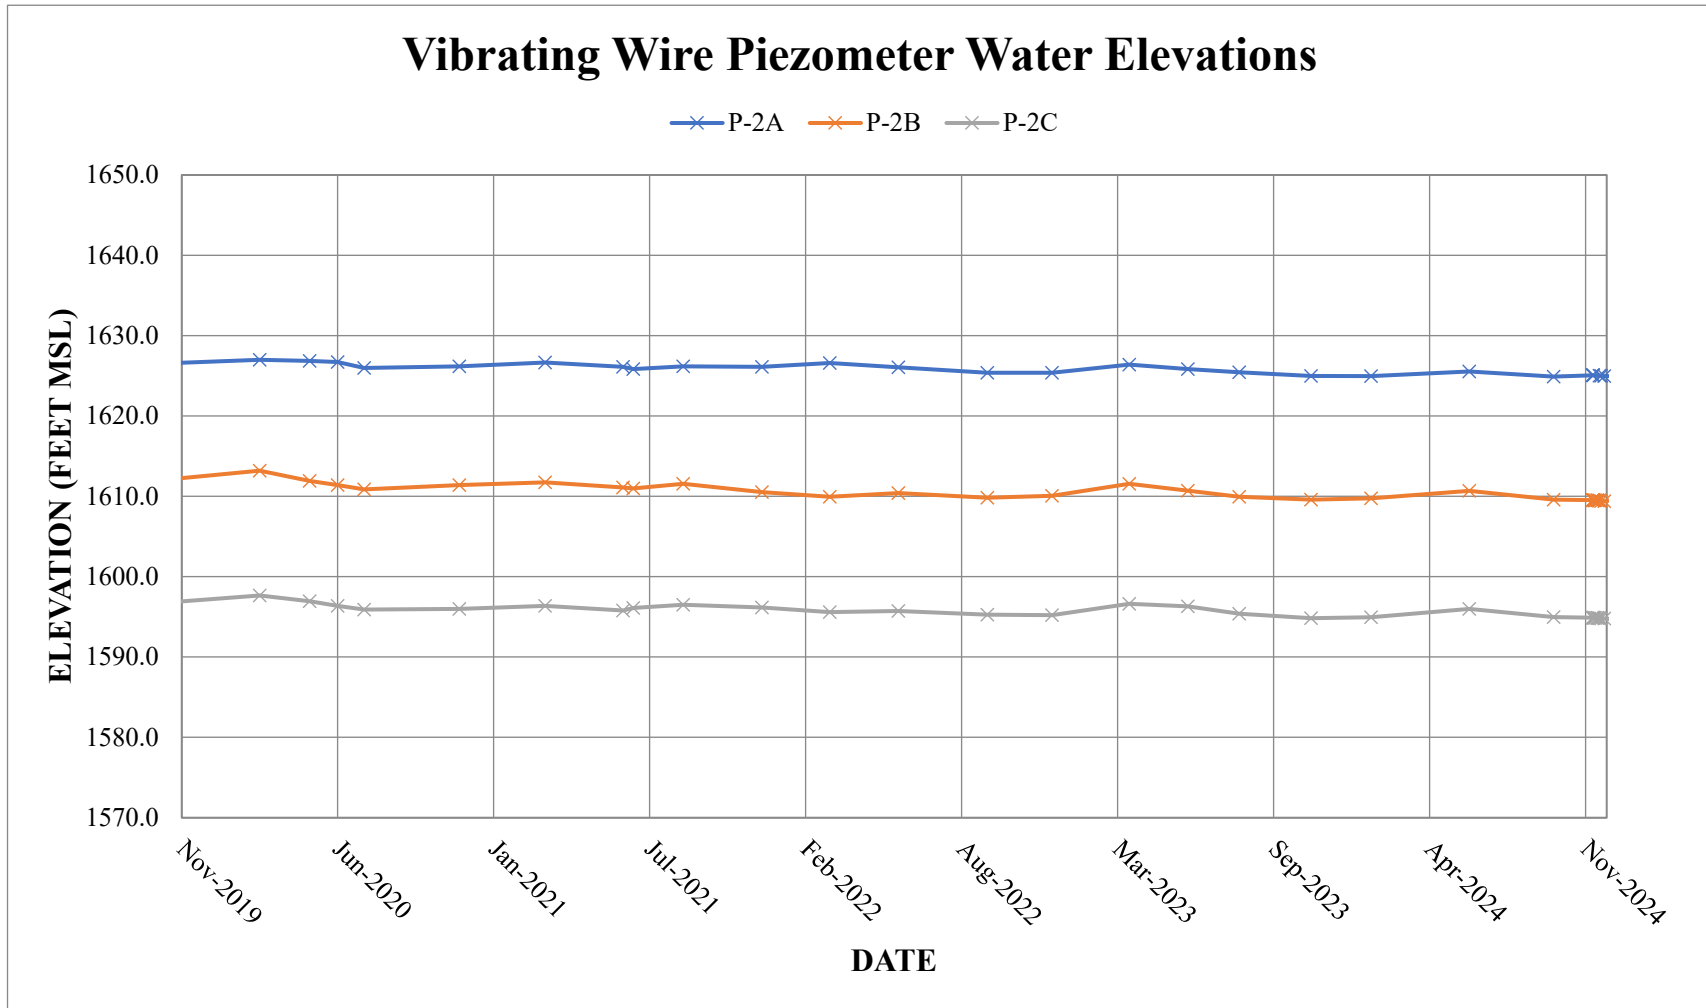
**Figure 1. Summary of Vibrating Wire Piezometer Data, P-2A, B, C
Lake Petit Dam, Big Canoe, GA**

When work was occurring, an Engineer's representative recorded twice-daily readings from vibrating wire piezometers located on Bench No. 1 and Bench No. 2, and daily readings from vibrating wire piezometers and open standpipe piezometers located at Bench No. 3, Bench No. 4, Bench No. 5, and the Crest of the Dam. Records of those readings, as well as readings since November 2019, are provided in plots shown in Attachment 2.

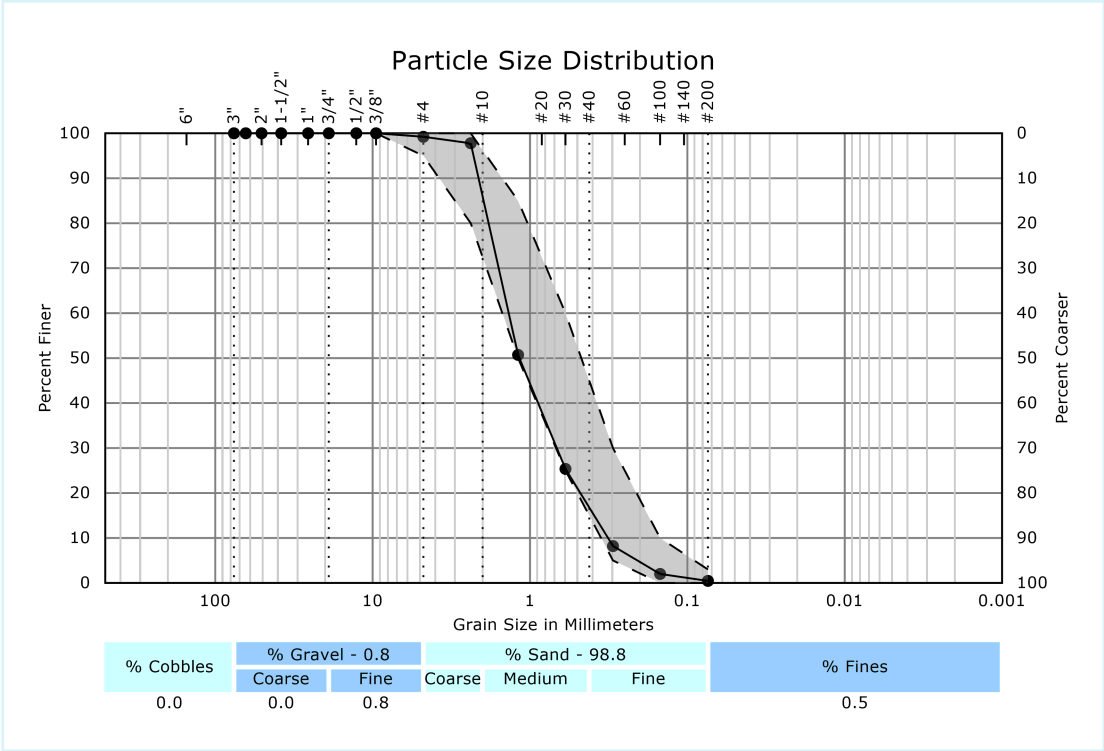
Specified drainage aggregates were delivered to the Site on 13 November 2024 and the Engineer's representative sampled for these for conformance testing. The materials met the gradation specifications for ASTM C-33 Sand and No. 89 Stone. Results are presented in Attachment 3.

Sieve Size	Percent Finer	Spec.*	Pass (X=Fail)
3"	100		
2-1/2"	100		
2"	100		
1-1/2"	100		
1"	100		
3/4"	100		
1/2"	100		
3/8"	100	100	
#4	99	95-100	
#8	98	80-100	
#16	51	50-85	
#30	25	25-60	
#50	8	5-30	
#100	2	0-10	
#200	0.5	0-3

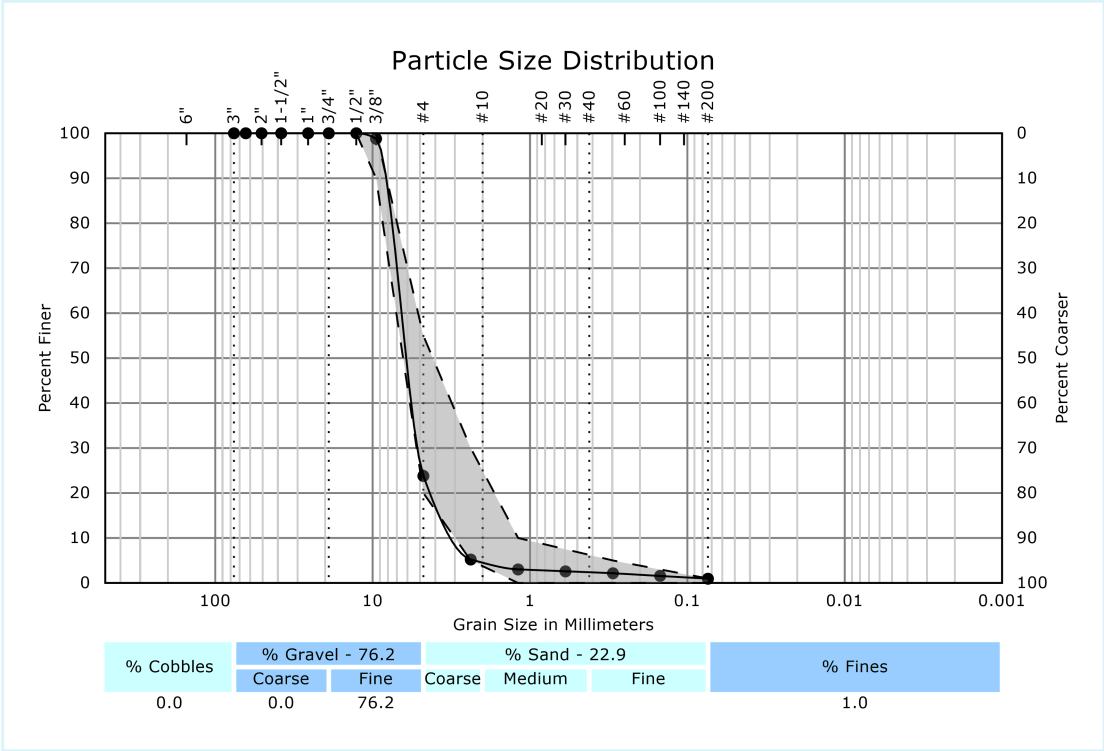
Sieve Size	Percent Finer	Spec.*	Pass (X=Fail)
3"	100		
2-1/2"	100		
2"	100		
1-1/2"	100		
1"	100		
3/4"	100		
1/2"	100	100-100	
3/8"	99	90-100	
#4	24	20-55	
#8	5	5-30	
#16	3	0-10	
#30	3		
#50	2	0-5	
#100	2		
#200	1	0-1
