Monthly Construction Progress Report

Date: 17 March 2025

Subject: Lake Petit Dam Seepage Collection System Modifications CQA

Lake Petit Seepage Collection CQA: Monthly Construction Progress Report February 2025

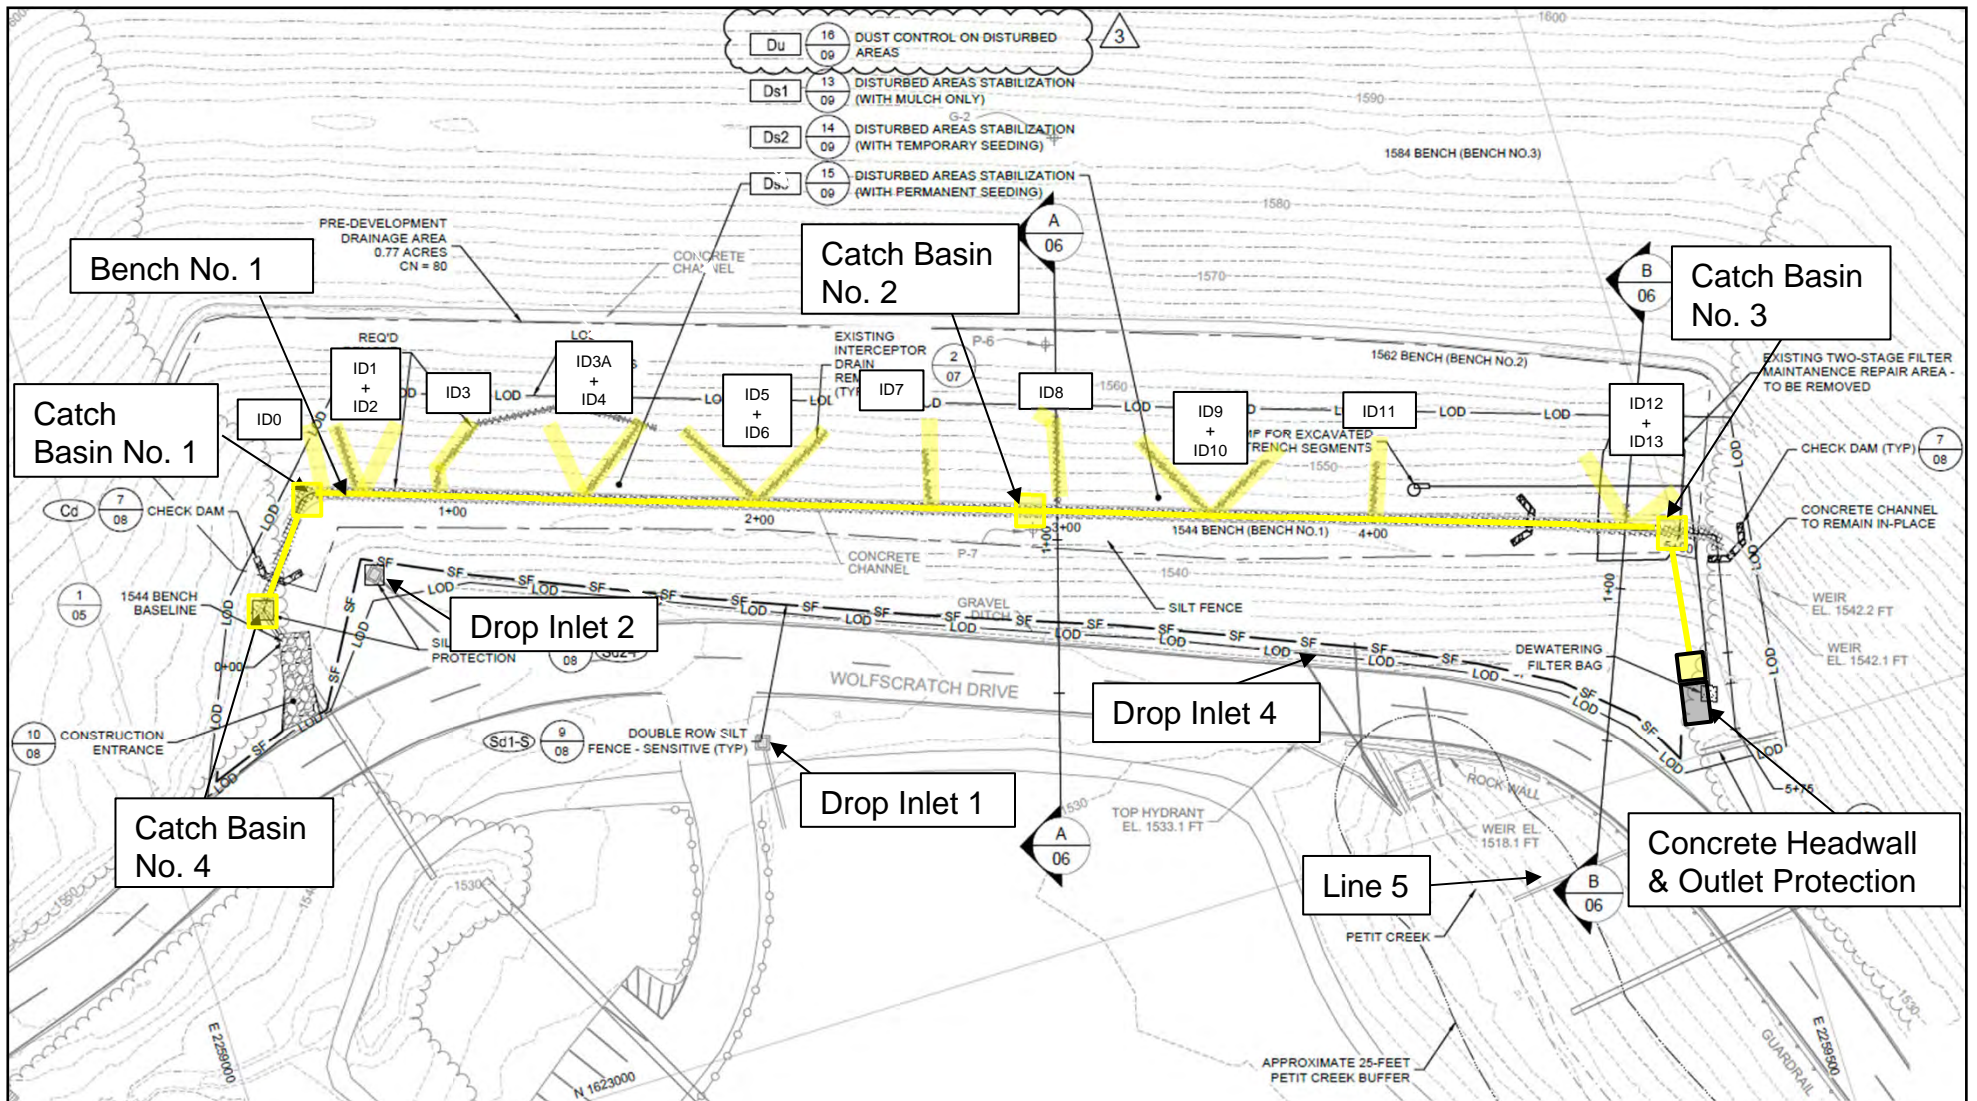
FIGURE 1. SITE LAYOUT

- INSTALLED CATCH BASINS AND ADS N-12 10-in. PIPE (CUMULATIVE)
- INSTALLED FILTER AND INTERCEPTOR DRAINS (CUMULATIVE)
- INSTALLED CONCRETE HEADWALL
- INSTALLED OUTLET PROTECTION

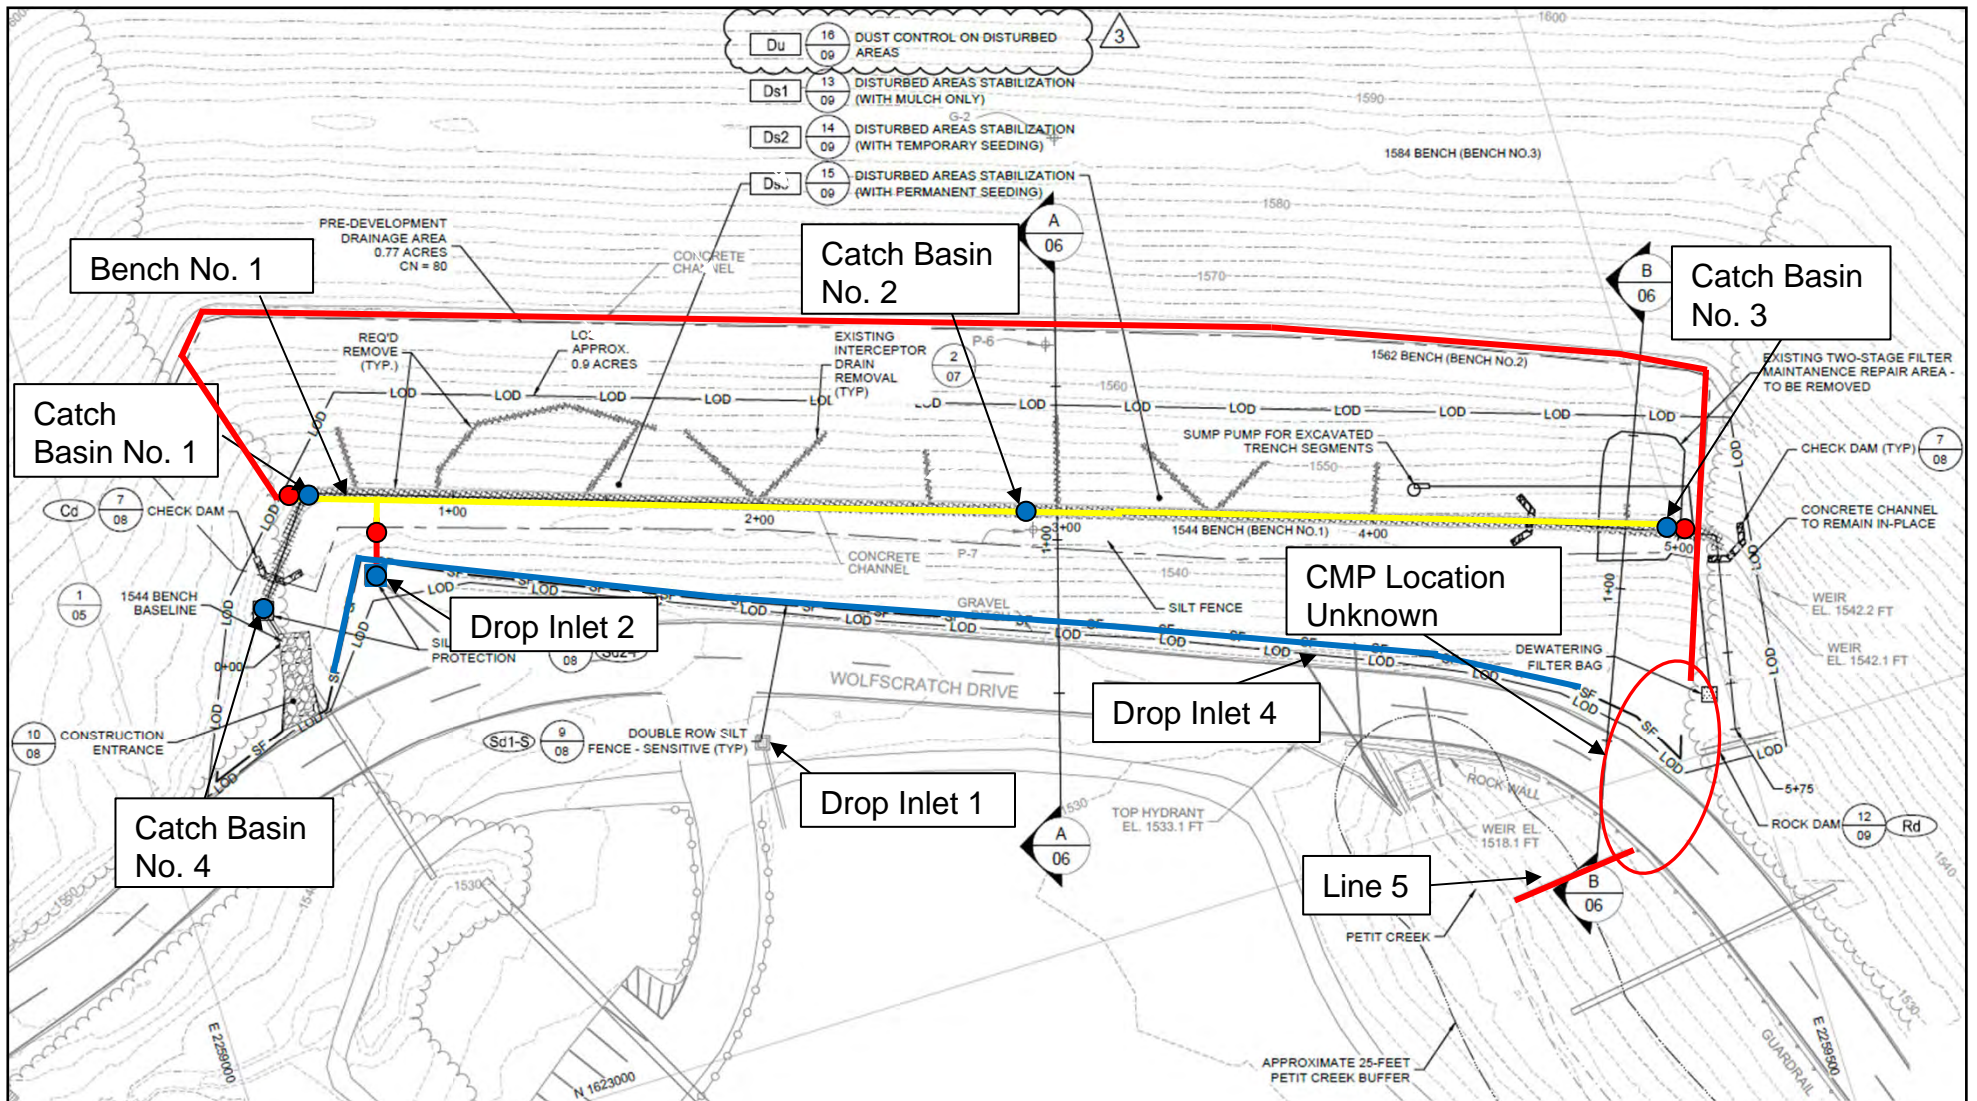
FIGURE 2. SITE LAYOUT

- █ EXISTING CORRUGATED METAL PIPE (CMP) DRAIN – REMOVED
- █ EXISTING CMP DRAIN – TO REMAIN IN-PLACE
- EXISTING CMP DRAIN – LOCATION OF FERNCO CAP
- █ SILT FENCE TO REMAIN IN PLACE UNTIL “FINAL STABILIZATION” OF THE SITE
- INLET PROTECTION TO REMAIN IN PLACE UNTIL “FINAL STABILIZATION” OF THE SITE

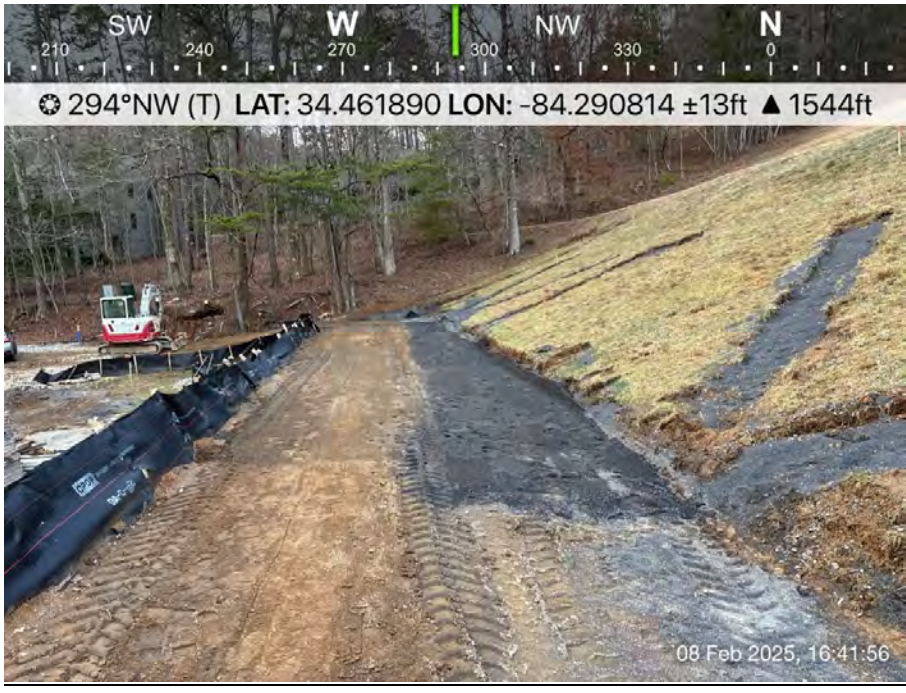
Photograph No. 09

Description: View of the west side of the bench after regrading was performed to promote surface runoff.

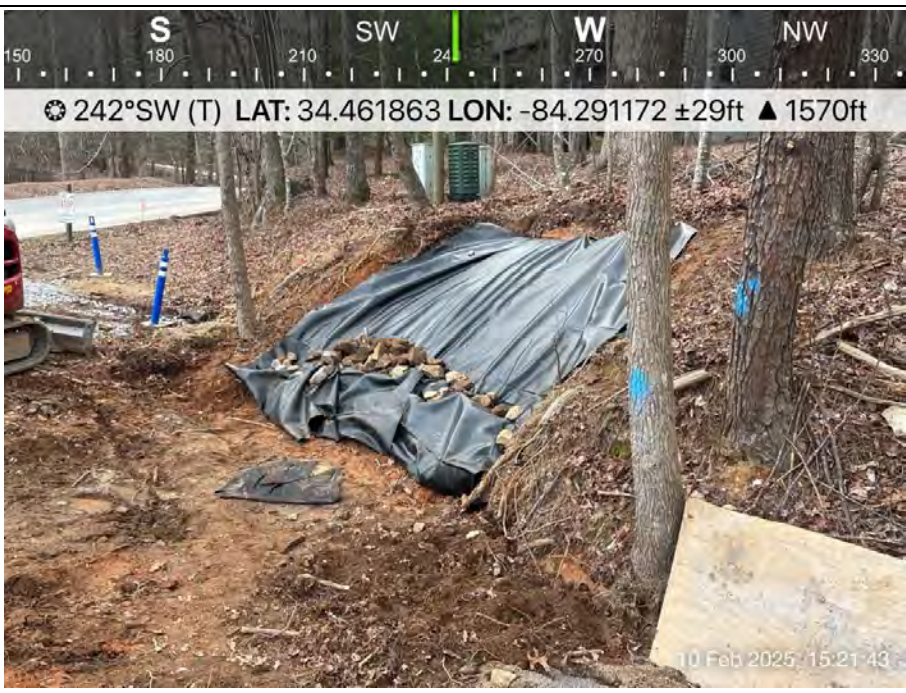
Photograph No. 10

Description: View of filter fabric placed near CB4.
