LAKE PETIT DAM

Summary of Visual Assessment

Geosyntec Consultants, Inc.

April 2024

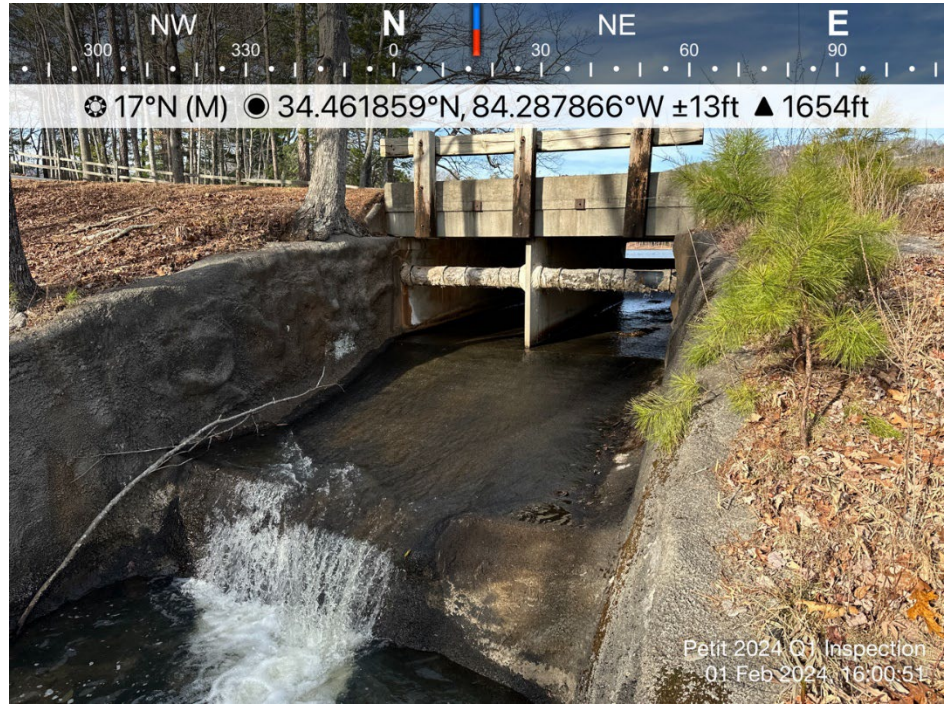
Comments: Spillway - View of the general conditions of the spillway.

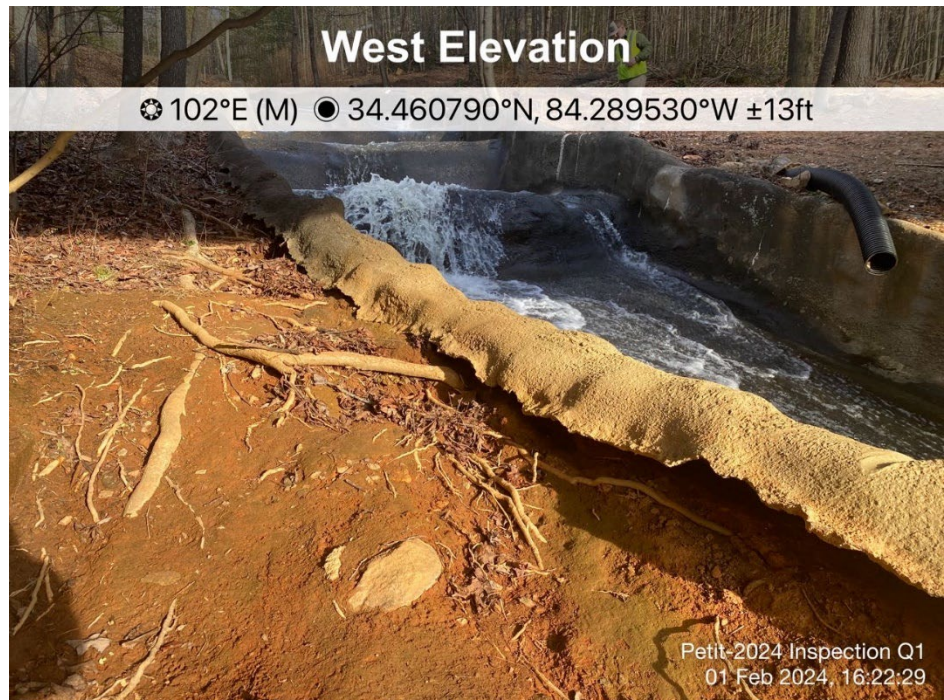
Photograph 2

Comments: Spillway - View of erosion behind right spillway wall.

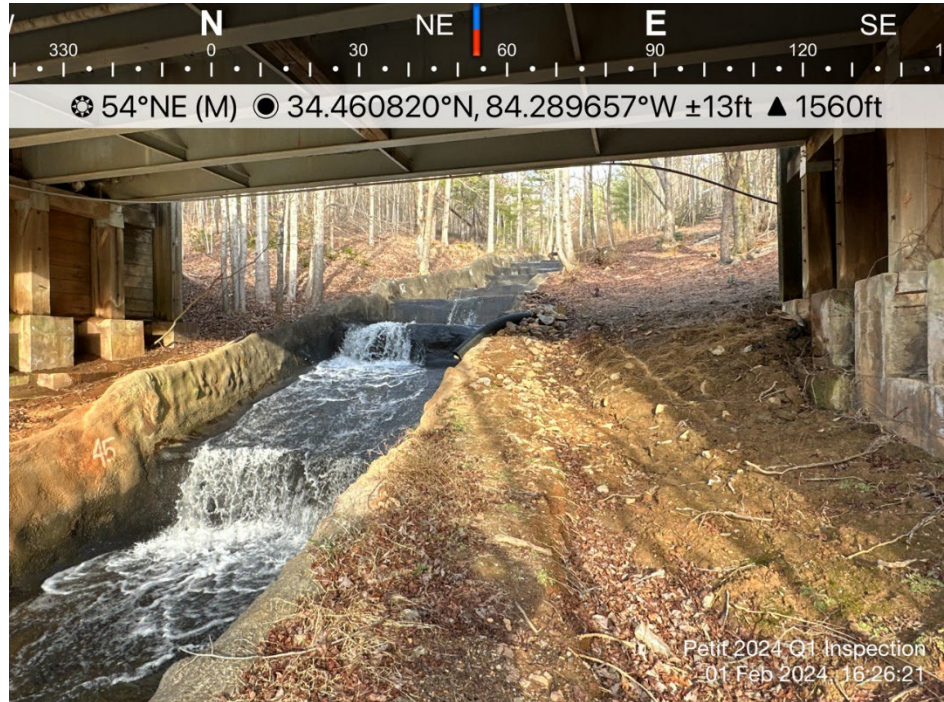
Comments: Spillway - View of surficial erosion near left side of spillway.

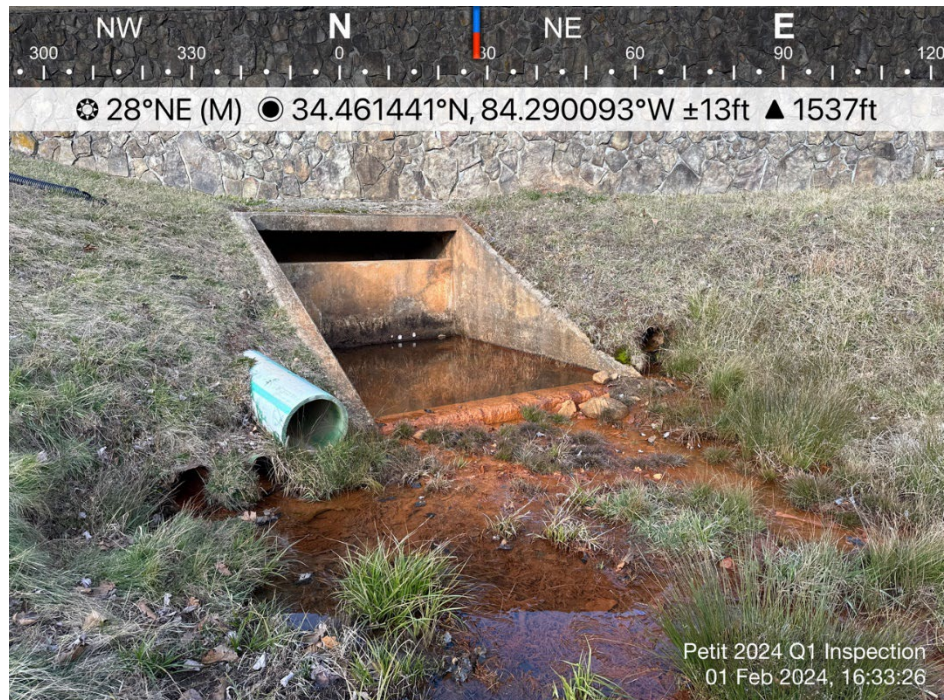
Photograph 4

Comments: Low Level Outlet - View of general conditions of the outlet structure of the Low Level Outlet.

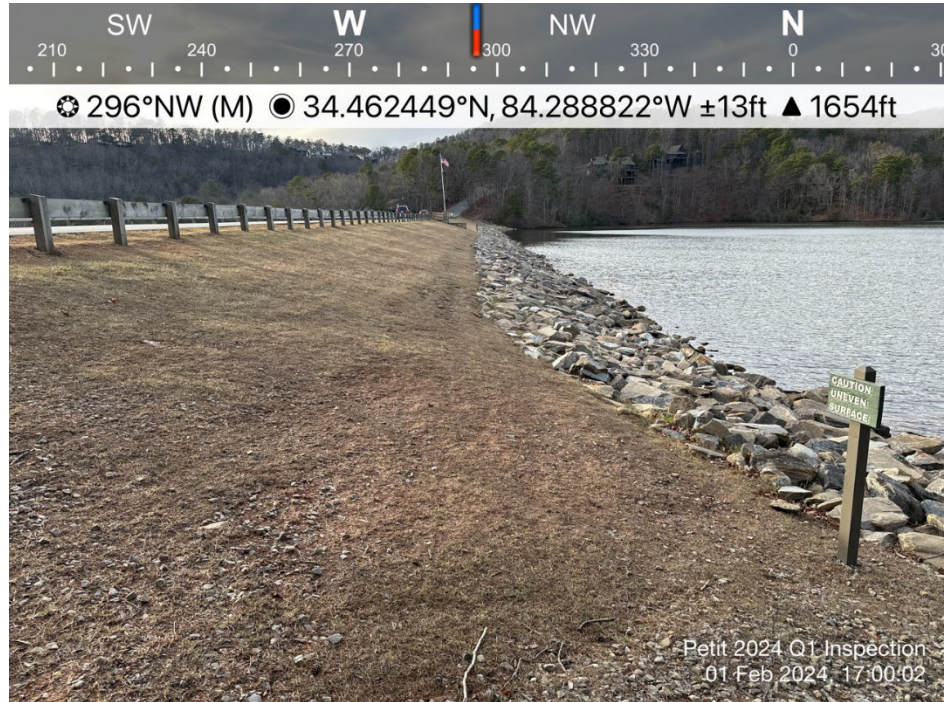
Comments: Upstream Slope - View of general conditions of the upstream slope.

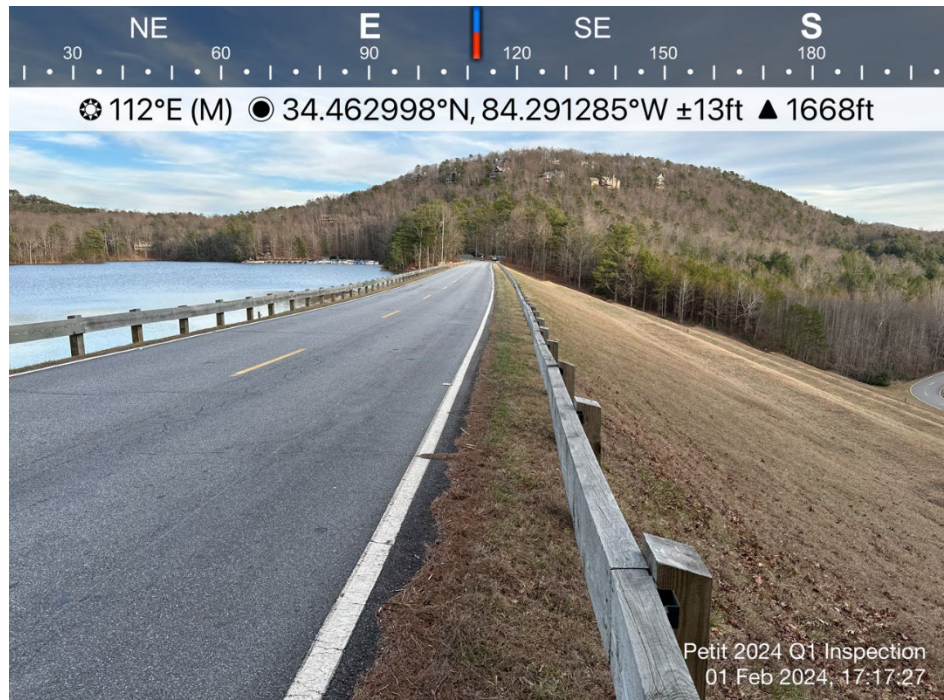
Photograph 6

Comments: Crest - View of general conditions of the crest of the dam from the right side.

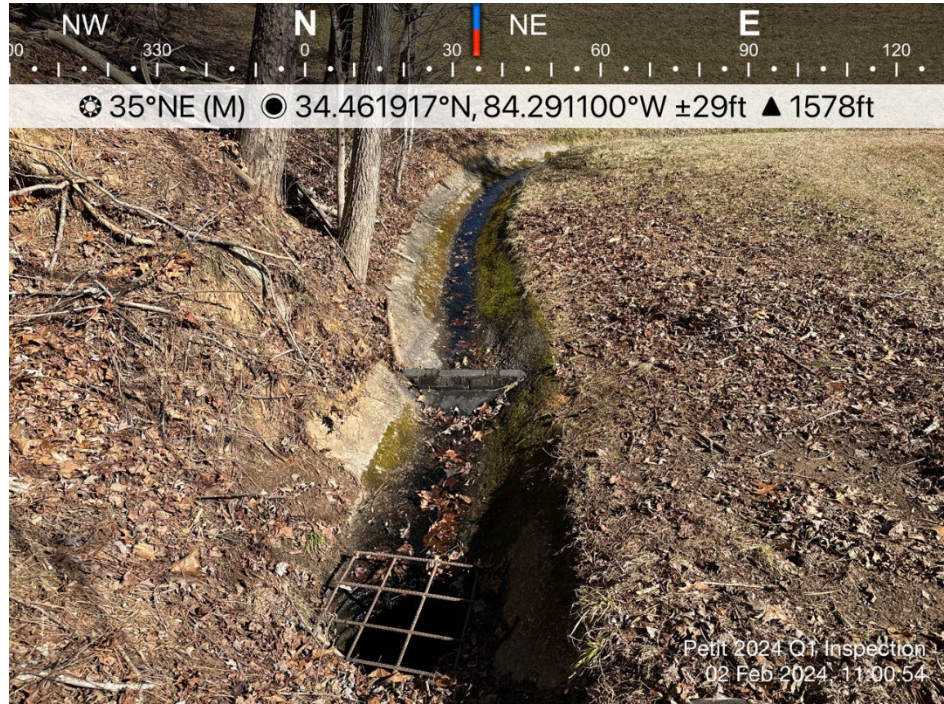
Comments: Downstream Slope - View showing the right side weir at Bench 1.

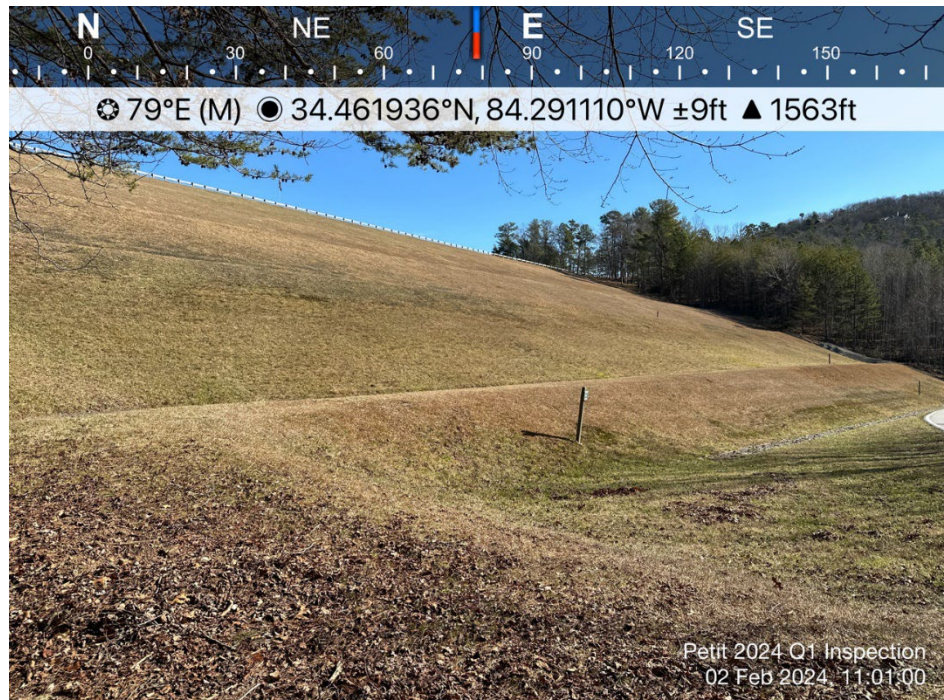
Photograph 8

Comments: Downstream Slope - View of the general conditions of the Downstream slope of the dam from the right side of Bench 1.

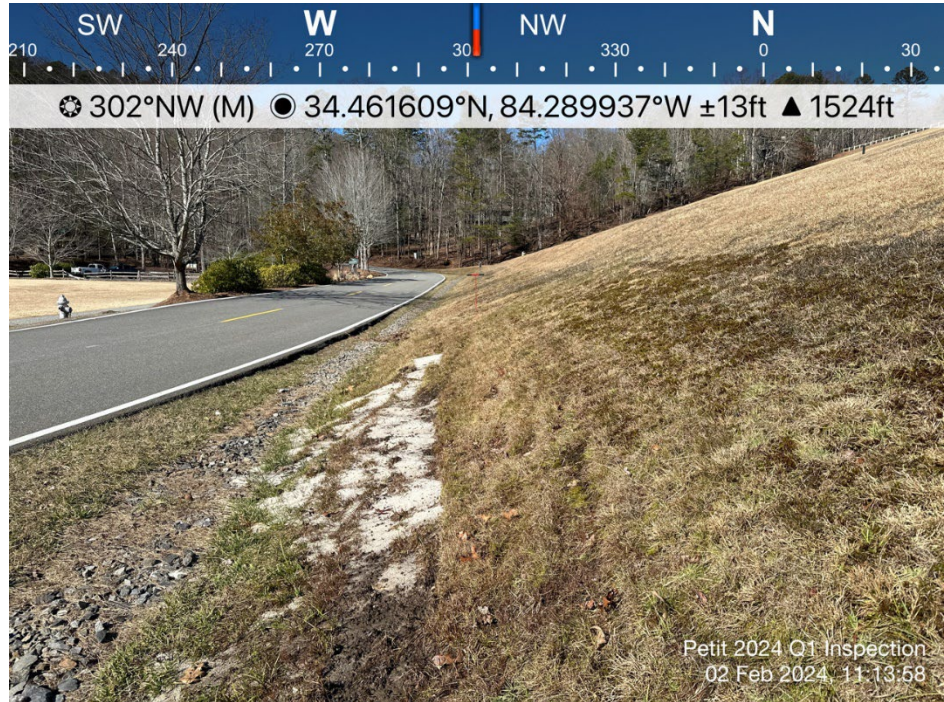
- The area between Benches 1 and 2 was found to have localized areas that were wet and slightly soft. This area generally corresponds to the location of interceptor drains and may indicate damage to an interceptor drain, causing water to flow into the backfill around the pipe instead of flowing through the pipe into the concrete channel. The wet areas may be compounded by expected seasonal conditions during the wettest part of the year in the first calendar quarter; however, these areas will be remediated as part of the seepage collection system modification.

Comments: Downstream Slope – View of previously observed wet area at downstream slope between Bench 1 and the roadway.

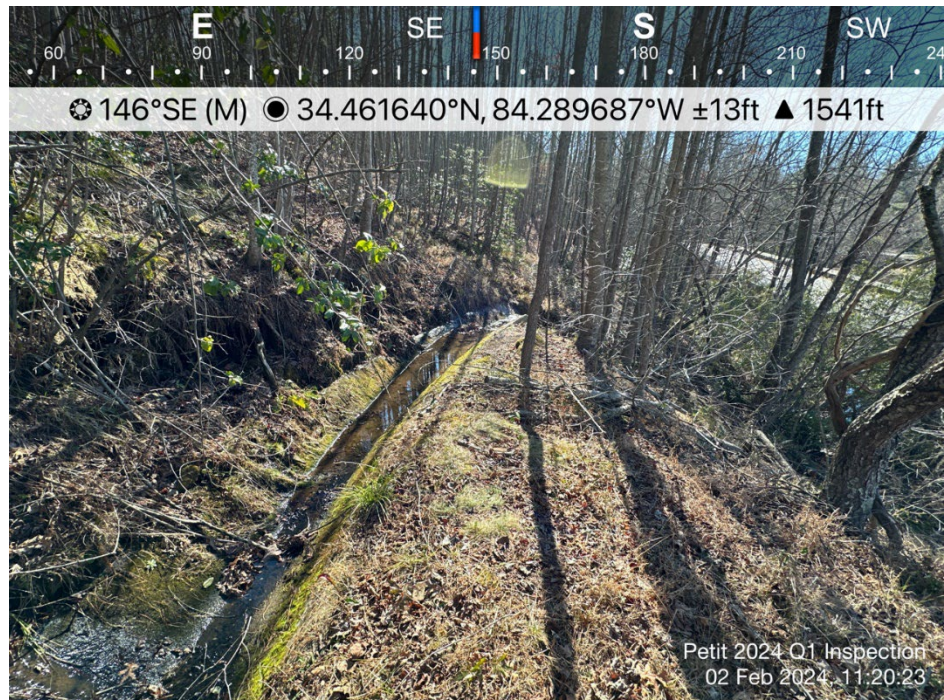
Photograph 10

Comments: Downstream Slope - View showing the left side weir of Bench 1.

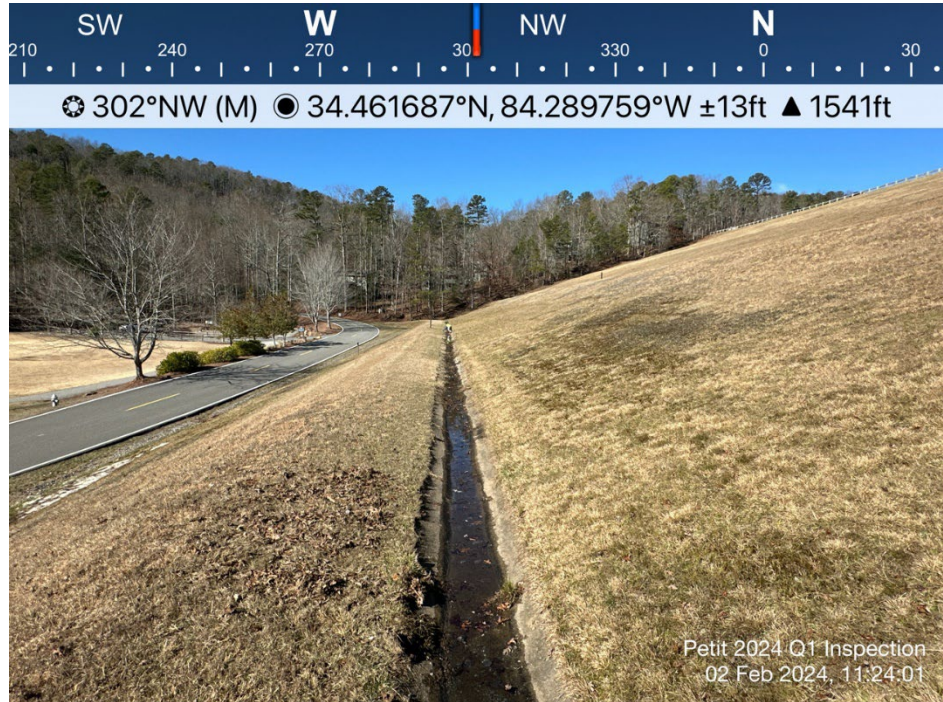
- The lower concrete channel was observed to be wet with slowly draining flow at the time of Inspection, and the upper concrete channel was dry. The lower channel tends to collect sediment and debris believed to be from backfill from around the interceptor drains eroding into the channel. This sediment should be routinely cleaned out to allow proper drainage of water toward the abutments. In addition, the concrete of both channels has deteriorated in certain locations and the joints between adjacent sections of channel are no longer watertight, though the majority of flow in the channels does appear to drain toward the abutments. Minor cracking and open joints in the concrete channel should be monitored for further deterioration and should be repaired if the cracking becomes large enough to impede or redirect flow. Areas in Benches 1 or 2 where the concrete in the channel has broken off should be repaired to restore the channel and prevent erosion.

Comments: Downstream Slope - View of the concrete lined bench drain at Bench 1.

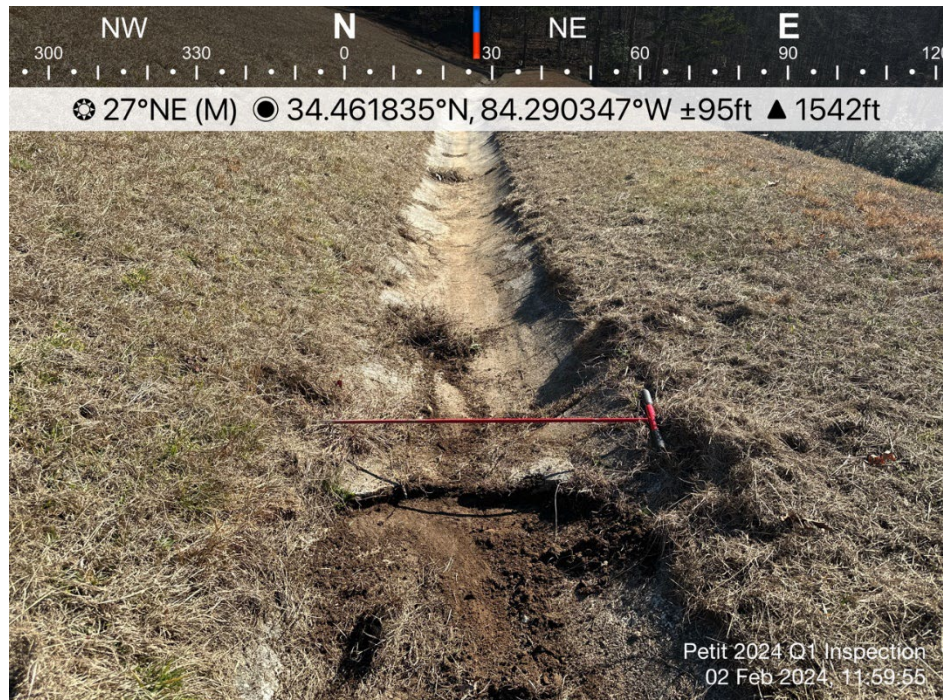
Photograph 12

Comments: Downstream Slope - View showing separation at a joint in the concrete of the concrete lined bench drain left of the dam centerline at Bench 2.

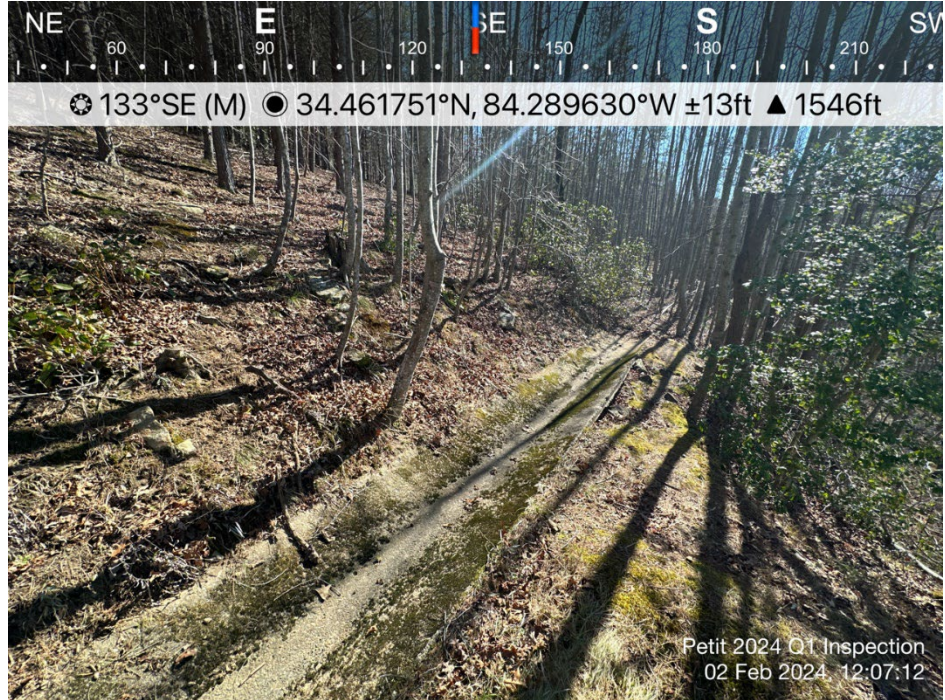
- The upper concrete channel on Bench 2 on the left abutment of the Dam was observed to have been undermined and eroded, likely from upstream flow. It is likely that the drainage bench upstream from this point was previously clogged with vegetation, which may have resulted in surface water being directed downslope to the upper concrete channel. The influx of surface water likely overtopped the upper concrete channel and initiated the observed undermining and erosion. The eroded areas should be repaired by placing and compacting clayey soils in the undermined area and establishing vegetation to the extent possible. Debris should be removed from channels on the left abutment above the affected area and all channels on the Dam and abutments should continue to be kept clean of loose debris and vegetation to ensure free flow of water.

Comments: Downstream Slope - View of the left side bench drain at Bench 2 showing erosion beneath the concrete channel.

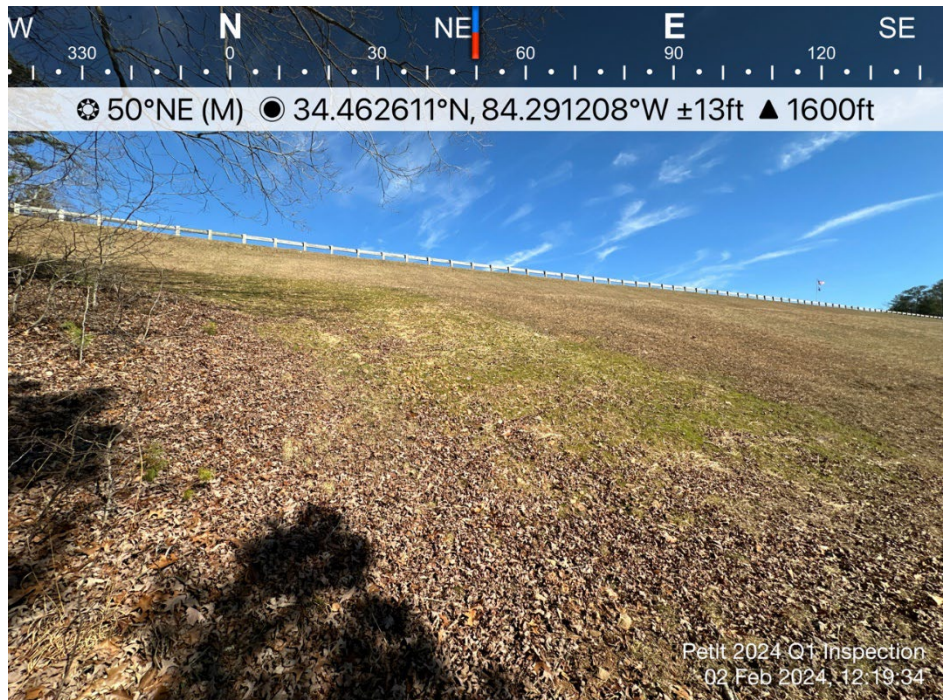
Photograph 14

Comments: Downstream Slope - View of reseeded area where surficial erosion had previously been noted near the right-side groin between Bench 4 and Bench 5.

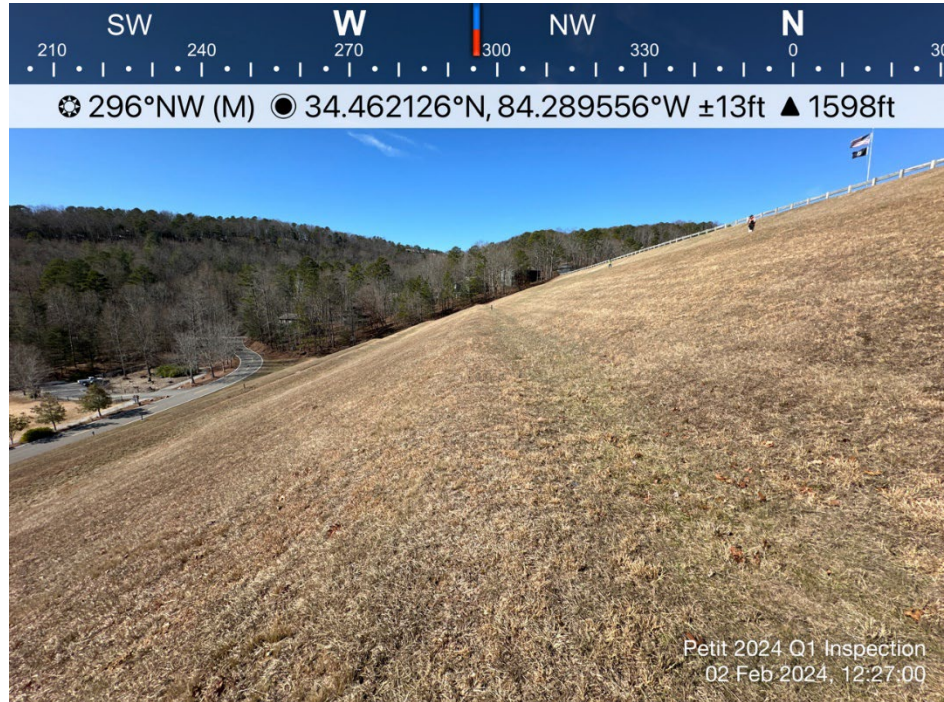
Comments: Downstream Slope - View of the general conditions of the downstream slope of the dam from the left side at Bench 4.

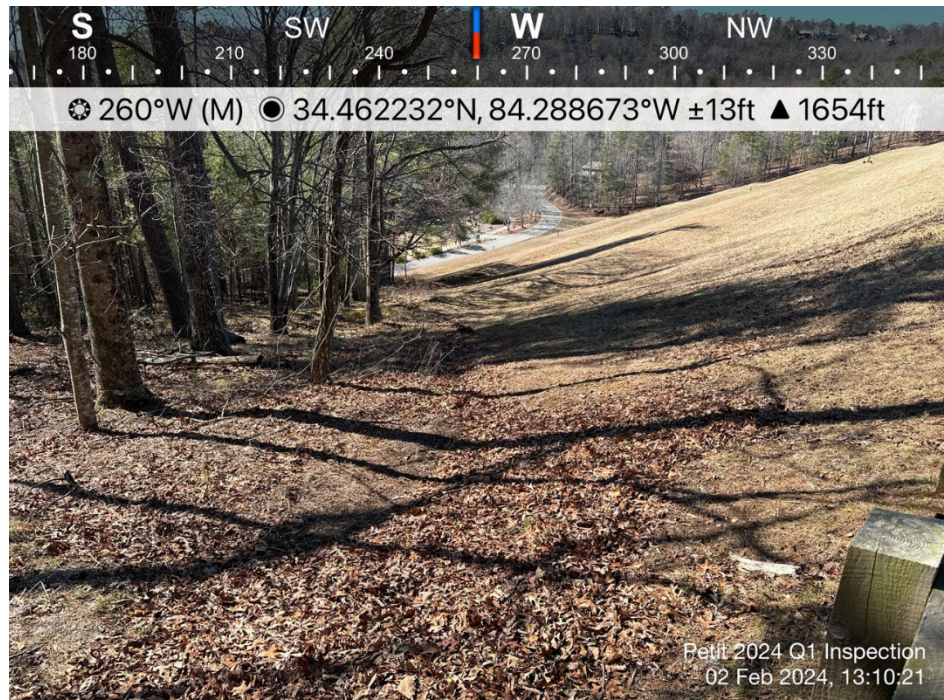
Photograph 16

Comments: Downstream Slope - View of surficial erosion at the left groin near the crest of the dam.

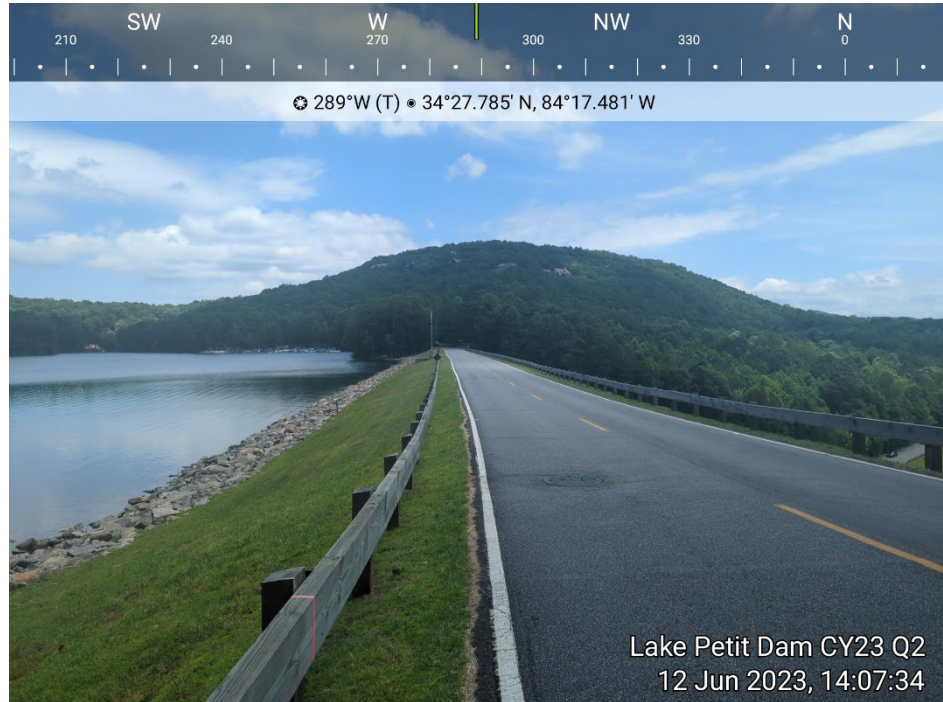
Comments: Crest - View of the asphalt roadway on the crest of the dam. Photograph was taken from the right abutment.

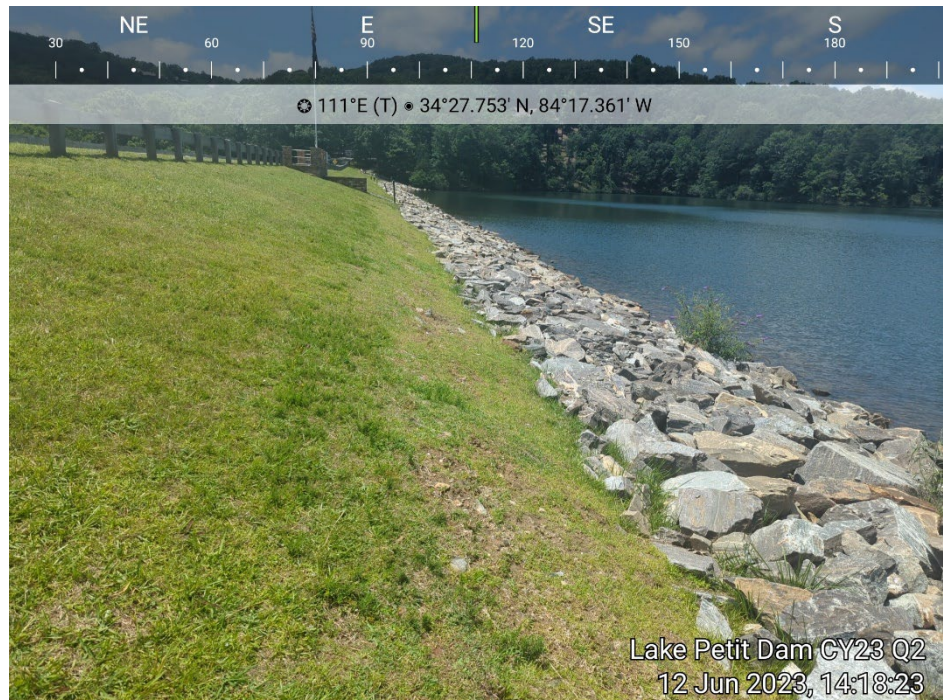
Photograph 2

Comments: Upstream Slope - View of the grass-covered upstream slope and riprap wave action protection. Photograph was taken from the left side of the upstream slope of the dam.

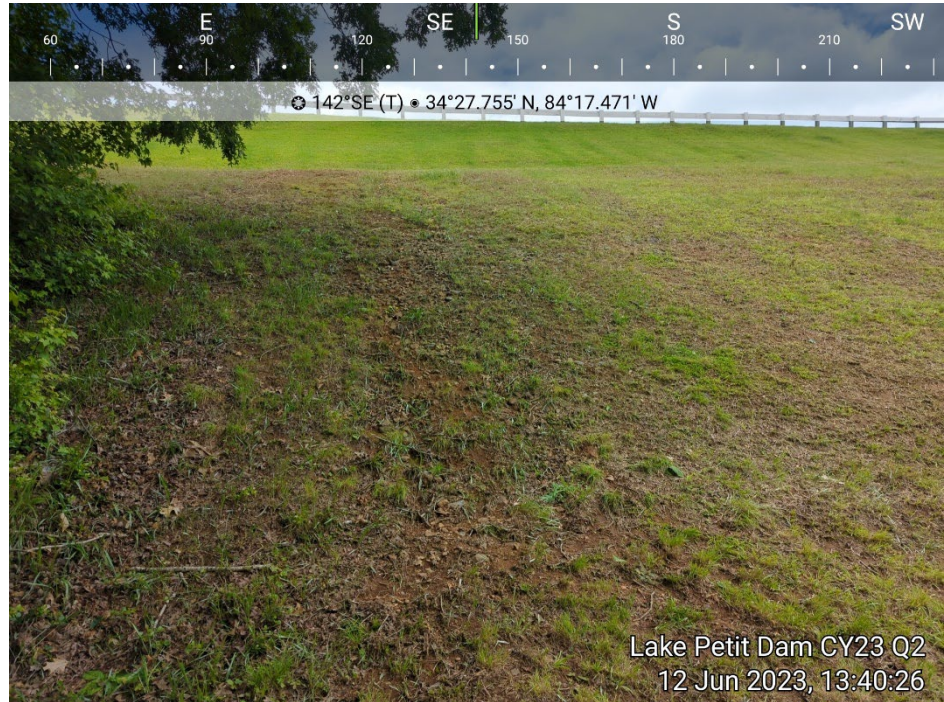
Comments: Downstream Slope - View of typical erosion/area of sparse vegetation (near right abutment, between Bench No. 4 and 5).

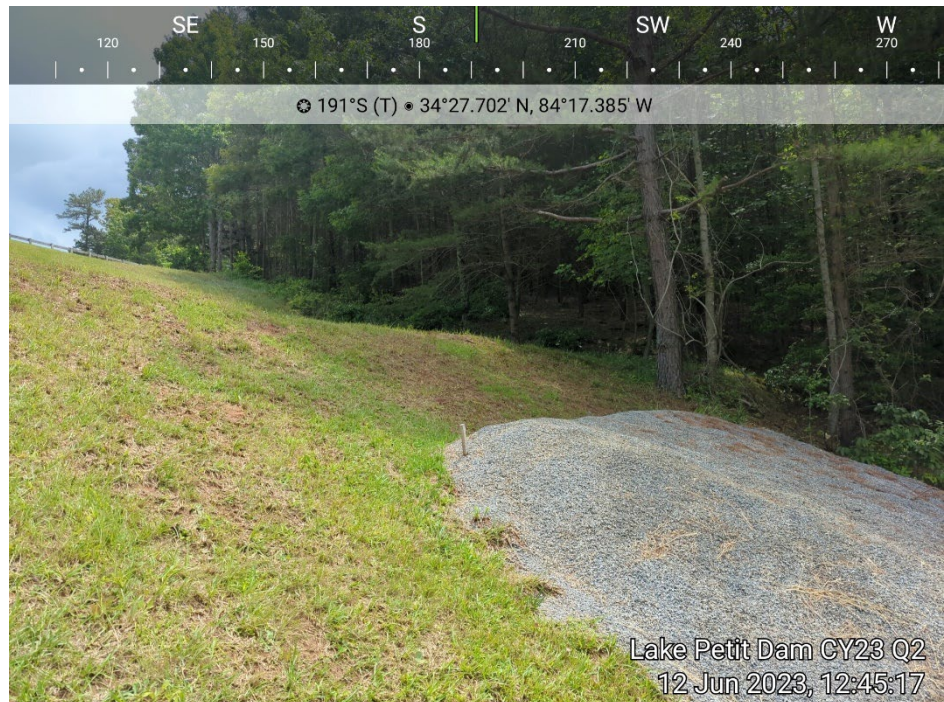
Photograph 4

Comments: Downstream Slope - View of surficial erosion above previously installed erosion and sediment control (ESC) measure near the left abutment.

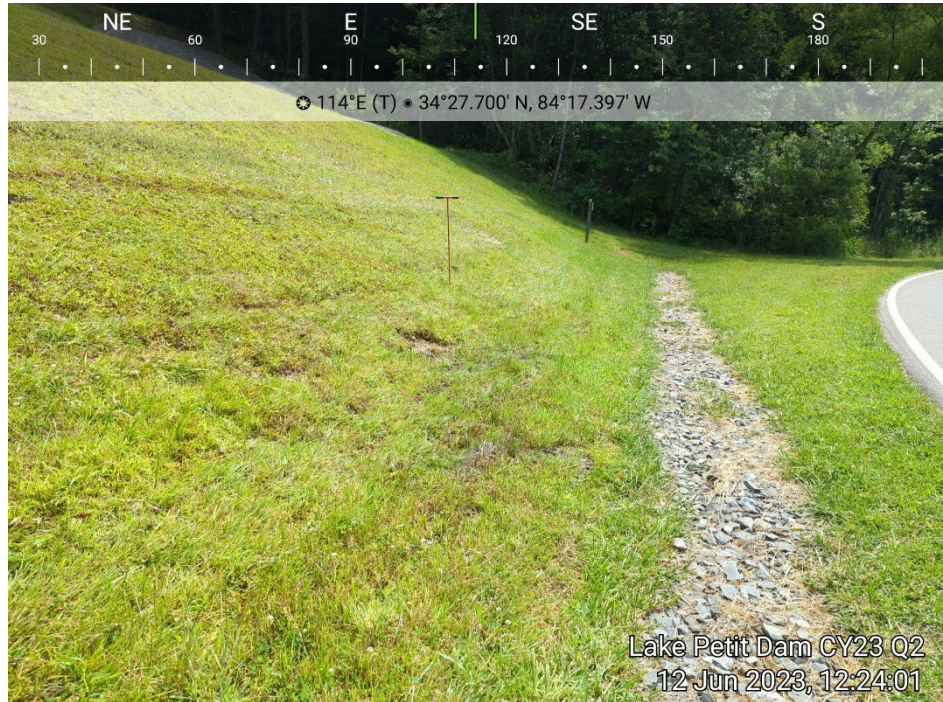
Comments: Downstream Slope - Wet area on left side of the slope between the road and Bench No.1, approximately 6 ft up the slope and 40 ft along the slope.

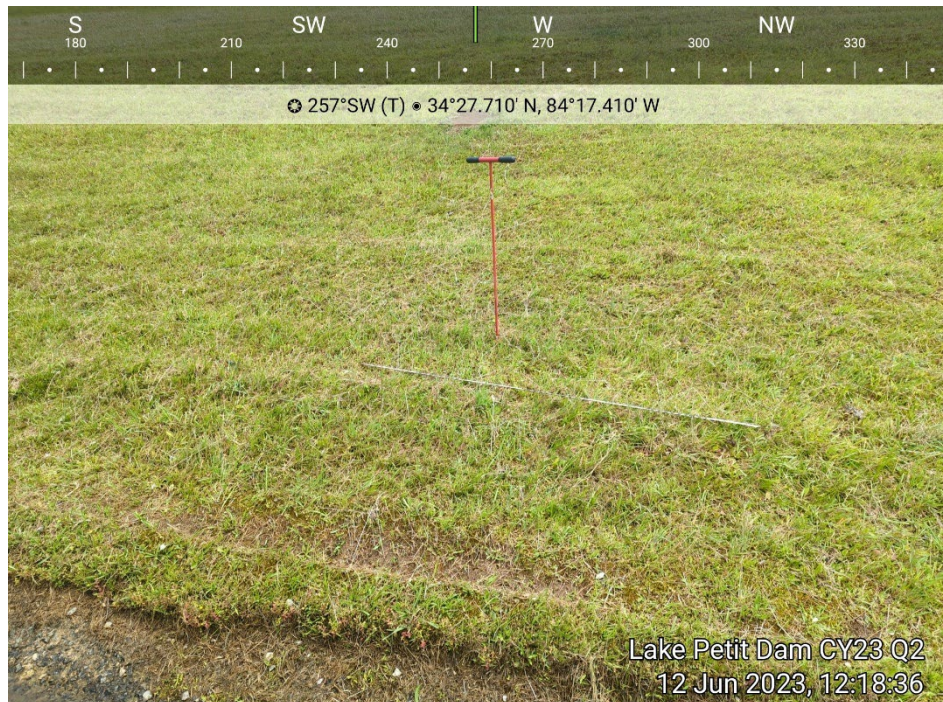
Photograph 6

Comments: Downstream Slope - Wet area to the left of interceptor drain No. 10 at Bench No. 1, approximately 5 ft up the slope and 10 ft along the slope.

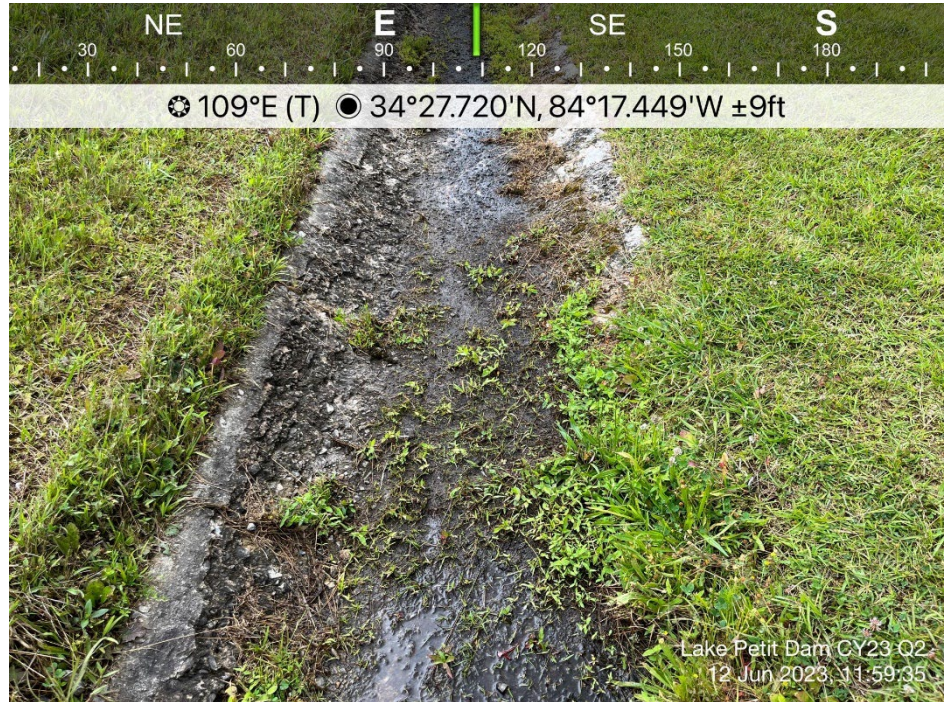
Comments: Downstream Slope - View of the sediment and vegetation build-up at the concrete channel located on Bench No. 1.

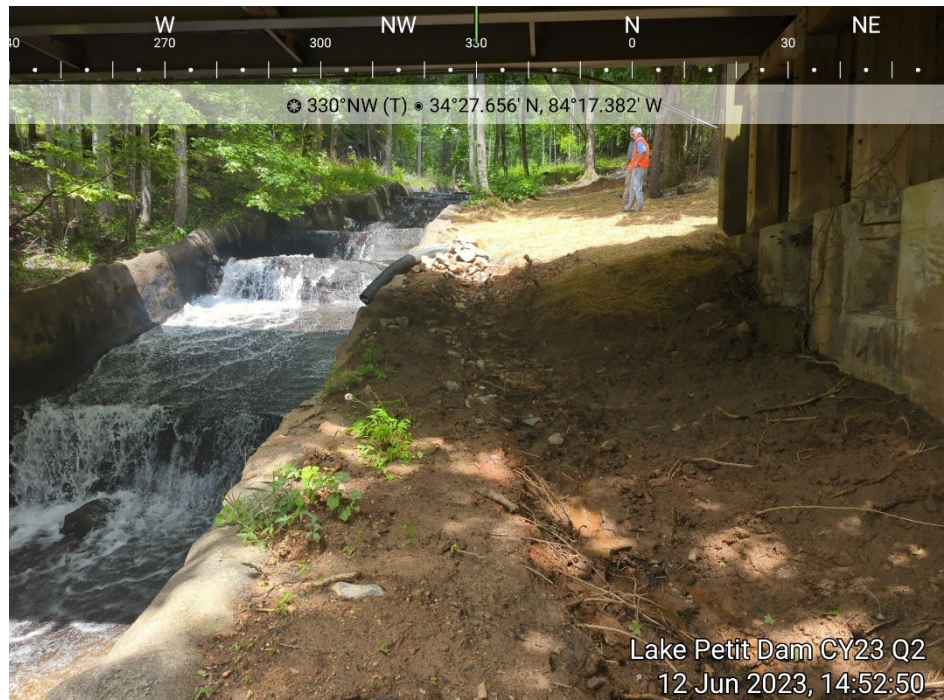
Photograph 8

Shortly after the April 2022 repairs, during the June 2022 Quarter 2 (Q2) Quarterly Owner Inspection, flow was once again observed to daylight near Step 45. Big Canoe POA conducted a dye test at the spillway to investigate potential sources of seepage. Observations by Big Canoe POA during the dye test suggested that the source of the daylighting water may be flow through the spillway. Based on these observations, the spillway was dewatered again in August 2023 to allow thorough inspection of the spillway chute for signs of deterioration and to inform a scope of work for additional repairs. Possible sources of seepage were identified on three steps (Steps 33, 37, and 42) during the Inspection, and maintenance grouting repairs to these steps were conducted on 31 August 2023. No flow has been observed to daylight adjacent to the spillway following these repairs, but the area around Step 45 should be monitored for changes to confirm that flow does not resume.

Comments: Spillway - Surficial flow was observed on the left side of Step 45 of the spillway.

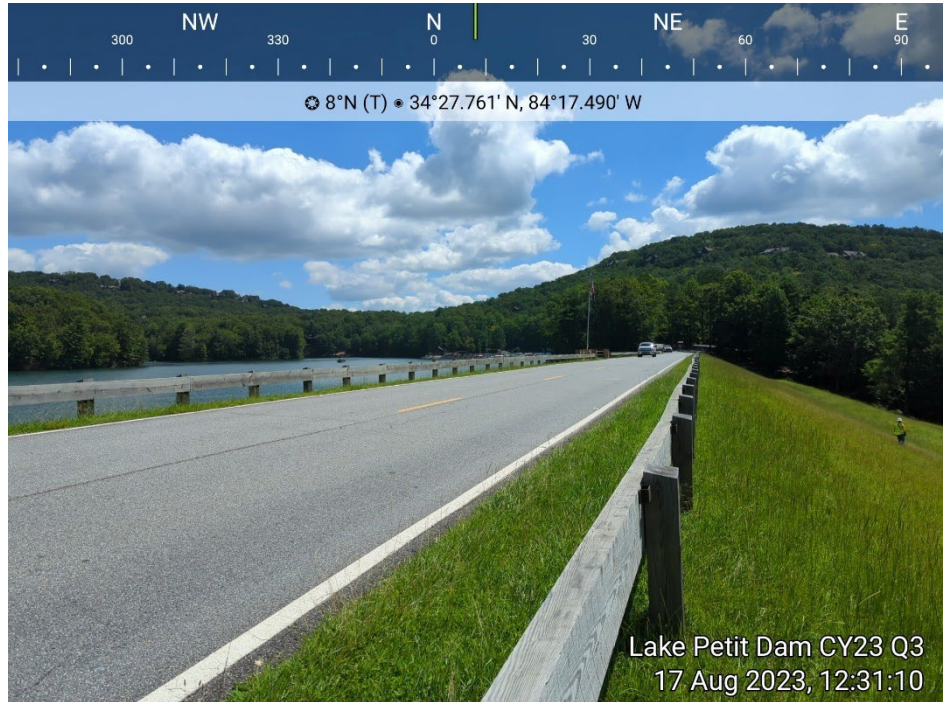
Comments: Crest - View of the asphalt roadway on the crest of the dam. Photograph was taken from the right abutment.

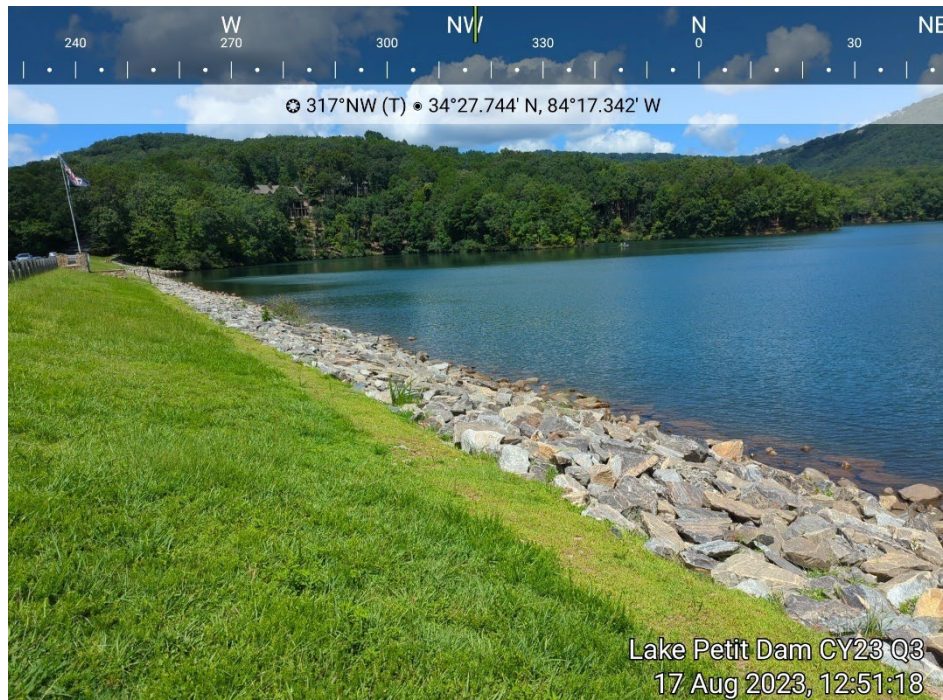
Photograph 2

Comments: Upstream Slope - View of the grass-covered upstream slope and riprap wave action protection. Photograph was taken from the left side of the upstream slope of the dam.

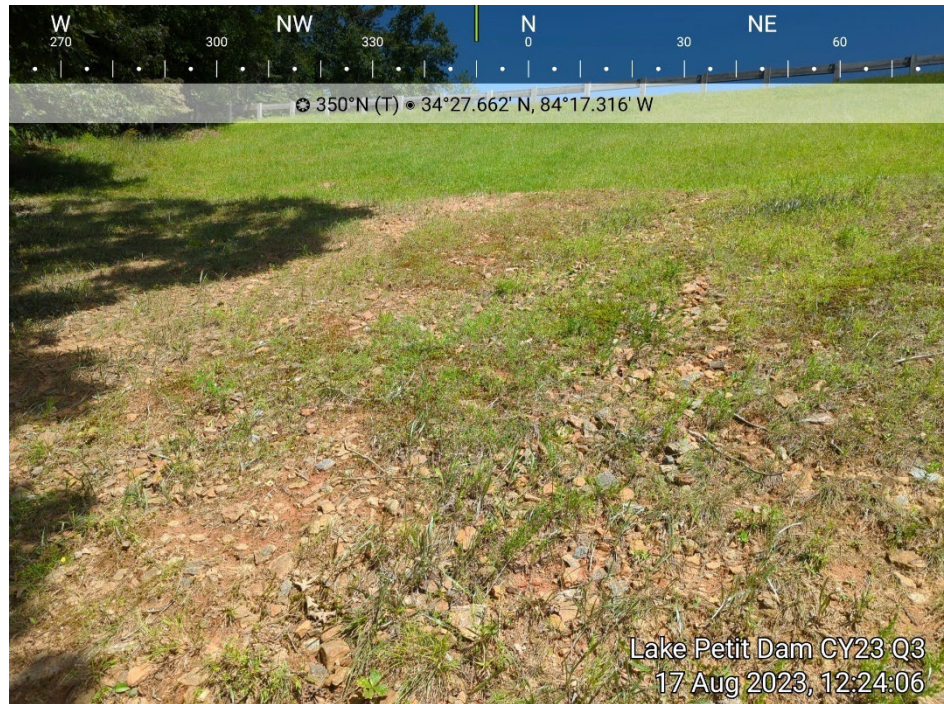
Comments: Downstream Slope - View of typical erosion/area of sparse vegetation (near right abutment, between Bench No. 4 and 5).

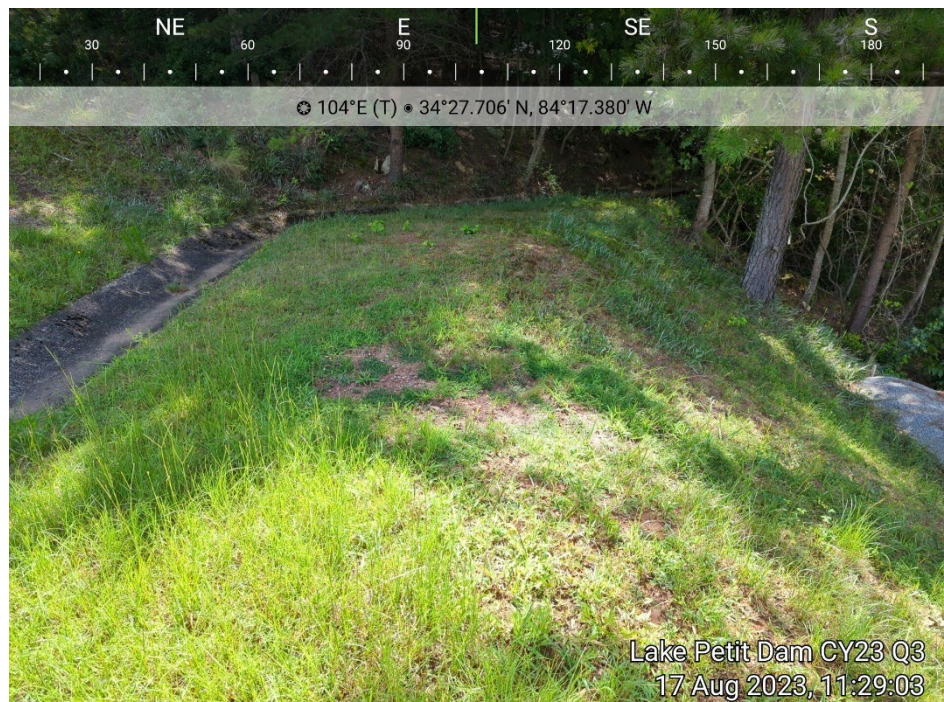
Photograph 4

Comments: Downstream Slope - View of surficial erosion above previously installed seepage repair near the left abutment.

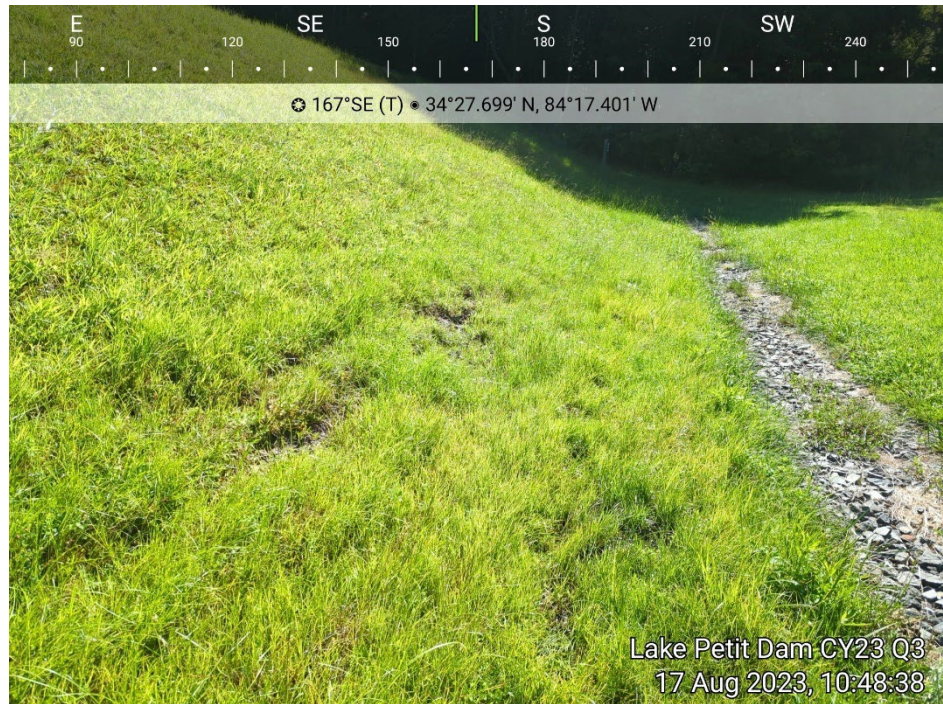
Comments: Downstream Slope - Wet area on left side of the slope between the road and Bench No.1, approximately 8 ft up the slope and 30 ft along the slope.

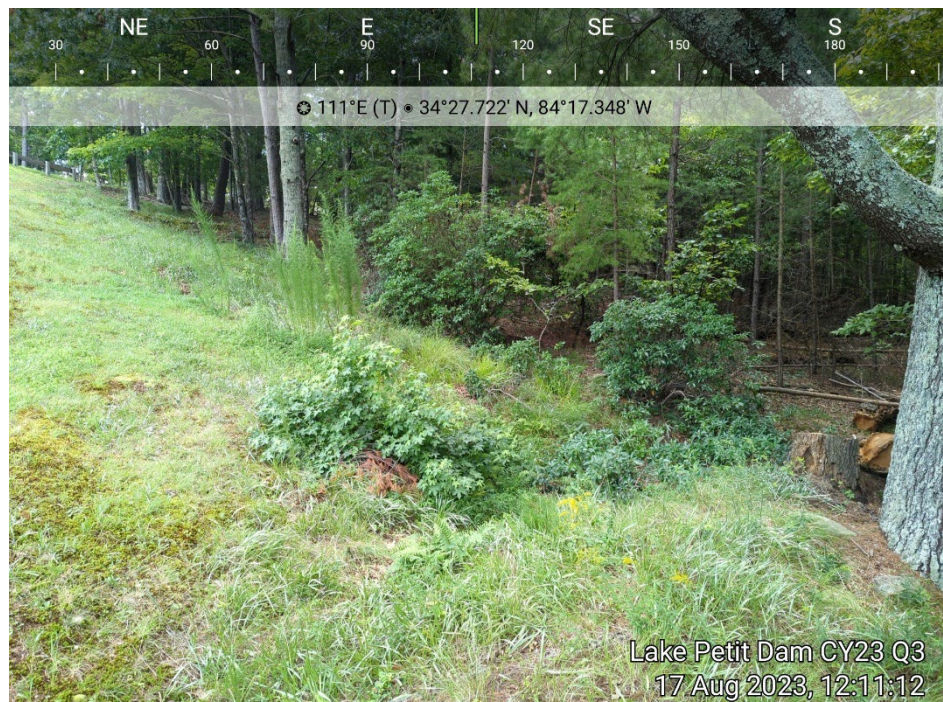
Photograph 6

Comments: Downstream Slope - Overgrown vegetation at the left abutment between Bench No. 4 and 5.

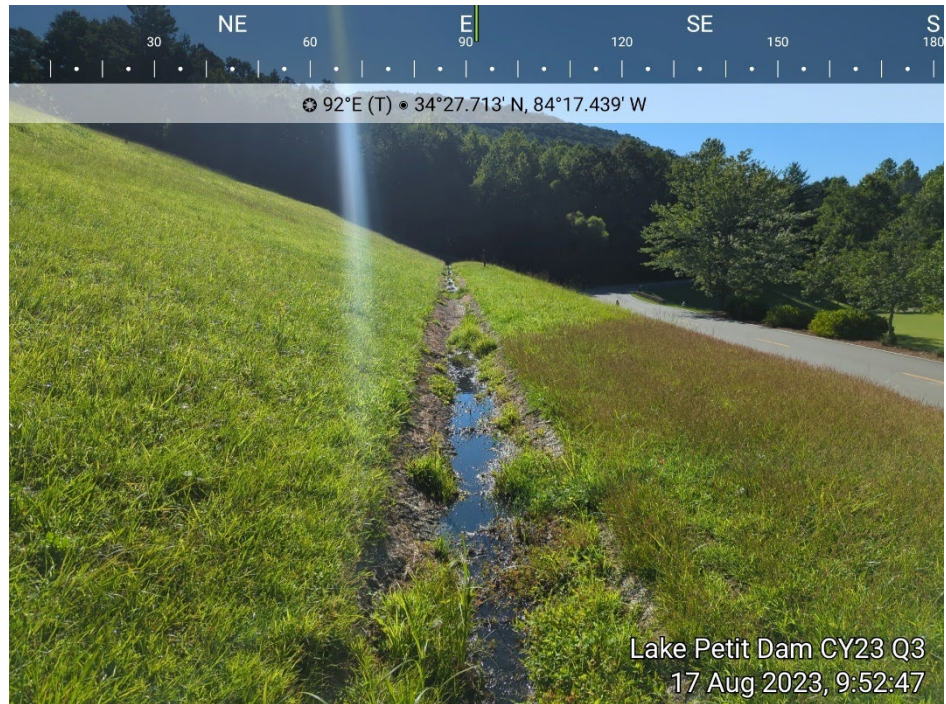
Comments: Downstream Slope - View of the sediment and vegetation build-up at the concrete channel located on Bench No. 1.

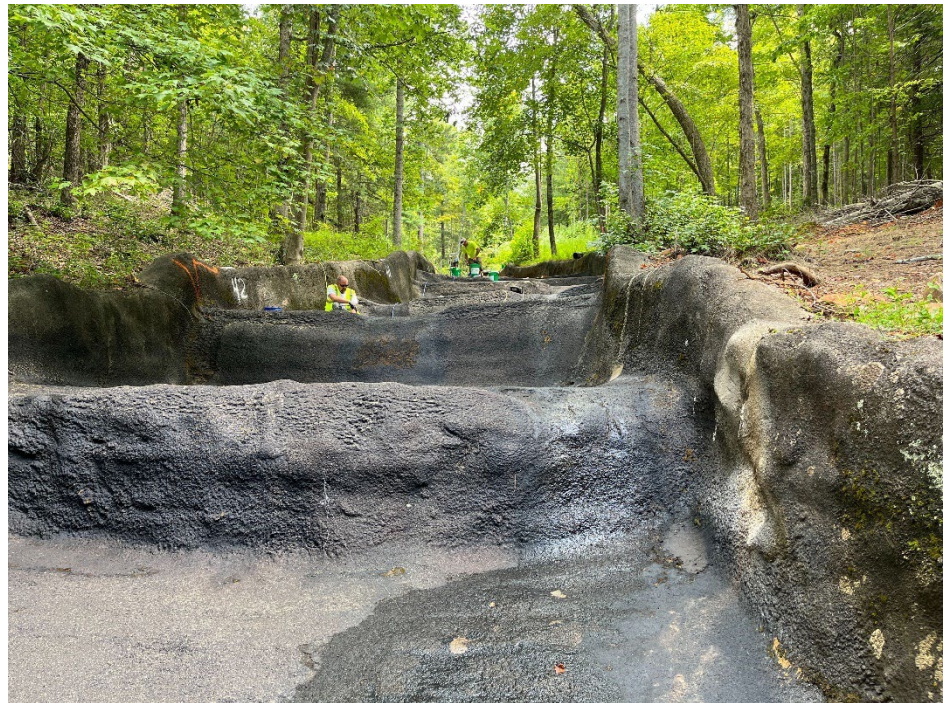
Photograph 8

Comments: Spillway - View of the spillway while reservoir was temporarily lowered for spillway maintenance.
