LAKE PETIT DAM

Summary of Visual Assessment

Geosyntec Consultants, Inc.

April 2024

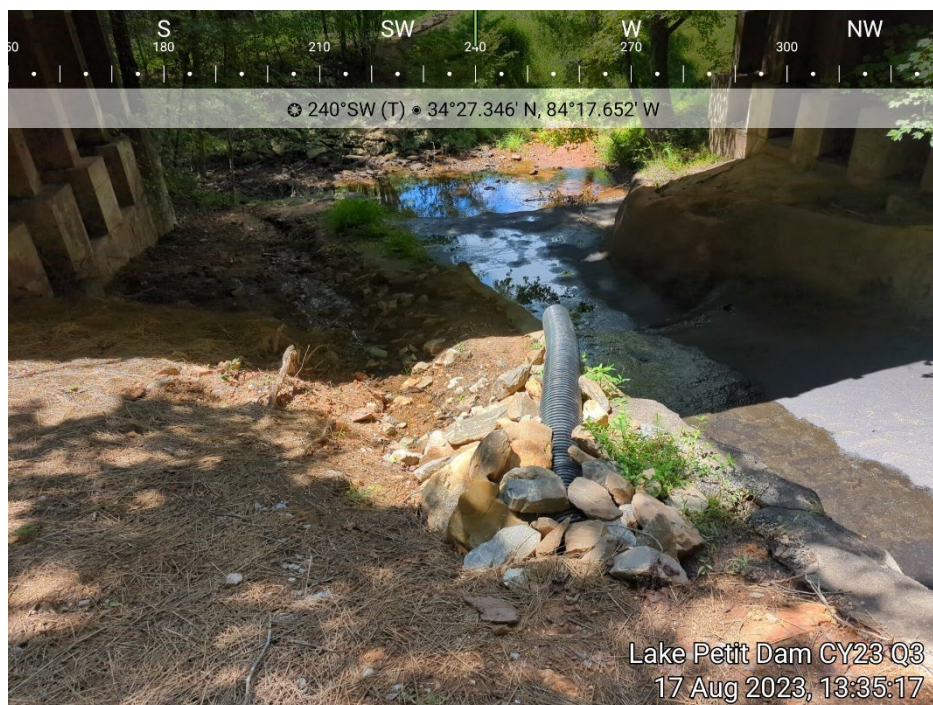
Comments: Spillway -
Surficial flow was
observed on the left side
of Step 45 of the spillway.

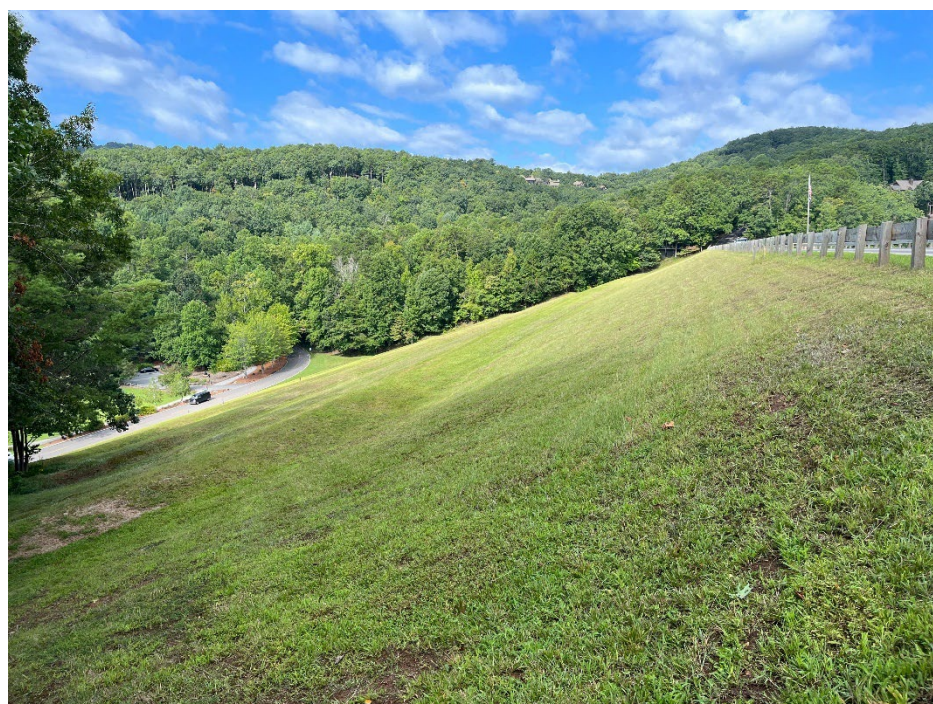
Photograph 10

Comments: Downstream
Slope - General
conditions observed on 31
August 2023.

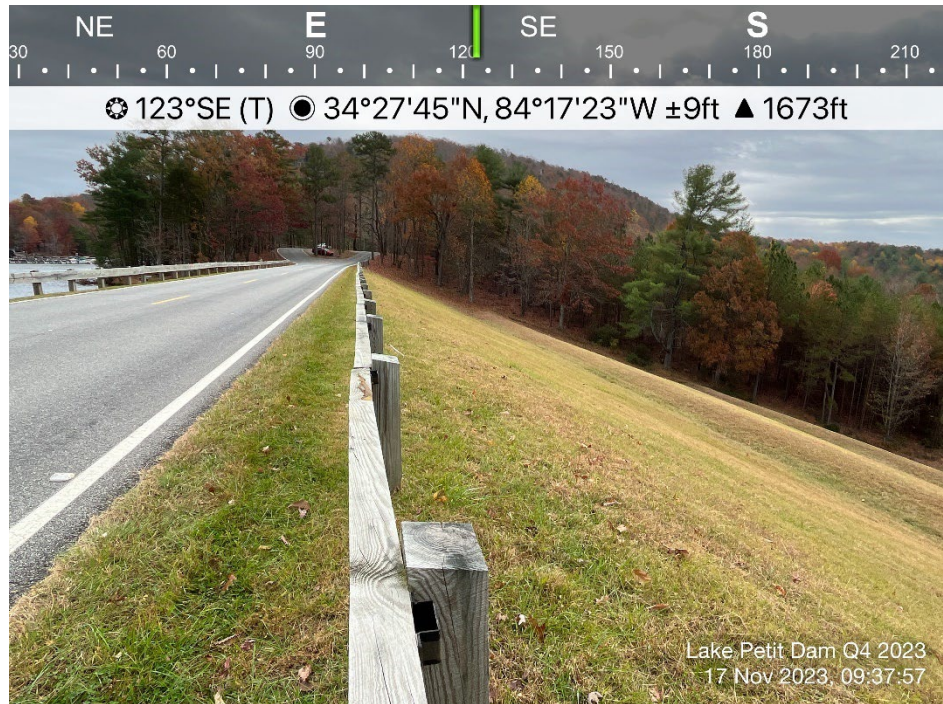
Comments: Crest - View of the asphalt roadway on the crest of the dam.

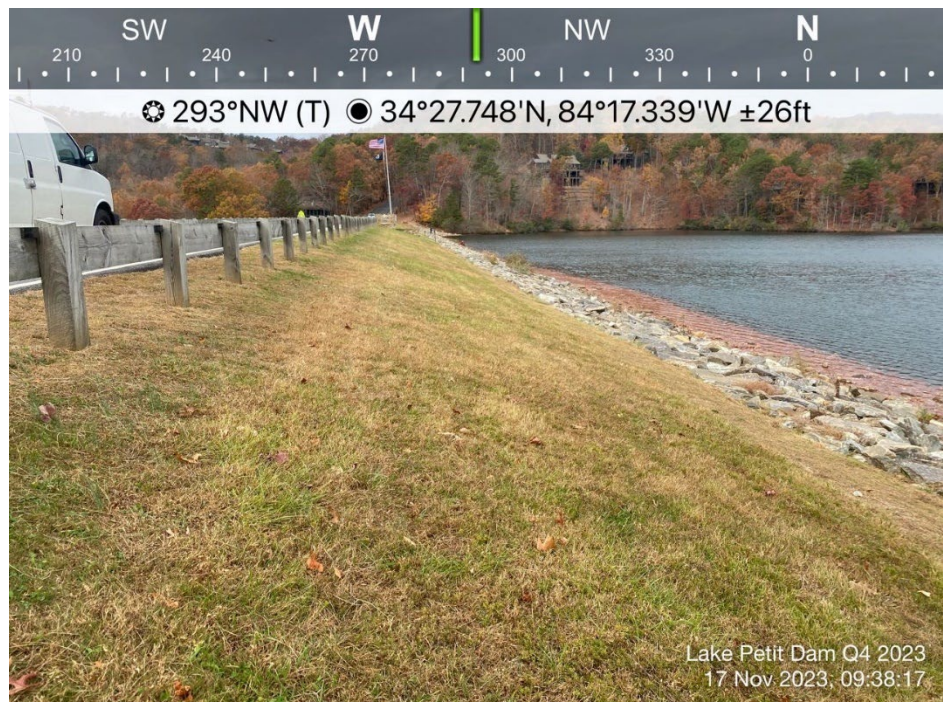
Photograph 2

Comments: Upstream Slope - View of the grass-covered upstream slope and riprap wave action protection. Photograph was taken from the left side of the upstream slope of the dam.

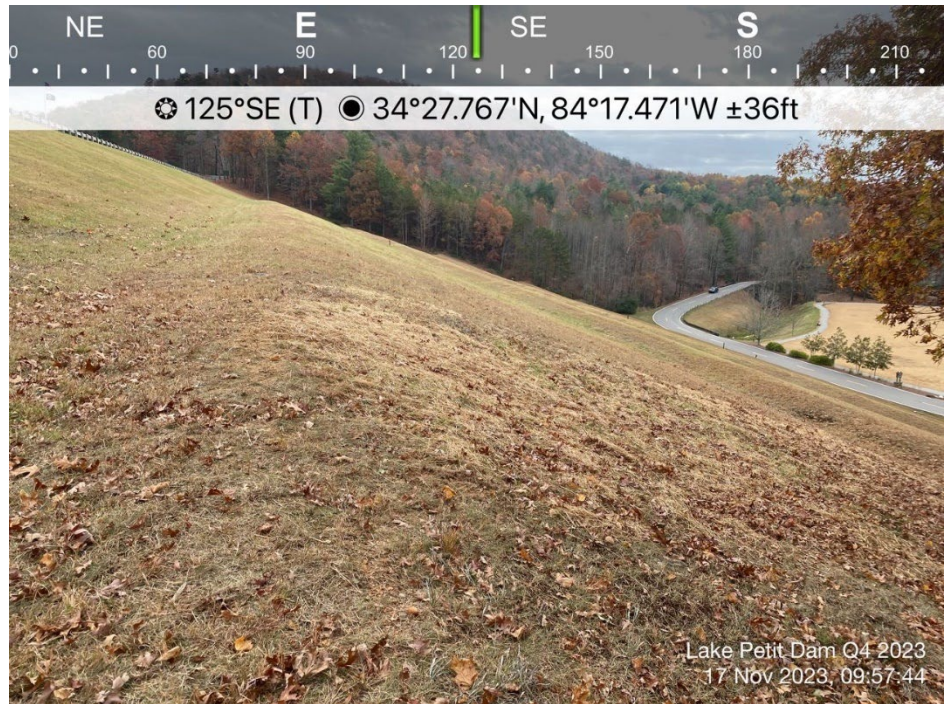
Comments: Downstream Slope - View of maintenance performed near right abutment between Bench No. 4 and 5 on area previously noted as having sparse vegetation.

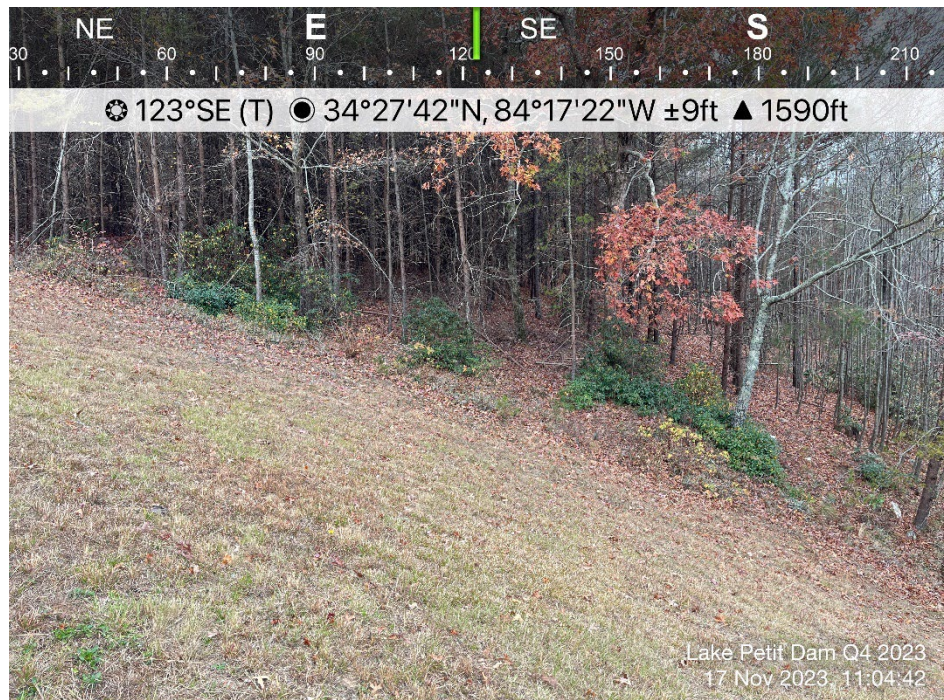
Photograph 4

Comments: Downstream Slope - View of vegetation near left abutment.

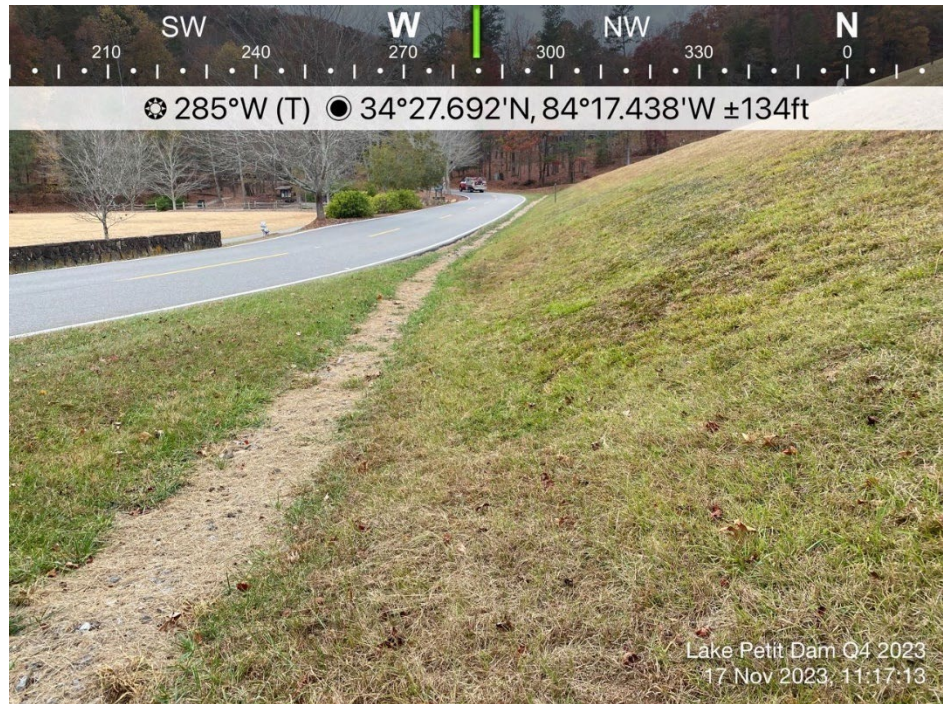
Comments: Downstream Slope - View of previously identified wet area on left side of the slope between the road and Bench No.1.

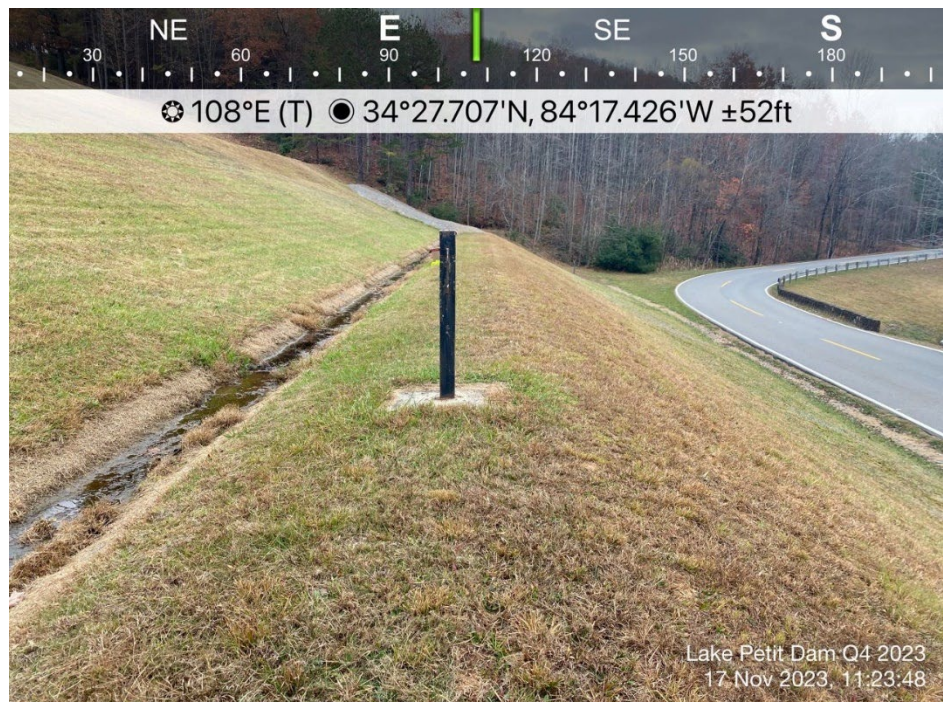
Photograph 6

Comments: Downstream Slope - View showing vegetation in the concrete channel located at Bench No. 1.

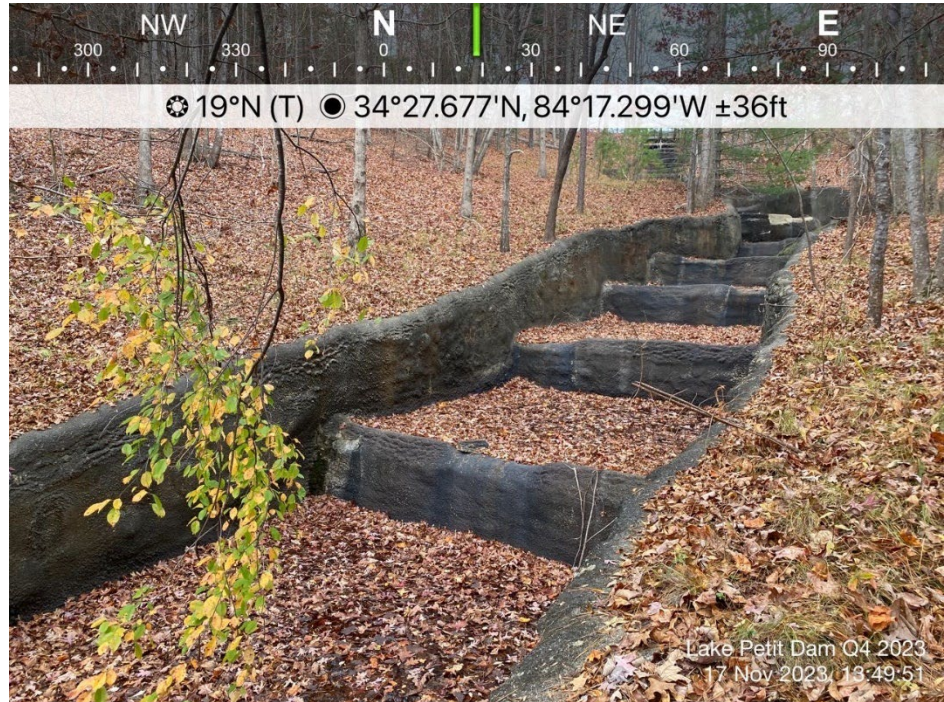
Comments: Spillway - View of the general conditions of the spillway when dry.

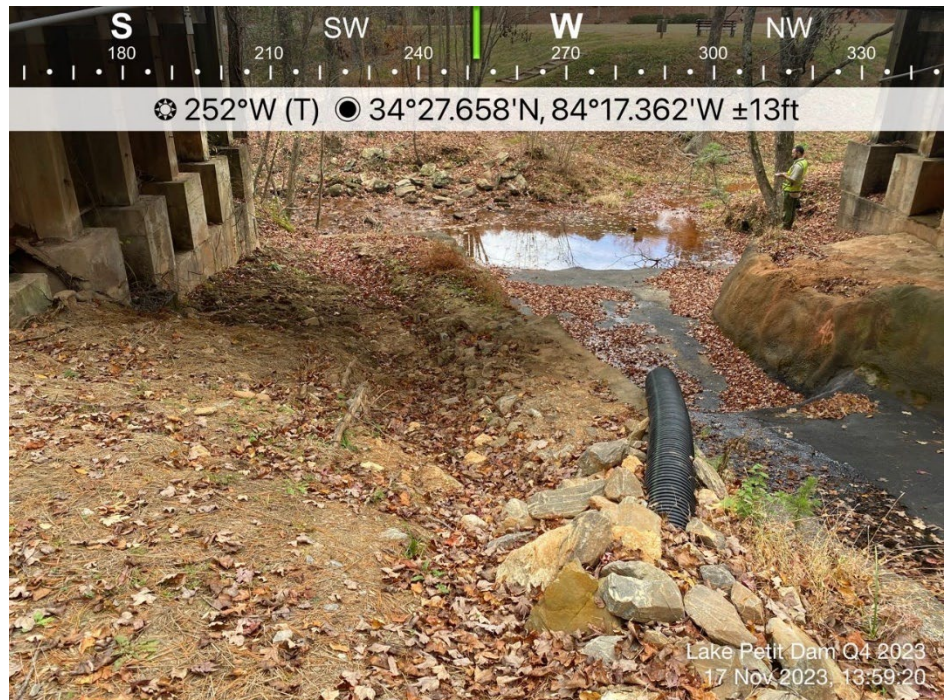
Photograph 8

Comments: Spillway – View of area where surficial flow was previously observed; flow not observed following recent repairs.
