**Subject: Owner Quarterly Inspection Reports 2020/2021 (Quarters 2, 3, and 4 of 2020 and Quarter 1 of 2021)  
Lake Petit Dam (ID Number (No.) 112-009-00462), Pickens County**

**ATTACHMENT A**  
**2020/2021 Reporting Year Quarterly Inspections**

## Embankment (Earth) Dam Inspection Form

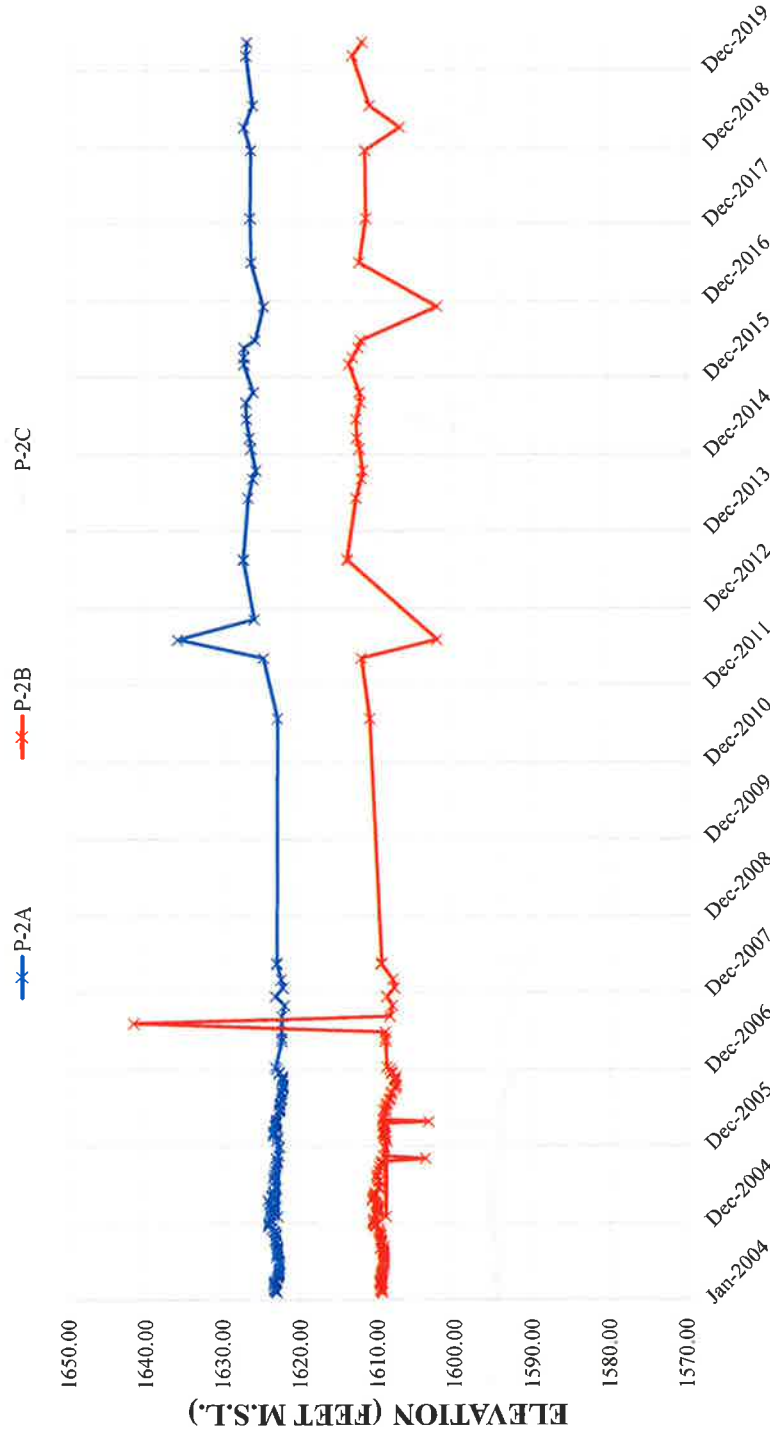
**Figure 2-2. Summary of Vibrating Wire Piezometer Data, P-2A, B, C (Feb 2004 through May 2020) - Lake Petit Dam, Big Canoe, GA**

Note: Historical data anomalies generally appear to be the result of transcription errors.

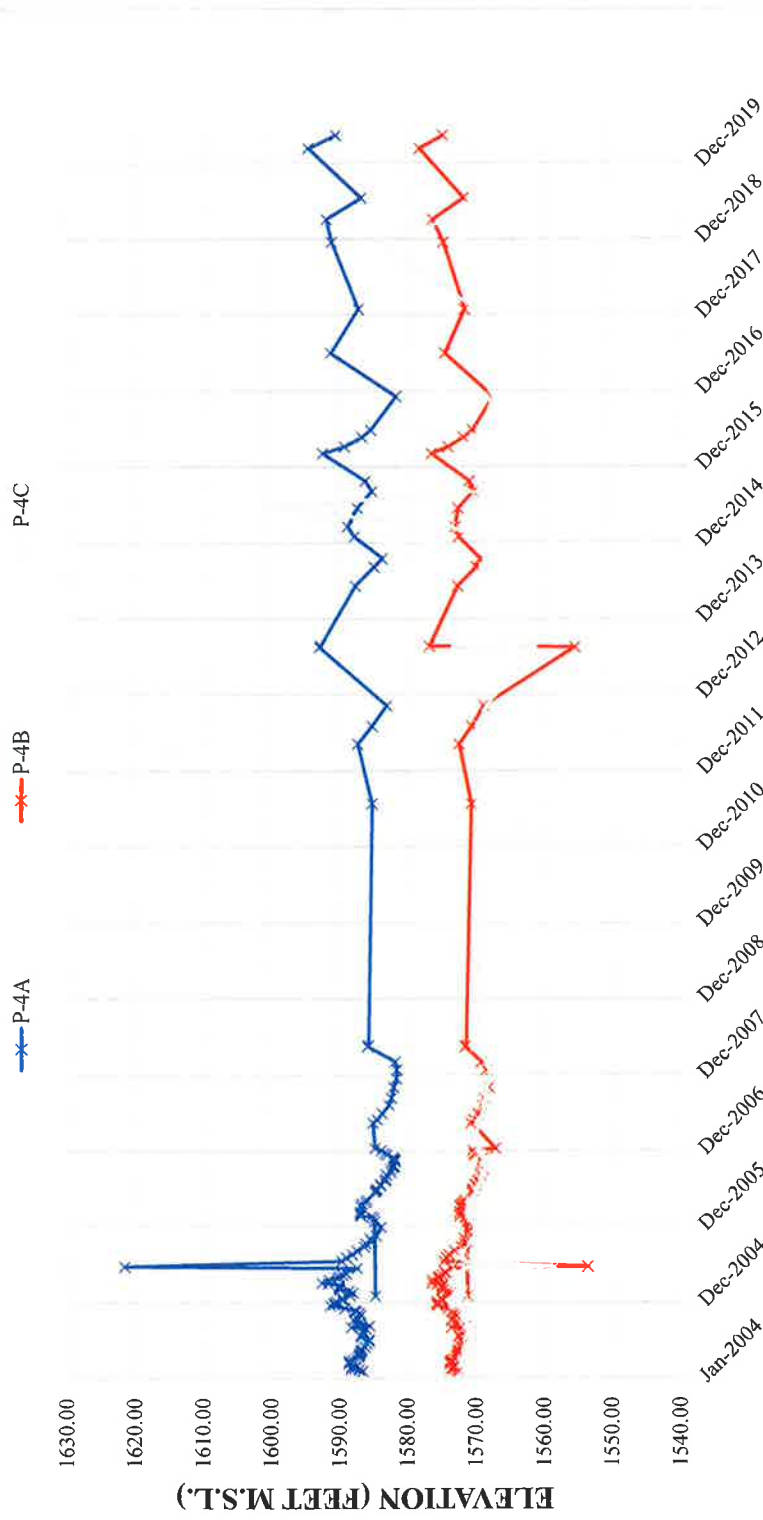
Note: Historical data anomalies generally appear to be the result of transcription errors.  
**Figure 2-3. Summary of Vibrating Wire Piezometer Data, P-4A, B, C (Feb 2004 through May 2020) - Lake Petit Dam, Big Canoe, GA**

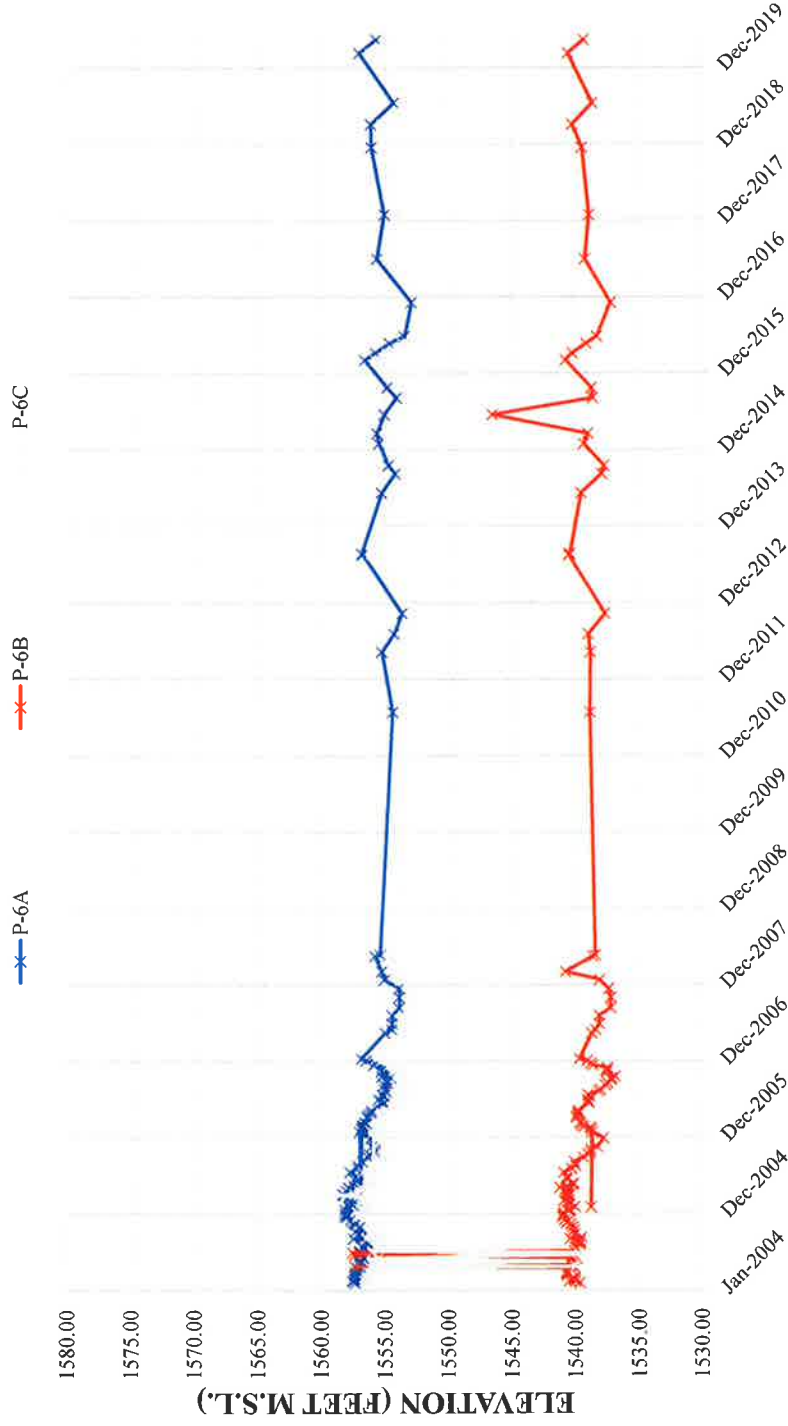
**Figure 2-4. Summary of Vibrating Wire Piezometer Data, P-6A, B, C (Feb 2004 through May 2020) - Lake Petit Dam, Big Canoe, GA**

Note: Historical data anomalies generally appear to be the result of transcription errors.

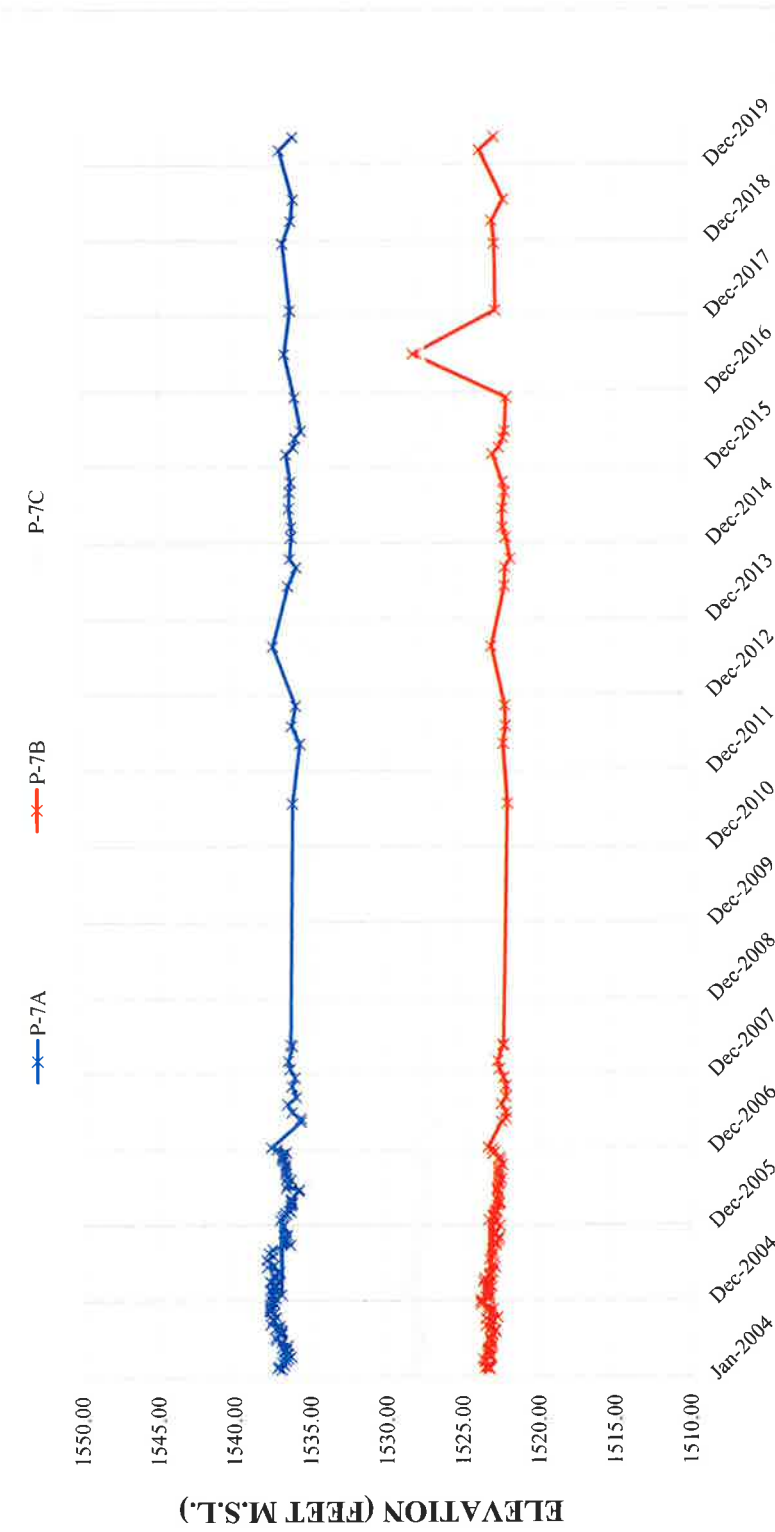
Note: Historical data anomalies generally appear to be the result of transcription errors.  
**Figure 2-5. Summary of Vibrating Wire Piezometer Data, P-7A, B, C (Feb 2004 through May 2020) - Lake Petit Dam, Big Canoe, GA**

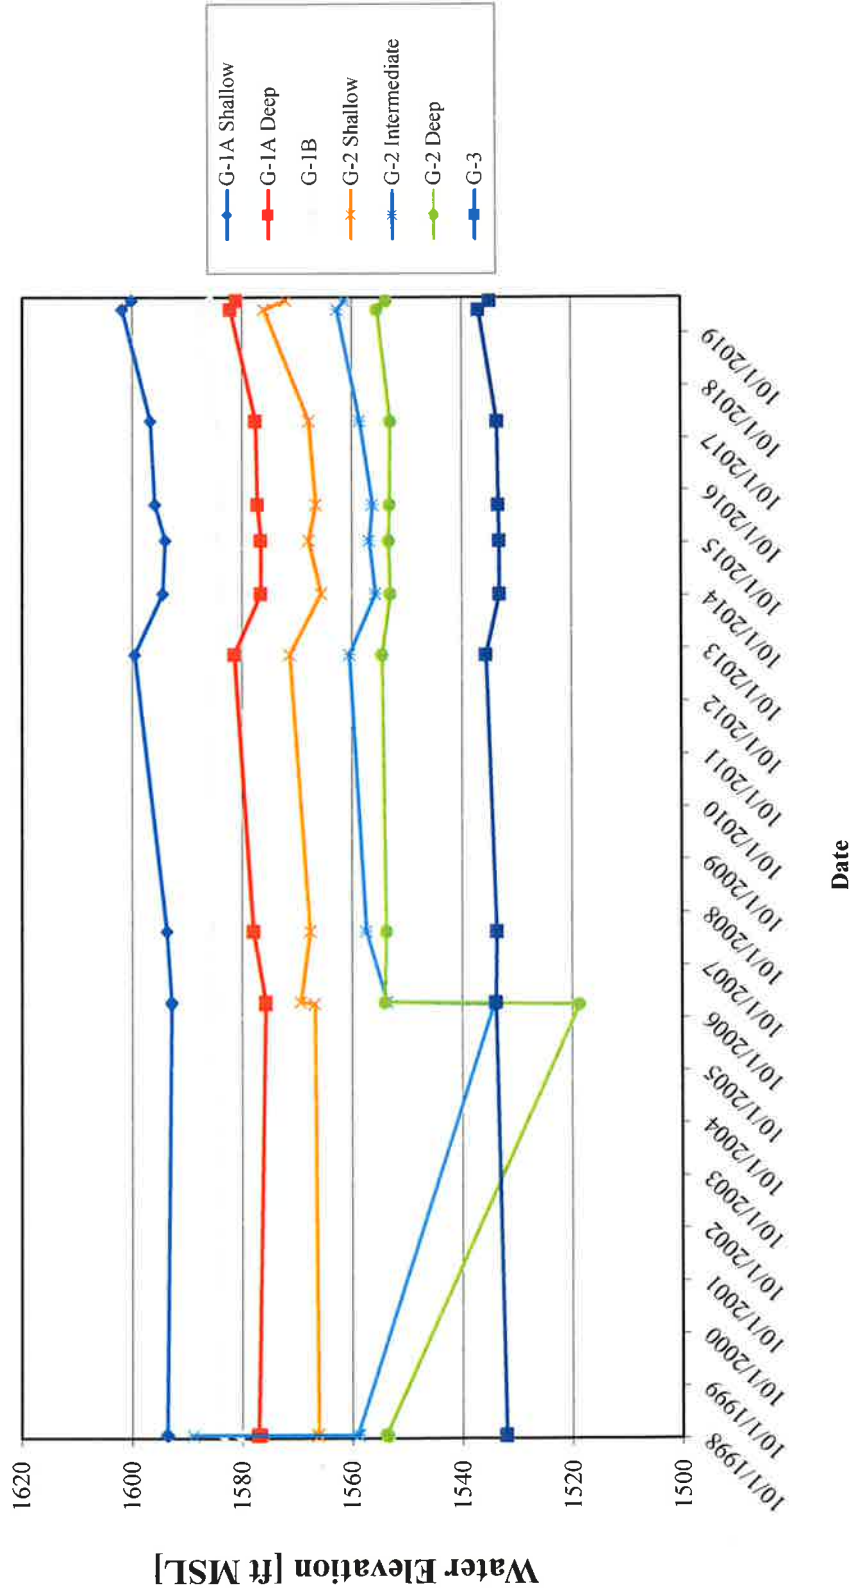
**Figure 2-6. Summary of Standpipe Piezometer Data**  
 (Oct 1998 through May 2020) - Lake Petit Dam, Big Canoe, GA.

Note: G-2 Shallow water levels noted as anomalous on 3 Jan 2007. Re-measured 19 Jan 2007, and levels more consistent with previous readings.

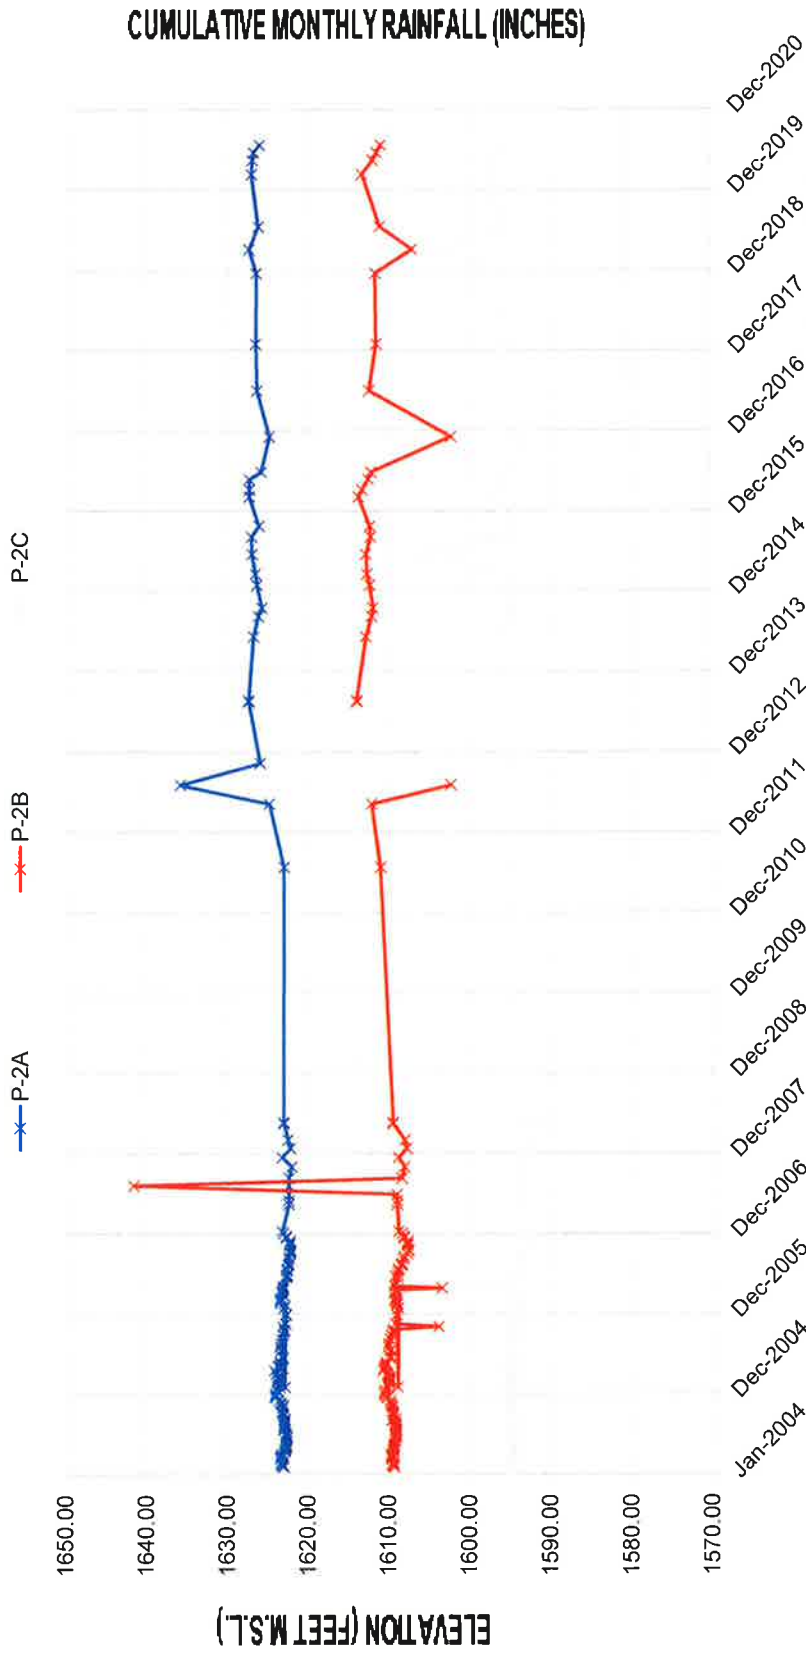
Figure 2-2. Summary of Vibrating Wire Piezometer Data, P-2A, B, C

Note: Historical data anomalies generally appear to be the result of transcription errors.

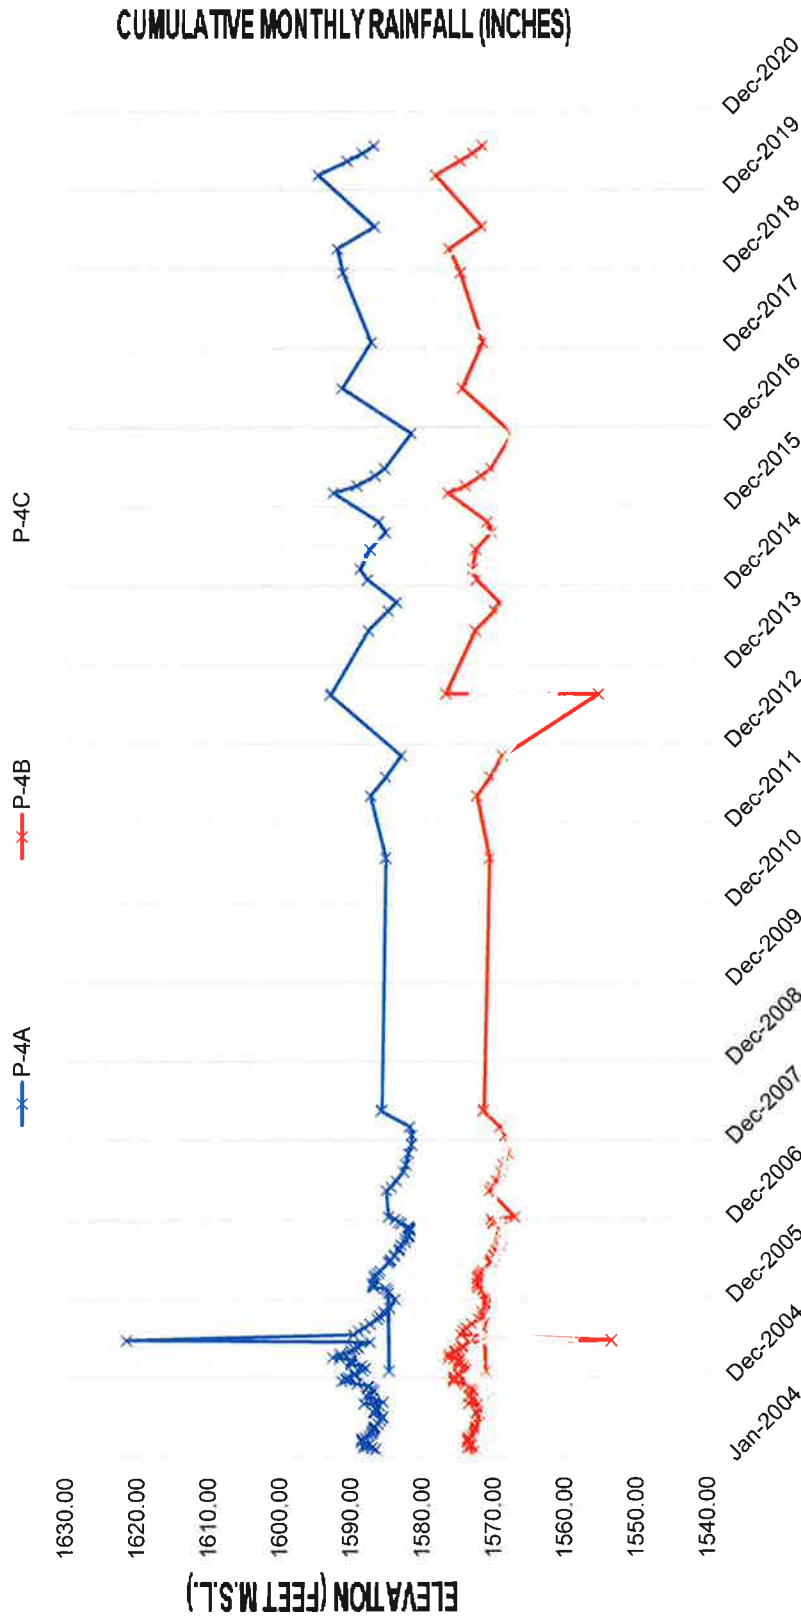
Figure 2-3. Summary of Vibrating Wire Piezometer Data, P-4A, B, C (Feb 2004 through July 2020) - Lake Petit Dam, Big Canoe, GA

Note: Historical data anomalies generally appear to be the result of transcription errors.

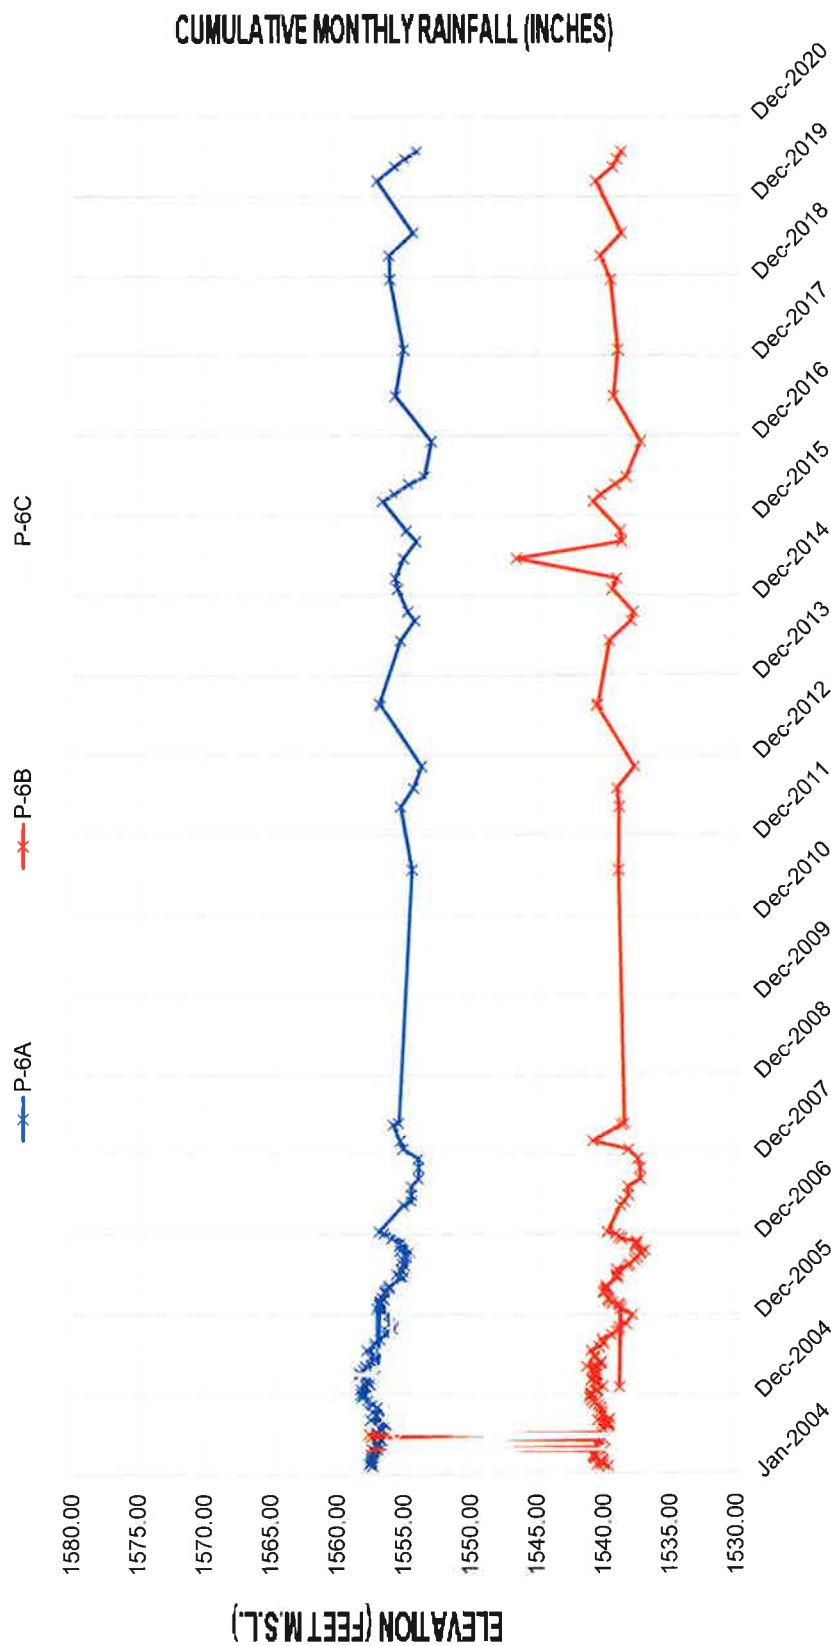
Note: Historical data anomalies generally appear to be the result of transcription errors.  
**Figure 2-4. Summary of Vibrating Wire Piezometer Data, P-6A, B, C**  
 (Feb 2004 through July 2020) - Lake Petit Dam, Big Cane, GA

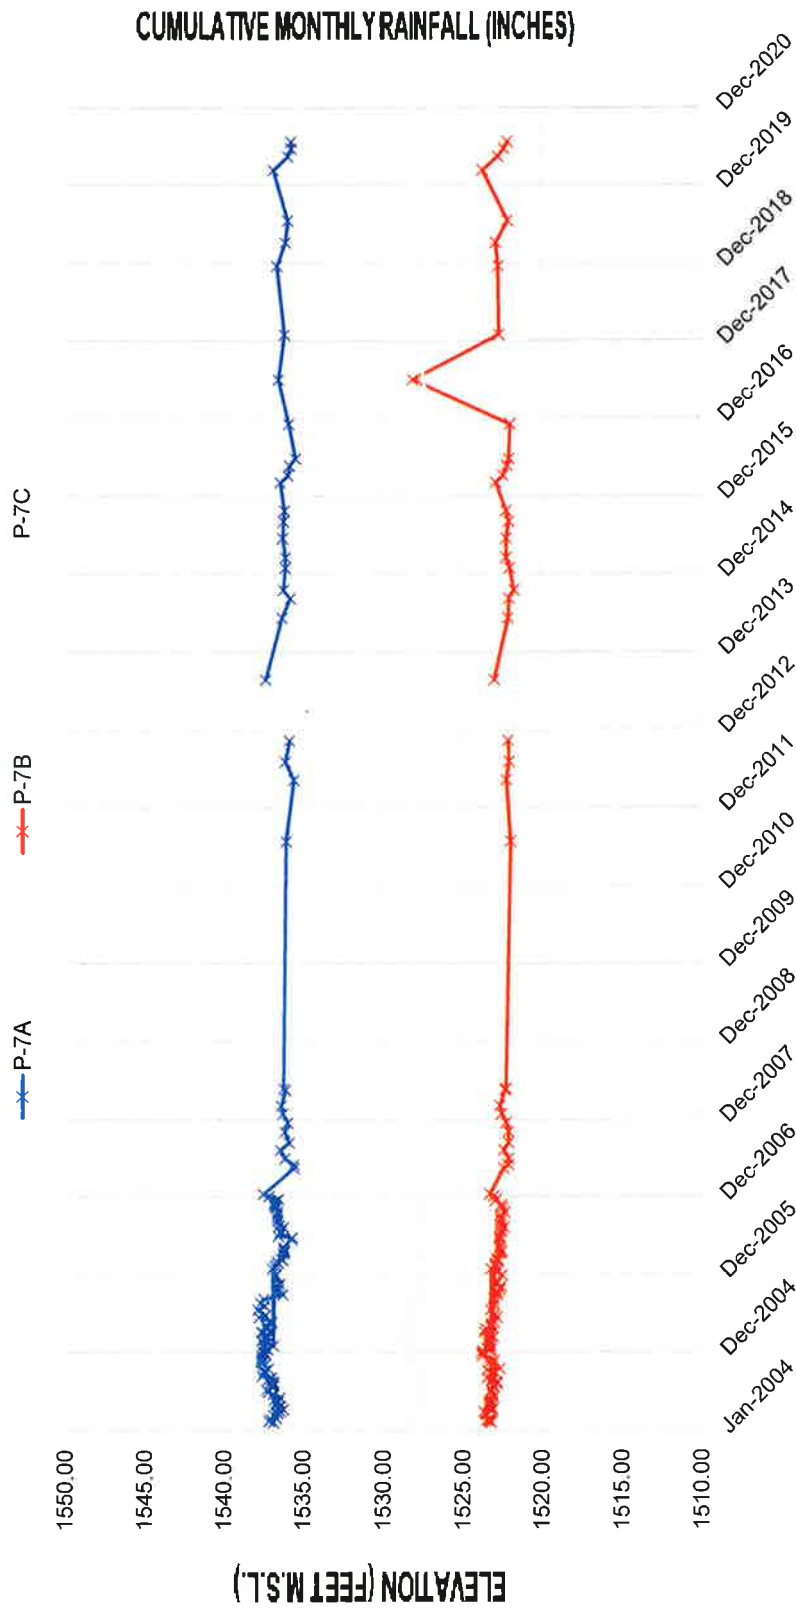
Figure 2-5. Summary of Vibrating Wire Piezometer Data, P-7A, B, C

Note: Historical data anomalies generally appear to be the result of transcription errors.

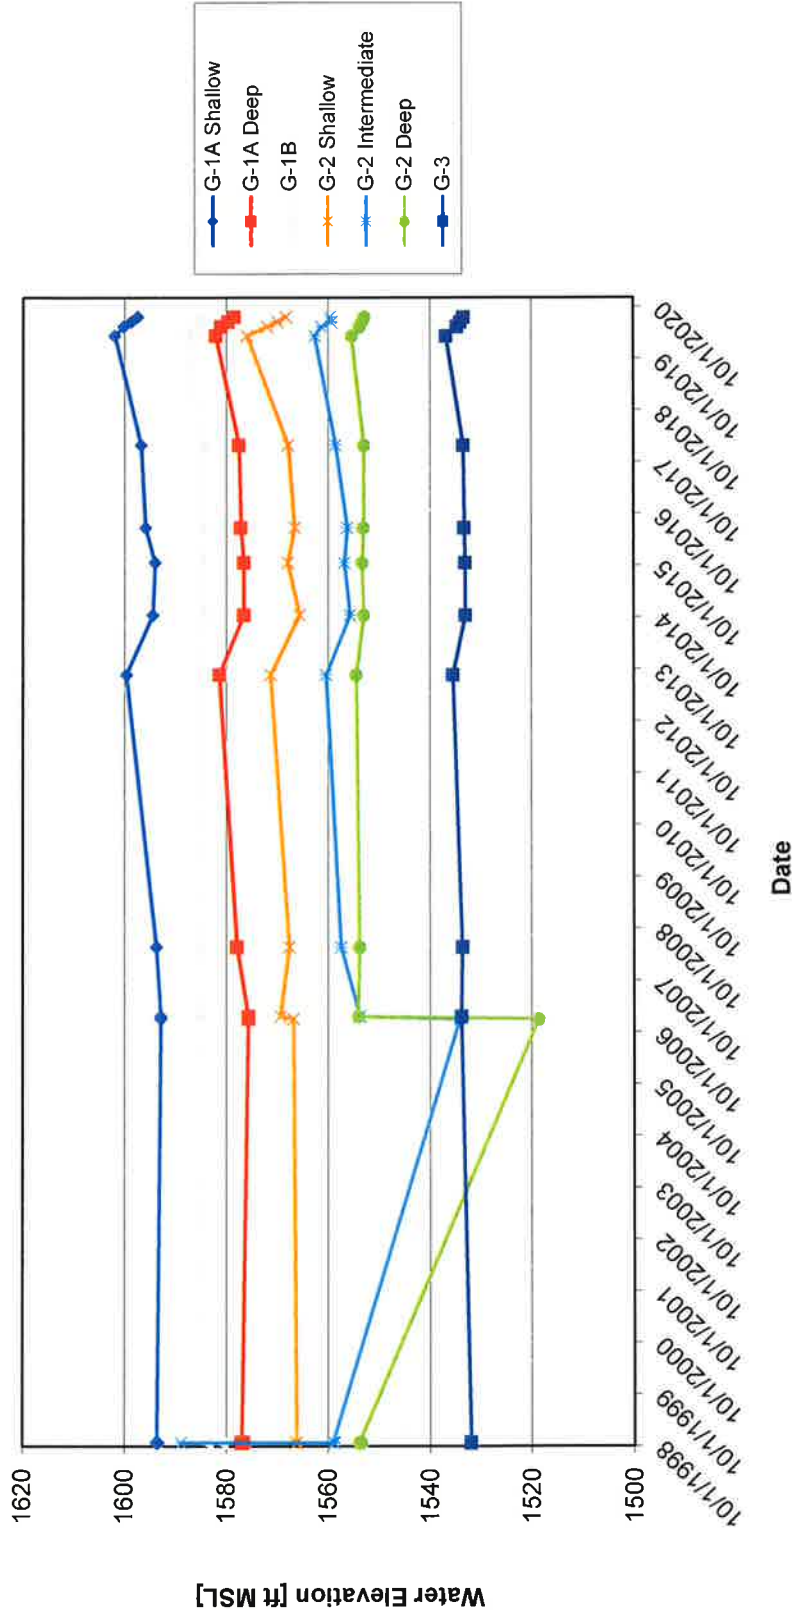
**Figure 2-6. Summary of Standpipe Piezometer Data (Oct 1998 through July 2020) - Lake Petit Dam, Big Canoe, GA.**

Note: G-2 Shallow water levels noted as anomalous on 3 Jan 2007. Re-measured 19 Jan 2007, and levels more consistent with previous readings.

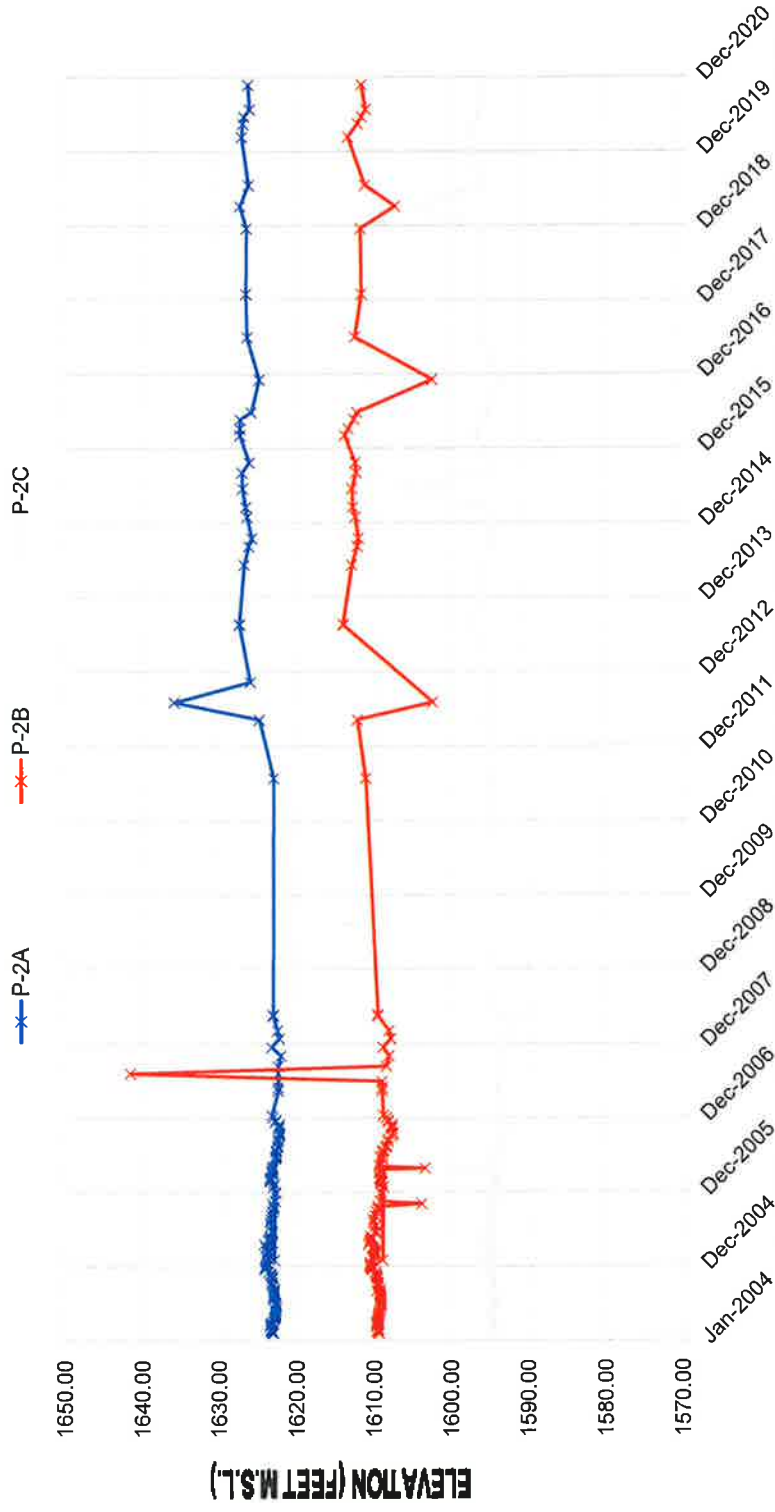
**Figure 2-2. Summary of Vibrating Wire Piezometer Data, P-2A, B, C**

Note: Historical data anomalies generally appear to be the result of transcription errors.

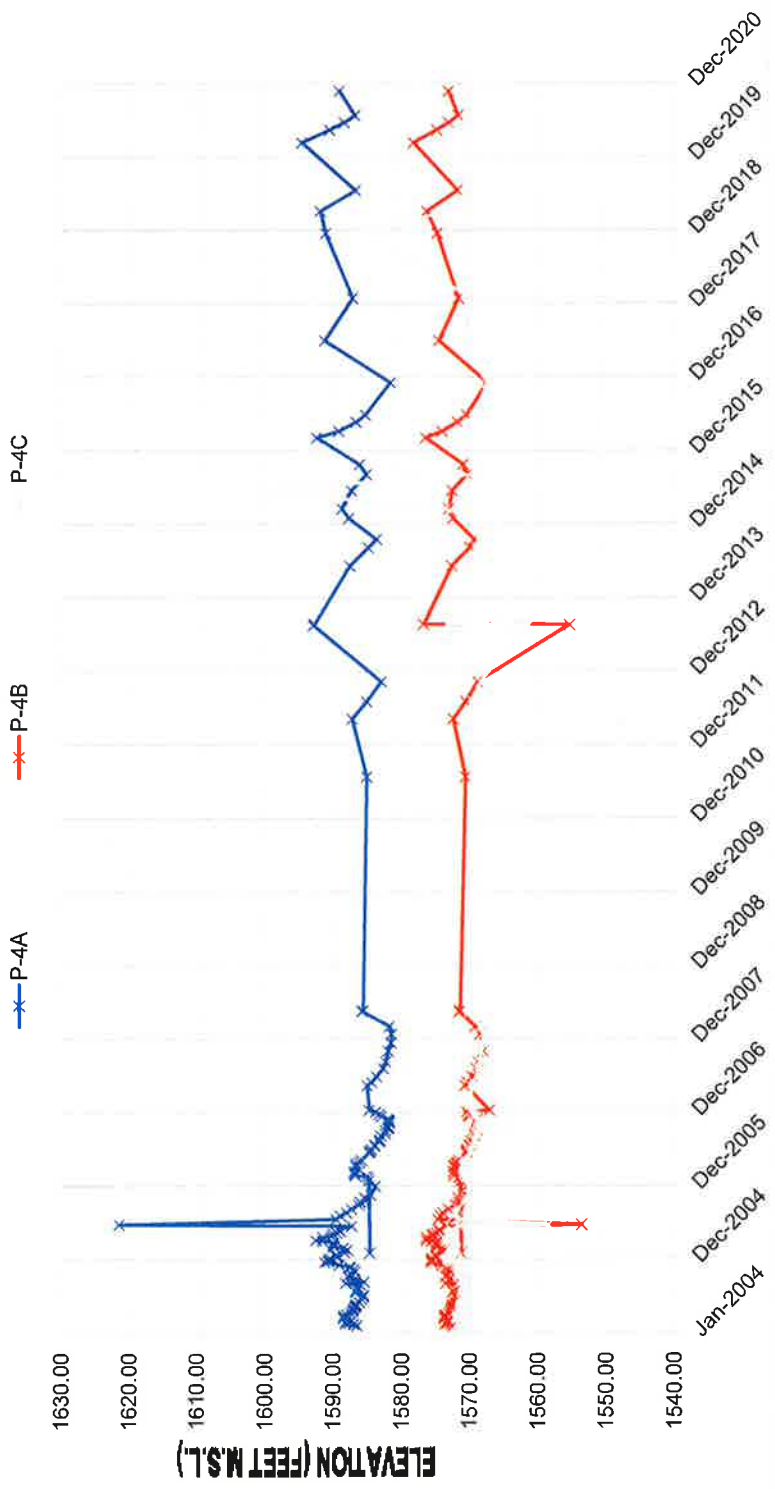
Figure 2-3. Summary of Vibrating Wire Piezometer Data, P-4A, B, C (Feb 2004 through Nov 2020) - Lake Petit Dam, Big Canoe, GA

Note: Historical data anomalies generally appear to be the result of transcription errors.

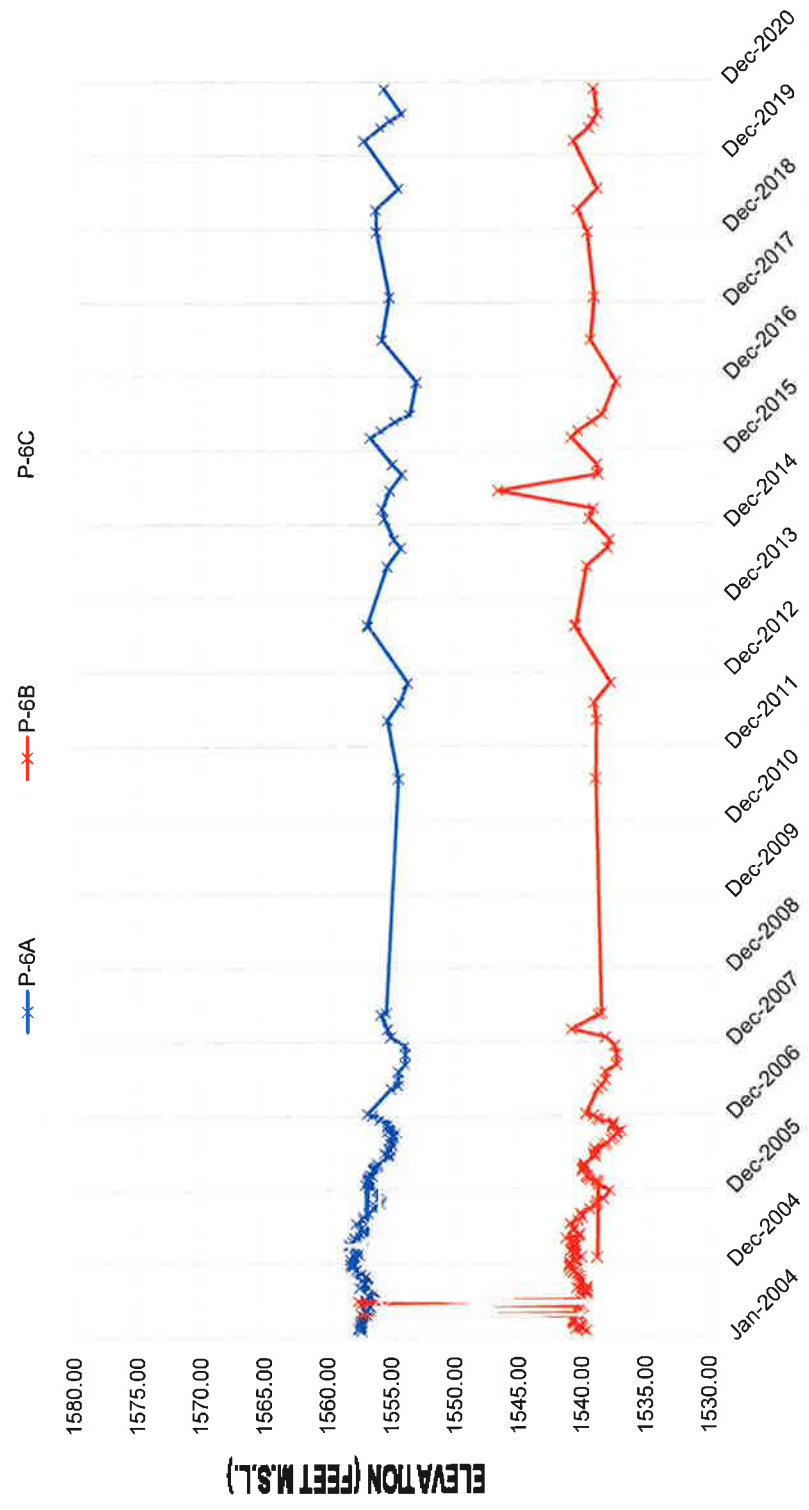
Note: Historical data anomalies generally appear to be the result of transcription errors.  
**Figure 2-4. Summary of Vibrating Wire Piezometer Data, P-6A, B, C**  
 (Feb 2004 through Nov 2020) - Lake Petit Dam, Big Canoe, GA

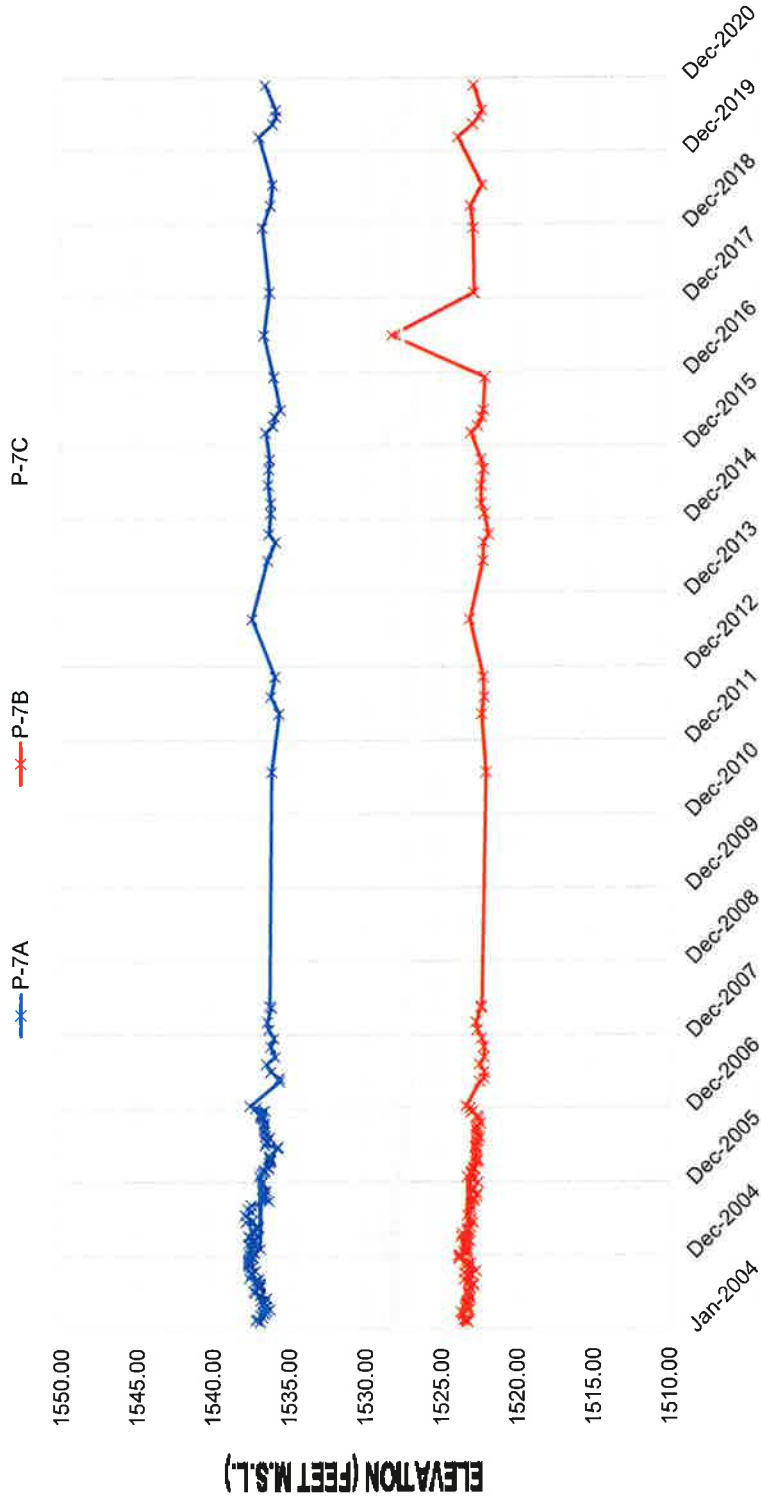
**Figure 2-5. Summary of Vibrating Wire Piezometer Data, P-7A, B, C**

Note: Historical data anomalies generally appear to be the result of transcription errors.

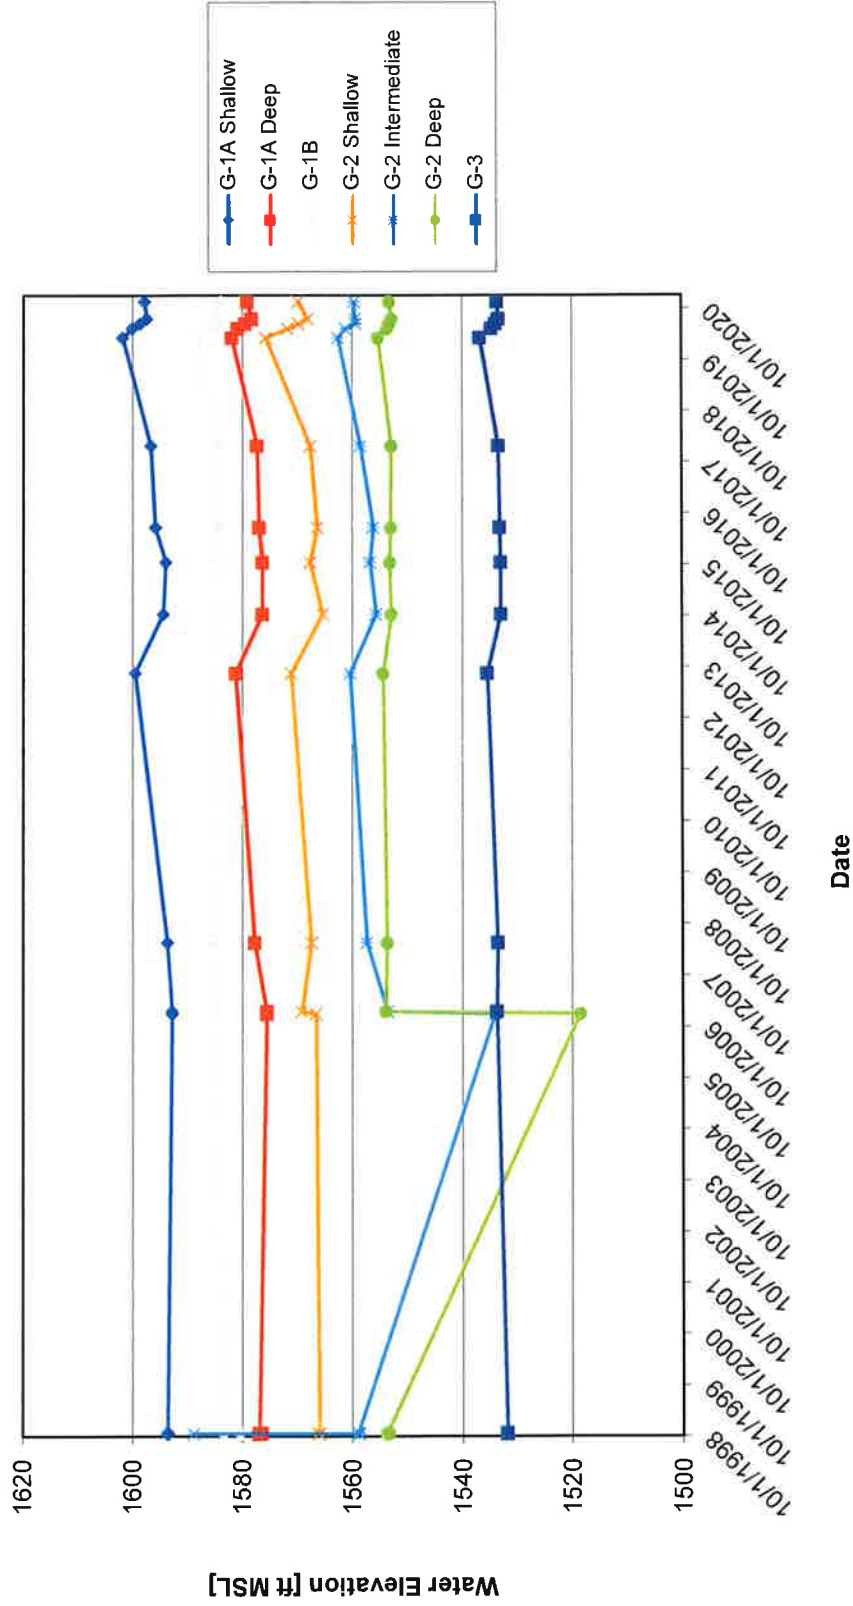
Figure 2-6. Summary of Standpipe Piezometer Data (Oct 1998 through Nov 2020) - Lake Petit Dam, Big Canoe, GA.

Note: G-2 Shallow water levels noted as anomalous on 3 Jan 2007. Re-measured 19 Jan 2007, and levels more consistent with previous readings.

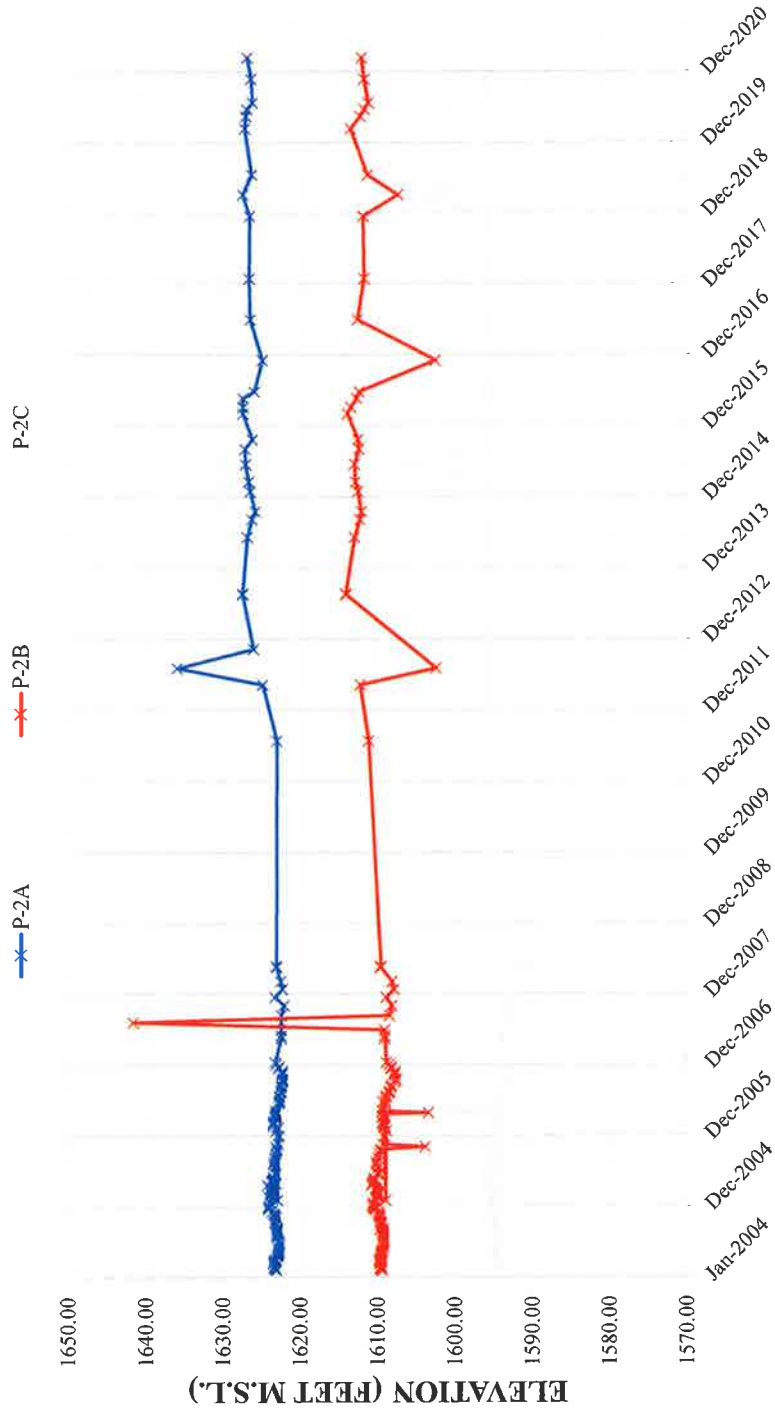
Note: Historical data anomalies generally appear to be the result of transcription errors.  
**Figure 2-2. Summary of Vibrating Wire Piezometer Data, P-2A, B, C (Feb 2004 through Mar 2021) - Lake Petit Dam, Big Canoe, GA**

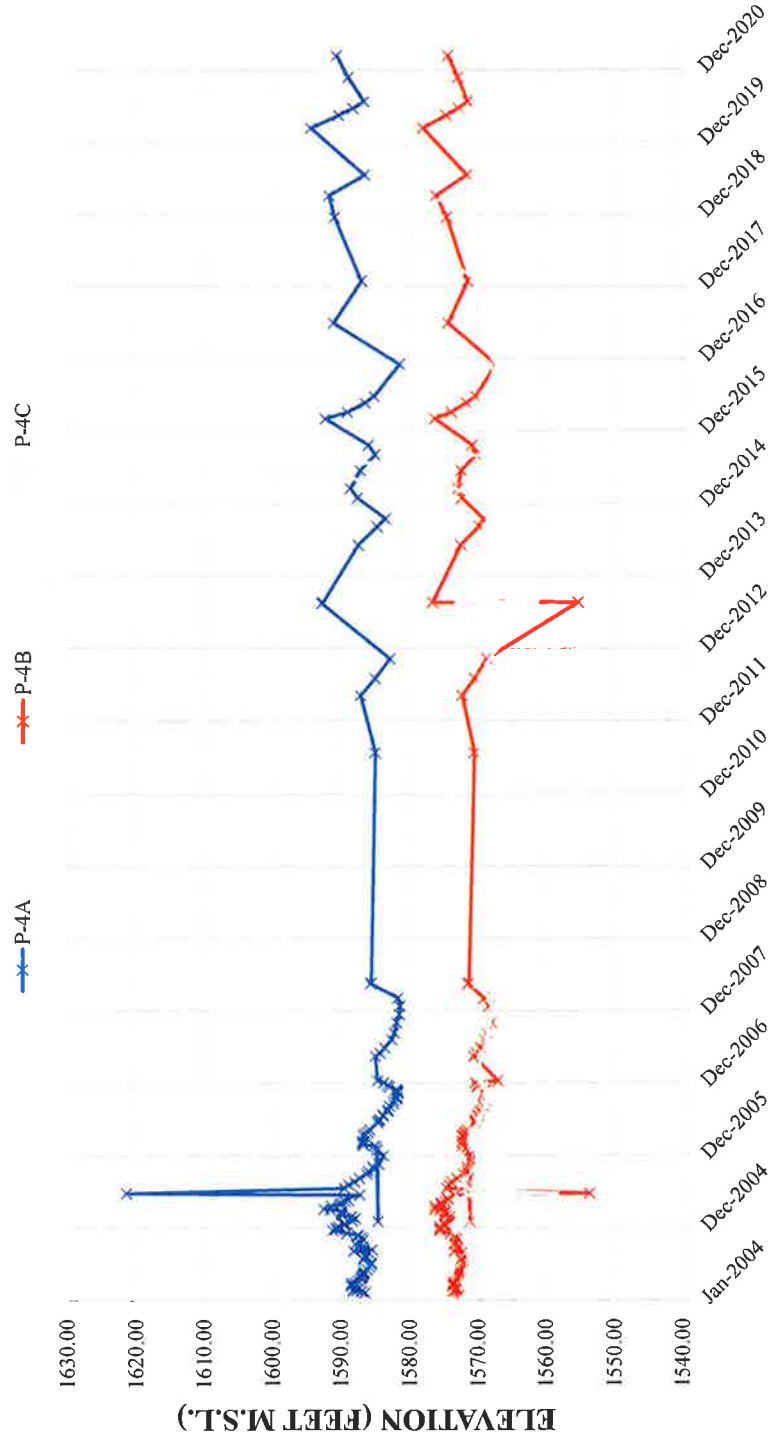
Note: Historical data anomalies generally appear to be the result of transcription errors.  
**Figure 2-3. Summary of Vibrating Wire Piezometer Data, P-4A, B, C (Feb 2004 through Mar 2021) - Lake Petit Dam, Big Canoe, GA**

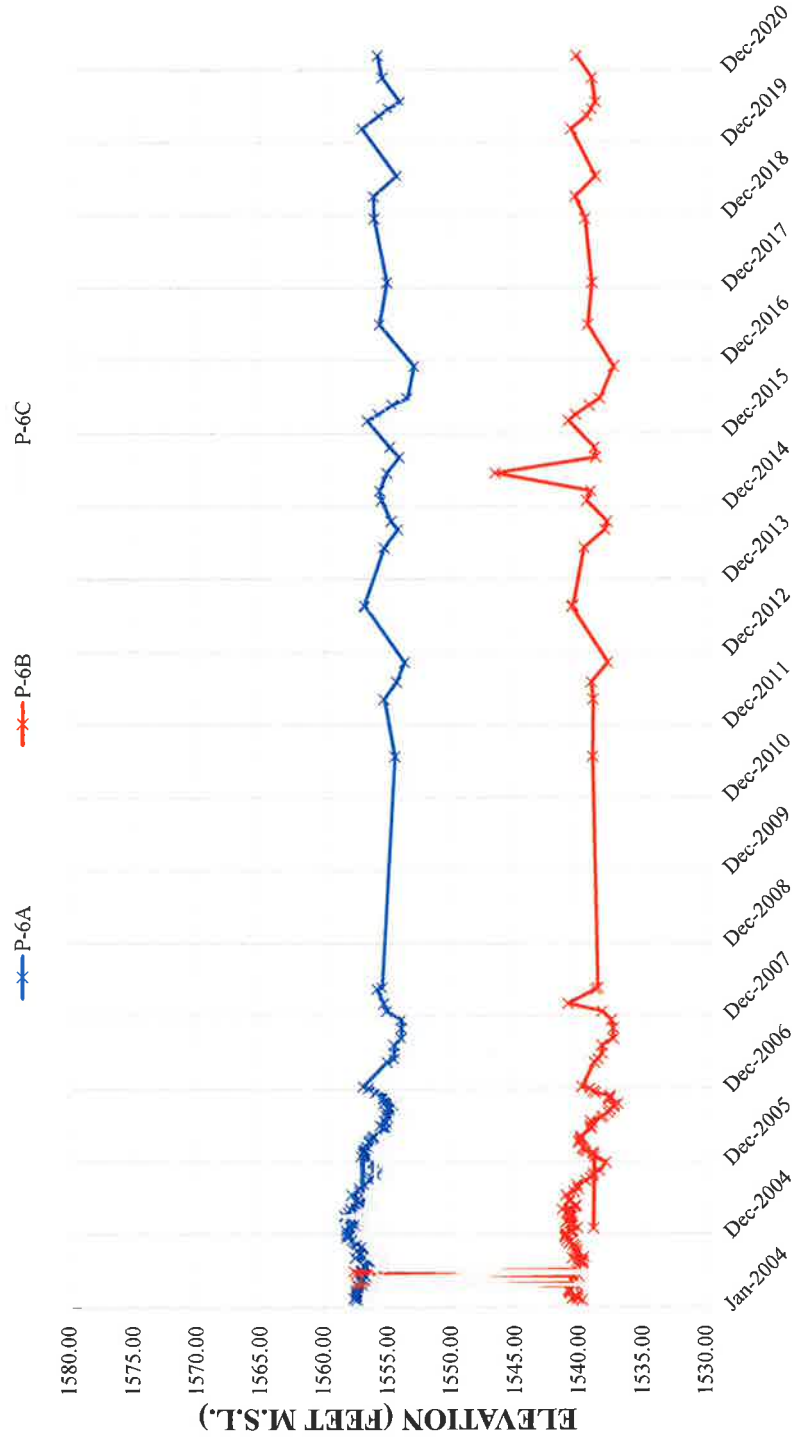
Figure 2-4. Summary of Vibrating Wire Piezometer Data, P-6A, B, C (Feb 2004 through Mar 2021) - Lake Petit Dam, Big Canoe, GA

Note: Historical data anomalies generally appear to be the result of transcription errors.
