**Subject: Owner Quarterly Inspection Reports 2020/2021 (Quarters 2, 3, and 4 of 2020 and Quarter 1 of 2021)  
Lake Petit Dam (ID Number (No.) 112-009-00462), Pickens County**

**ATTACHMENT A**  
**2020/2021 Reporting Year Quarterly Inspections**

## Embankment (Earth) Dam Inspection Form

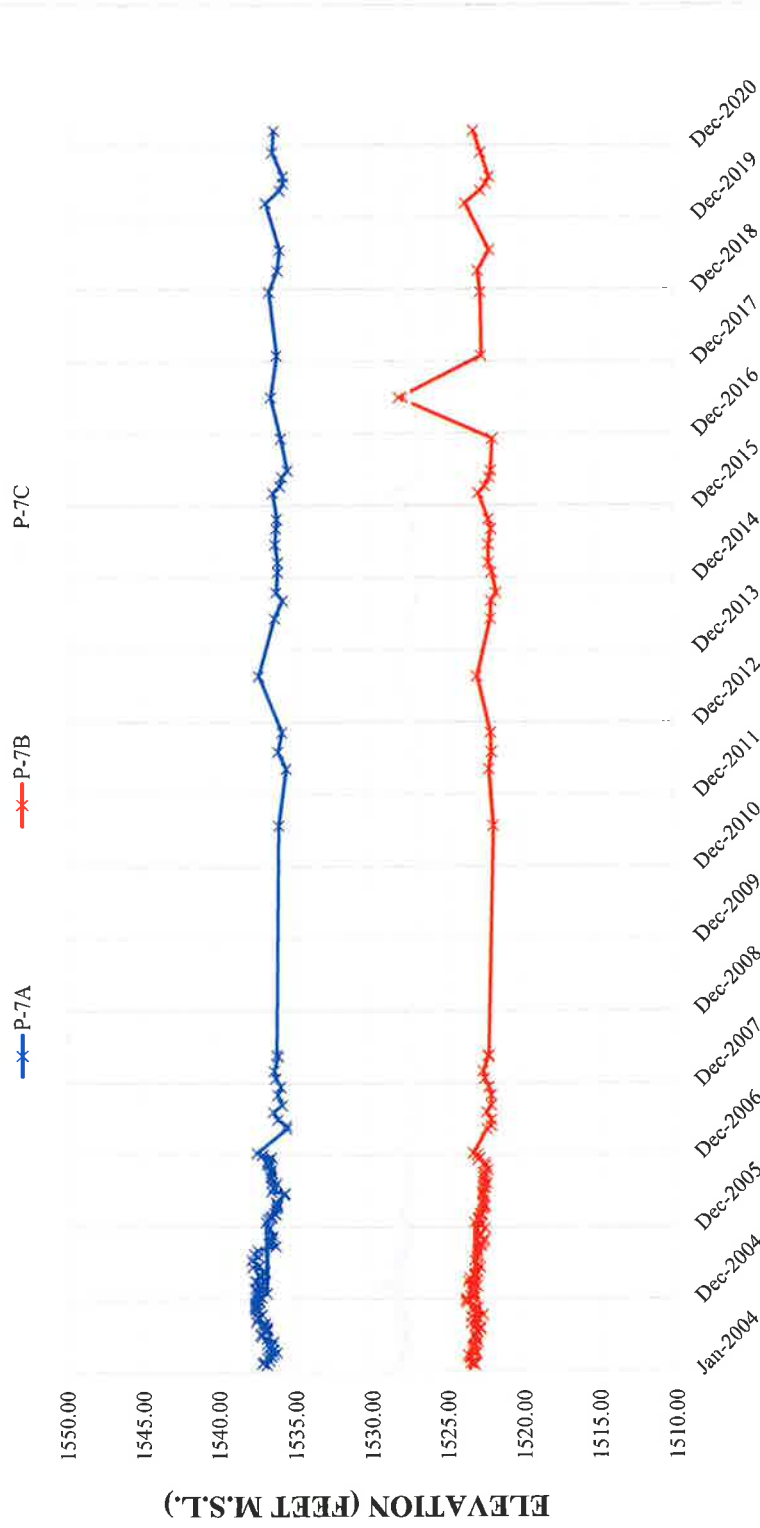
Note: Historical data anomalies generally appear to be the result of transcription errors.  
**Figure 2-5. Summary of Vibrating Wire Piezometer Data, P-7A, B, C (Feb 2004 through Mar 2021) - Lake Petit Dam, Big Canoe, GA**

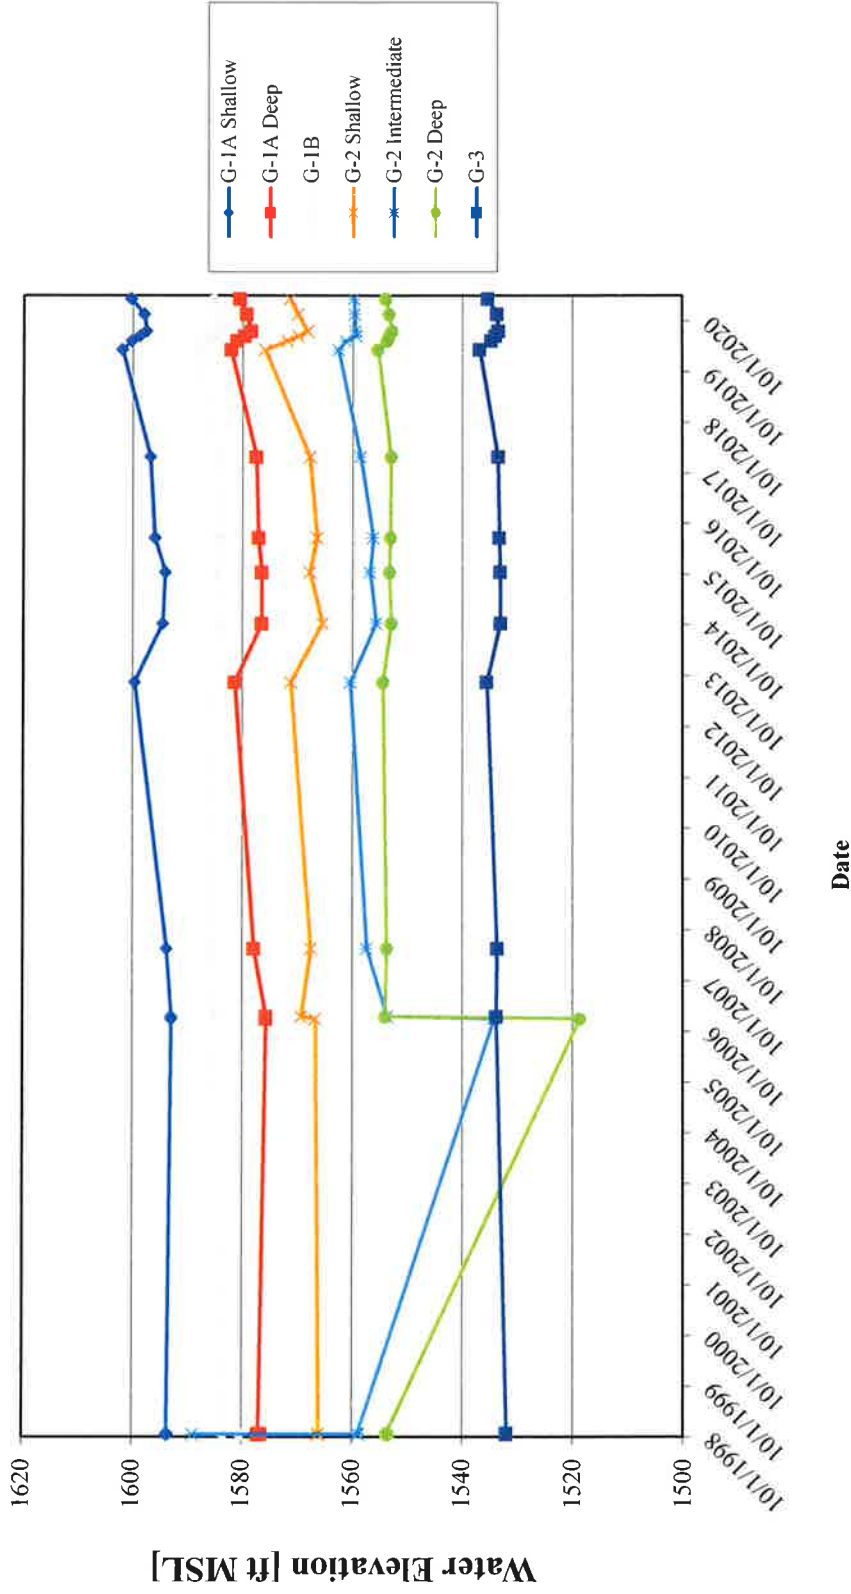
**Figure 2-6. Summary of Standpipe Piezometer Data (Oct 1998 through March 2021) - Lake Petit Dam, Big Canoe, GA.**

Note: G-2 Shallow water levels noted as anomalous on 3 Jan 2007. Re-measured 19 Jan 2007, and levels more consistent with previous readings.
