**Subject: Owner Quarterly Inspection Reports 2022/2023 (Quarters 2, 3, and 4 of 2022 and Quarter 1 of 2023)
Lake Petit Dam (ID Number (No.) 112-009-00462), Pickens County**

Embankment (Earth) Dam Inspection Form

Name of Dam: Lake Petit Dam Date: 06 June 2022
Location of Dam (County): Pickens County Weather: Sunny, 82 degrees F
Inspected by (Print Name): Edisson O. Avila, E.I.

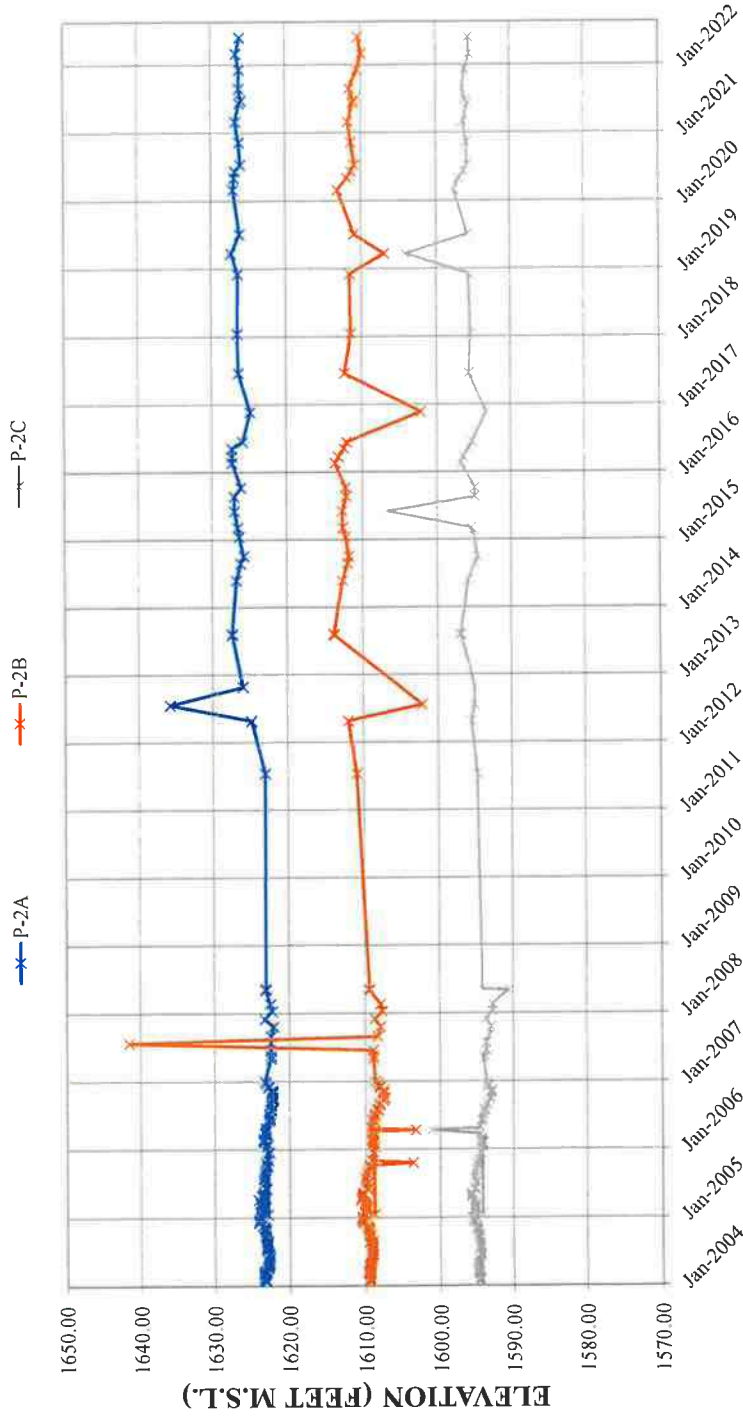
Note: Historical data anomalies generally appear to be the result of transcription errors.
Figure 2-2. Summary of Vibrating Wire Piezometer Data, P-2A, B, C (Feb 2004 through June 2022) - Lake Petit Dam, Big Canoe, GA

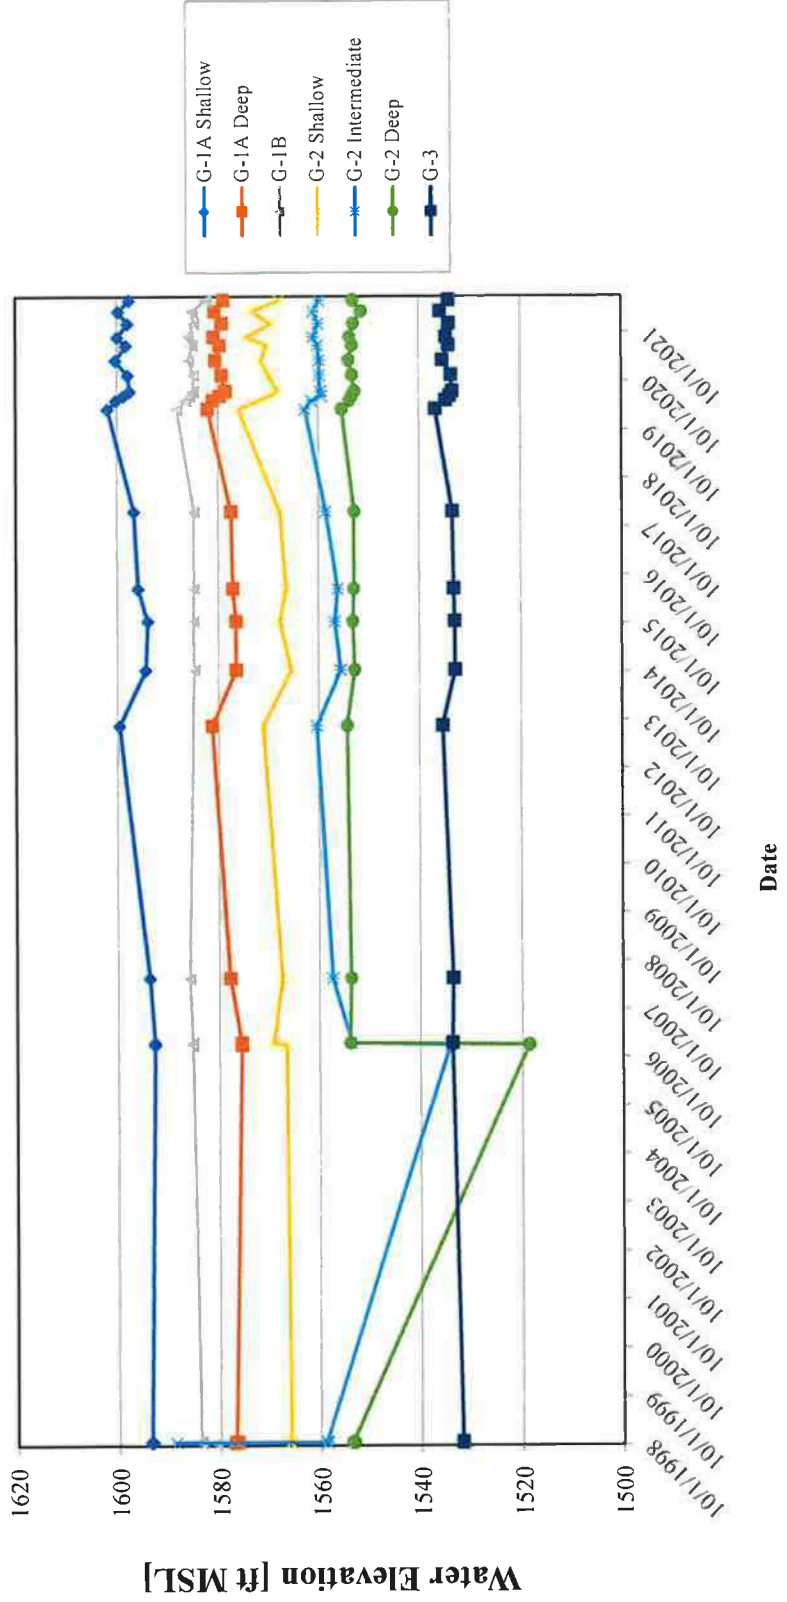
Figure 2-6. Summary of Standpipe Piezometer Data (Oct 1998 through March 2022) - Lake Petit Dam, Big Canoe, GA.

Note: G-2 Shallow water levels noted as anomalous on 3 Jan 2007. Re-measured 19 Jan 2007, and levels more consistent with previous readings.

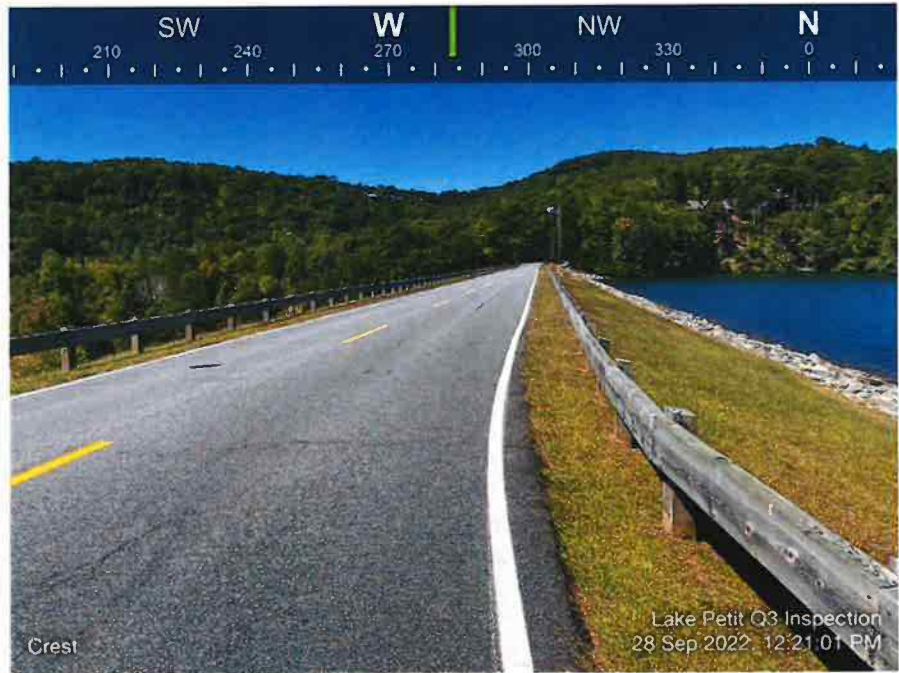
Comments: Crest - General view of the asphalt roadway on the crest of the dam. Photograph taken from the left abutment.

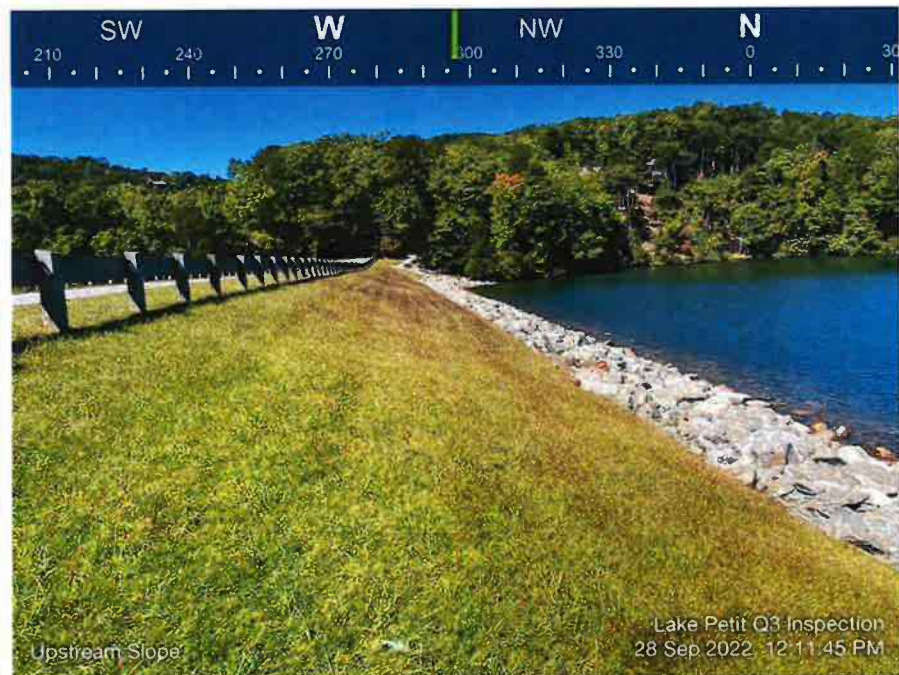
Photograph 2

Comments: Upstream Slope - View of the grass covered upstream slope and riprap wave protection. Photograph taken from the approximate center of the dam.

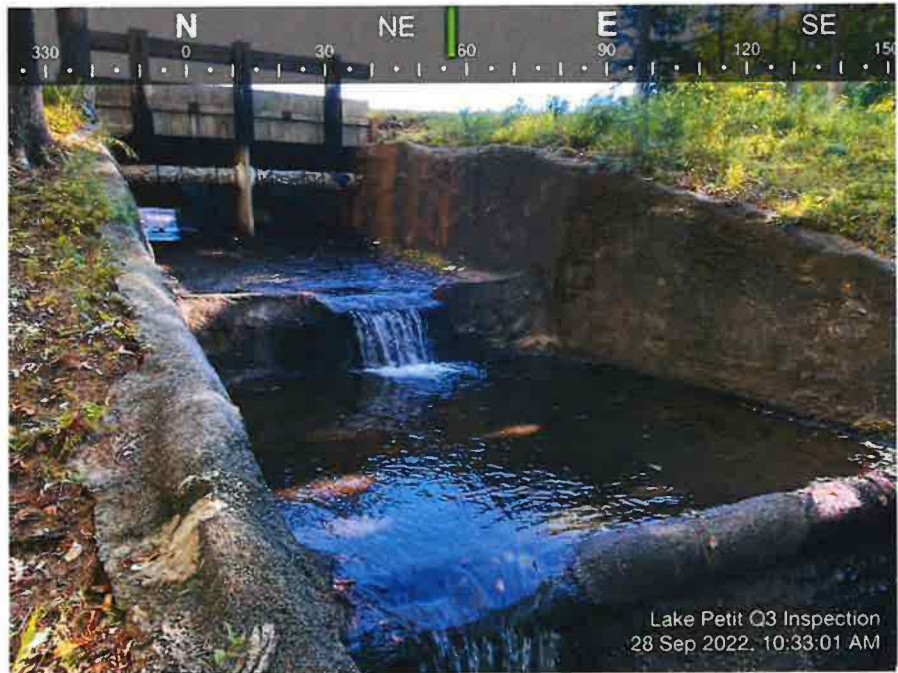
Comments: Overflow Spillway - General view of the overflow spillway towards the upstream end. No debris observed blocking flow during the inspection.

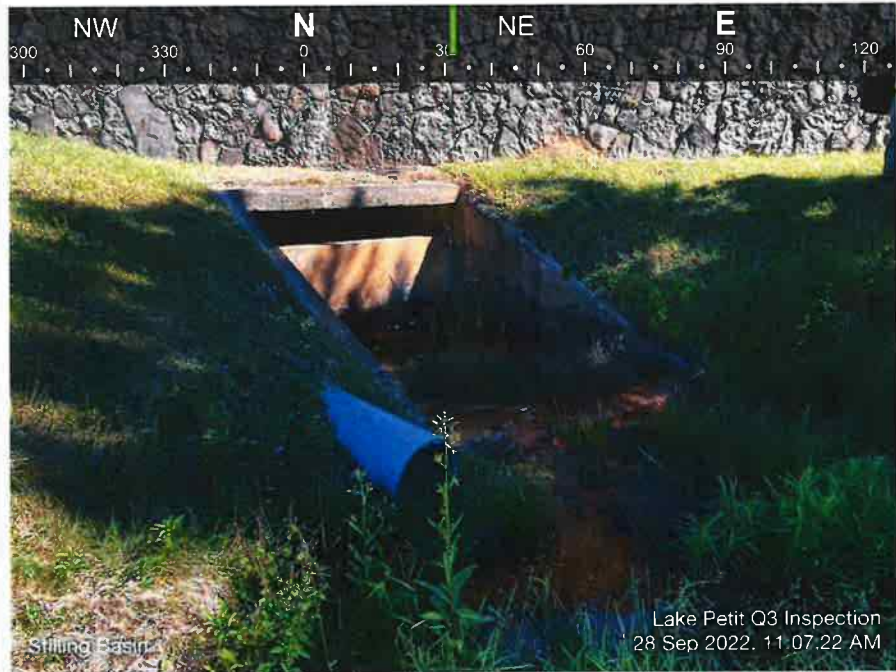
Comments: Impact Stilling Basin - General view of the impact stilling basin and associated drain outlets at the downstream toe of the dam.

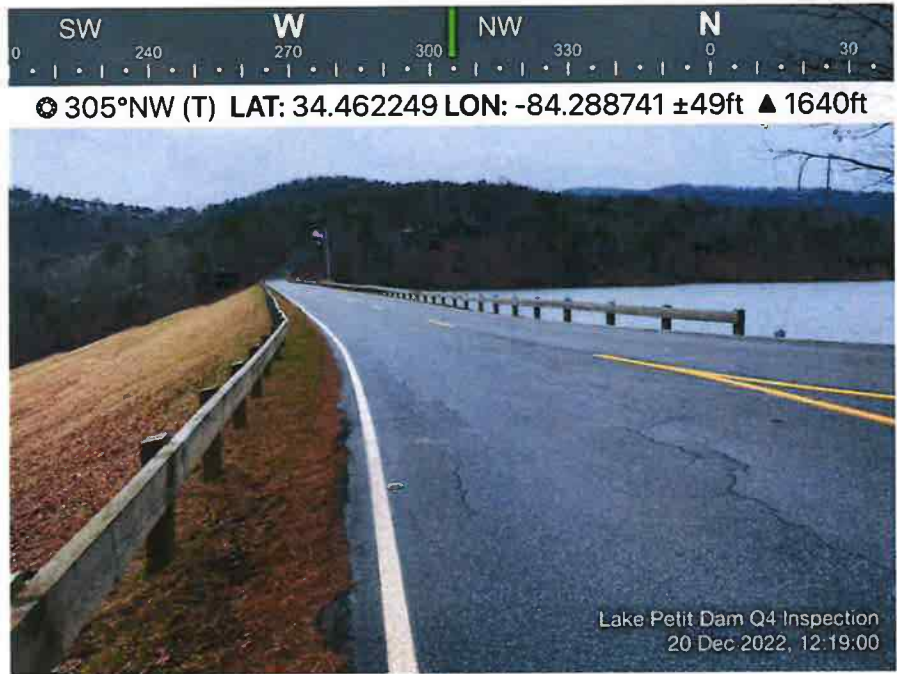
Comments: Crest - General View of the asphalt roadway on the crest of the dam. Photograph taken from the left abutment.

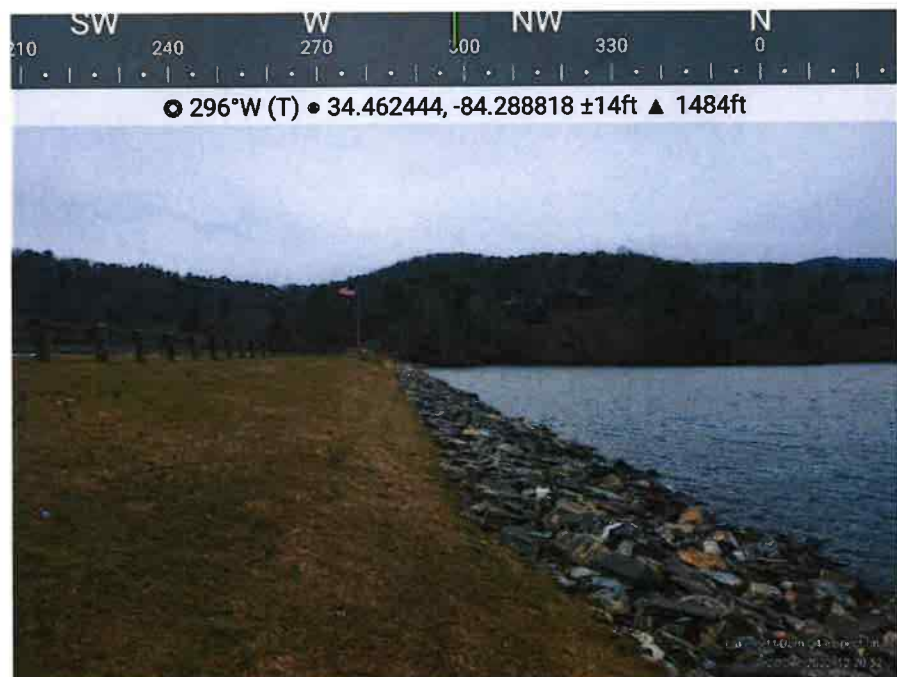
Photograph 2

Comments: Upstream Slope - View of the grass covered upstream slope and riprap wave action protection. Photograph taken from the left side of the dam.

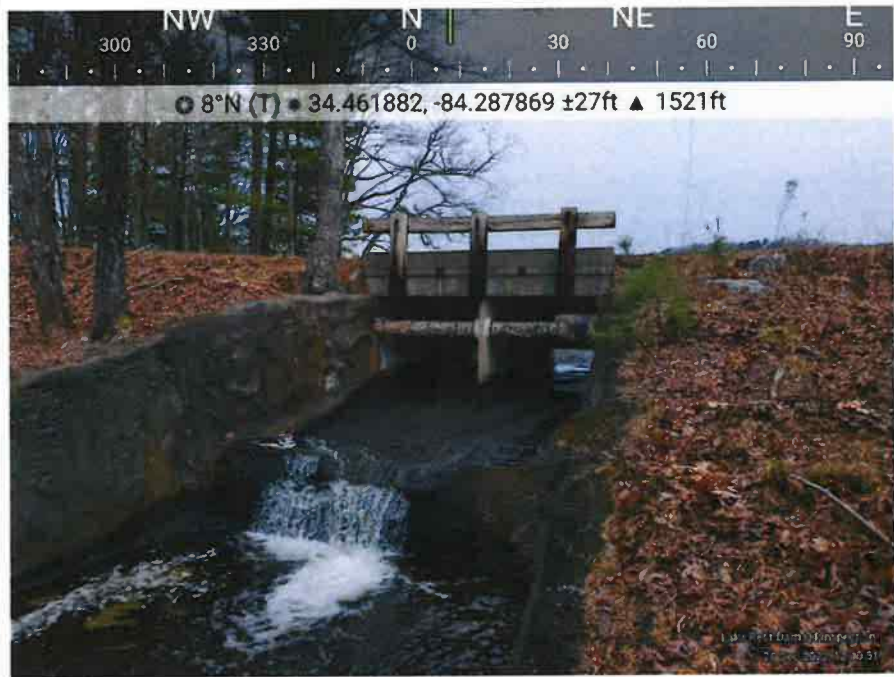
Comments: Overflow Spillway - General view of the overflow spillway towards the upstream end. No debris observed blocking flow during the inspection.

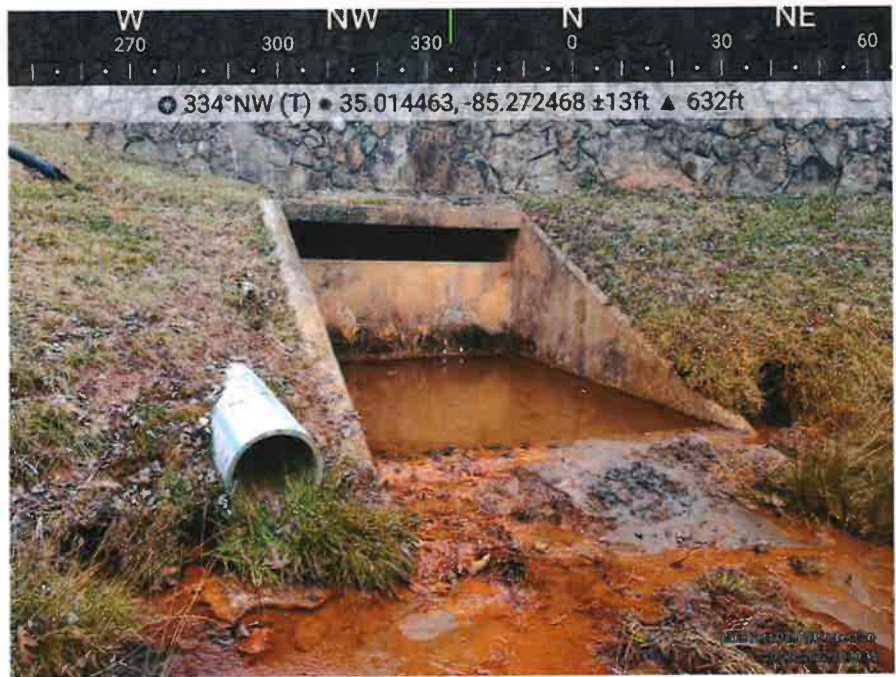
Comments: Impact Stilling Basin - General view of the impact stilling basin and associated drain outlets at the downstream toe of the dam.

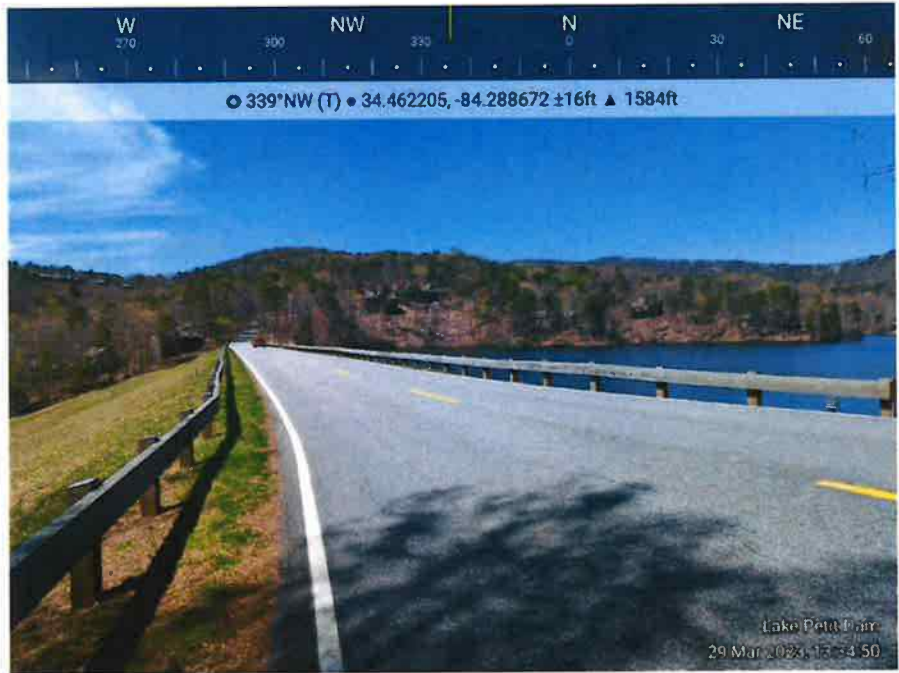
Comments: Crest - View of the asphalt roadway on the crest of the dam. Photograph was taken from the left abutment.

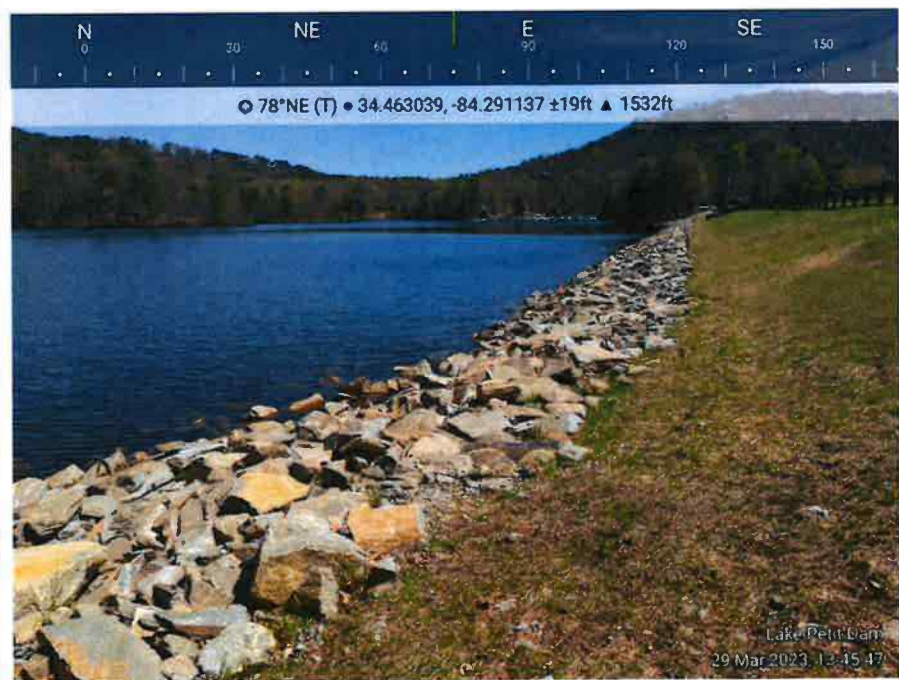
Photograph 2

Comments: Upstream Slope - View of the grass-covered upstream slope and riprap wave action protection. Photograph was taken from the right side of the upstream slope of the dam.
