## Monthly Construction Progress Report

Date: 14 February 2025

Subject: Lake Petit Dam Seepage Collection System Modifications CQA, Revision 1

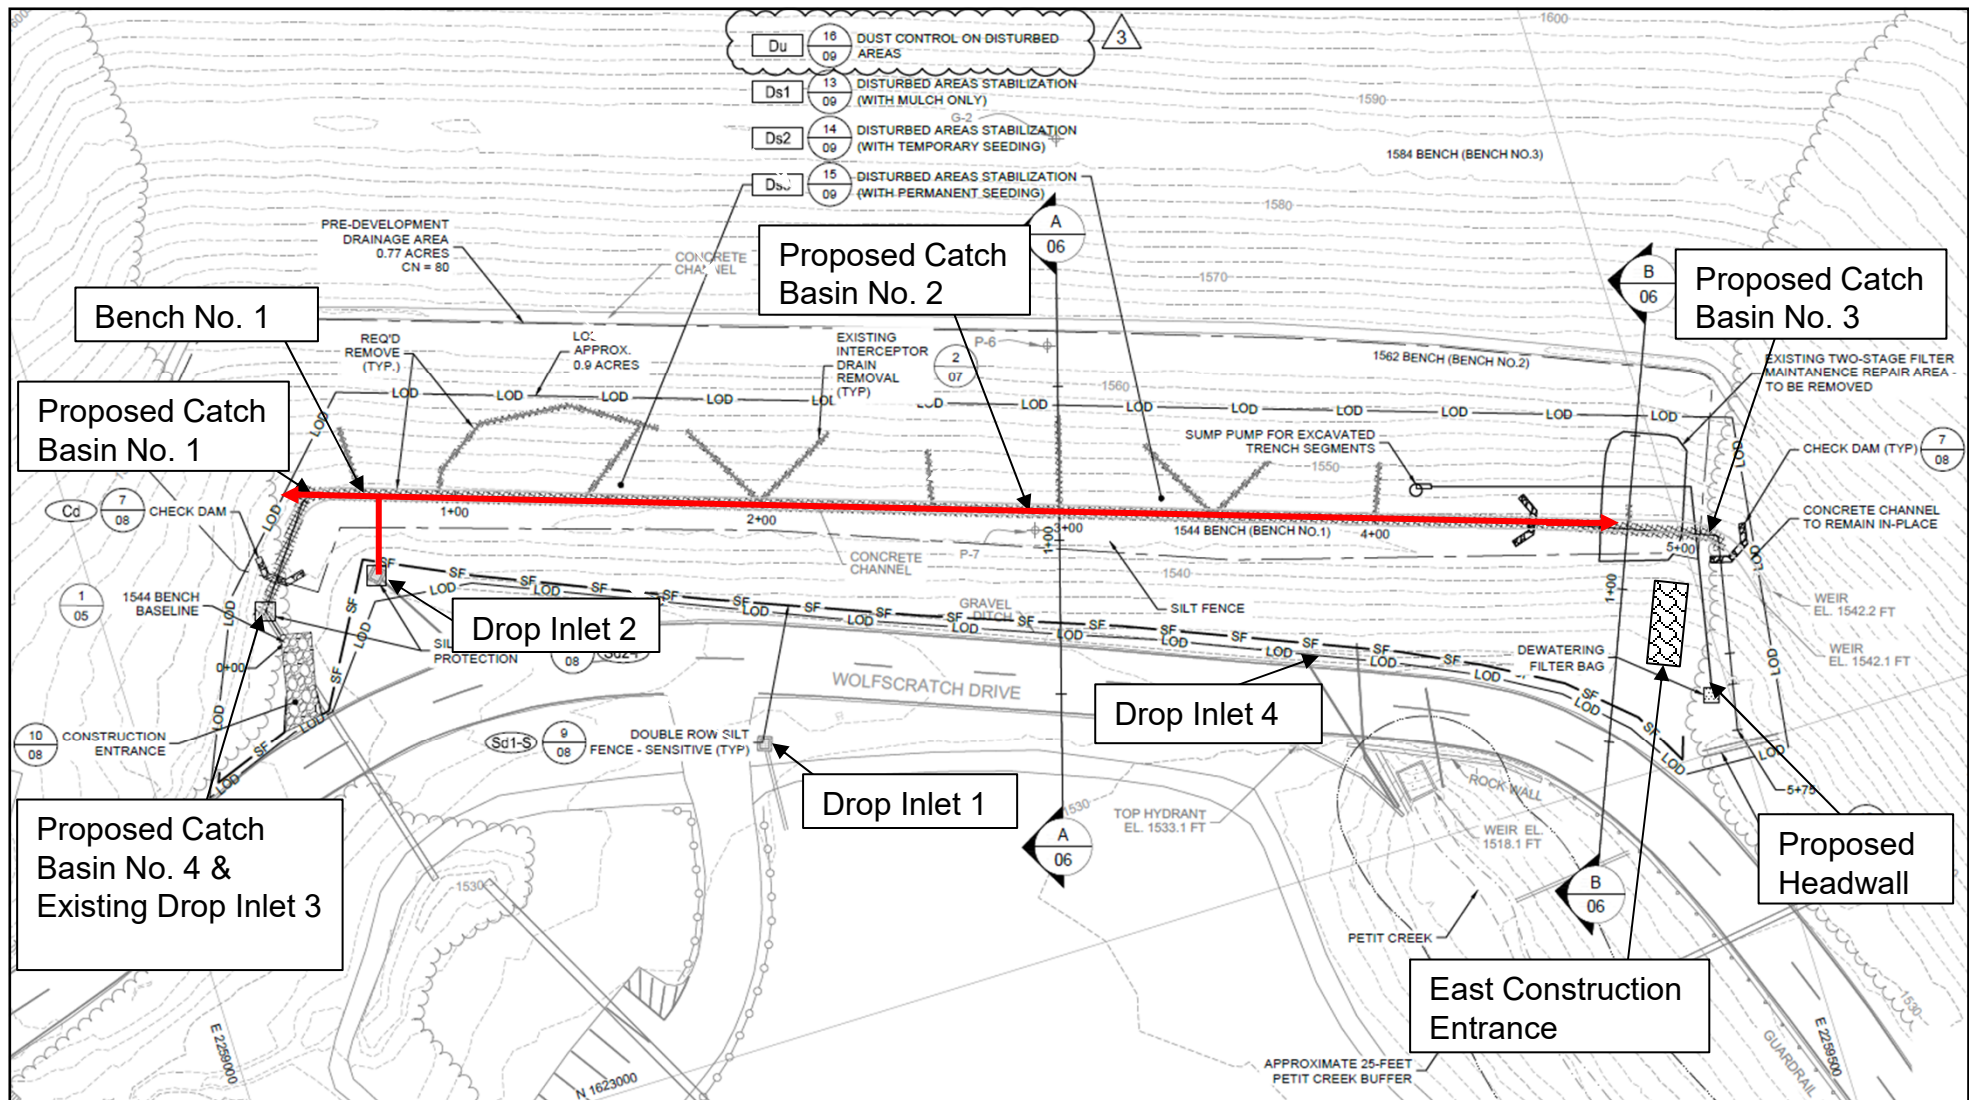
**FIGURE 2. SITE LAYOUT**

Excavation of the embankment began on 02 December 2024. A 10-in. diameter, CMP was encountered approximately 3 ft below the ground surface (bgs), at approximately Station 3+00 (near proposed CB2). This CMP was not noted in historical construction records of the Dam. A short section of the CMP was exposed, removed, and inspected by the engineering team. The CMP contained perforations and appeared to be part of a previously installed and undocumented internal drainage system. Additionally, the CMP appeared to be approaching the end of its service life. Note, water was not visually observed to be flowing within this section of pipe.

The CMP was observed to continue toward the right abutment, past CB1. This pipe was clogged and no flow was observed. The Contractor cleared the observed clog on 07 December 2024, and no additional obstructions, or flow, were observed. The orientation west of CB1 is unknown to the Engineer. The CMP opening was covered with coarse aggregate and connected to the filter surrounding CB1 to allow any discharge from the right abutment to flow into the new bench drain.

On 17 December 2024, the Engineer notified GSDP of the CMP discovery and the intentions to remove the deteriorated pipe as part of the approved installation of the new bench drain system. Since its discovery, the Engineer has determined that the existing CMP was likely installed shortly after Dam construction, based on a recommendation contained in an 18 May 1974 Law Engineering Testing Company report titled “Report of Engineering Evaluation” to address concentrated seepage at the Dam.

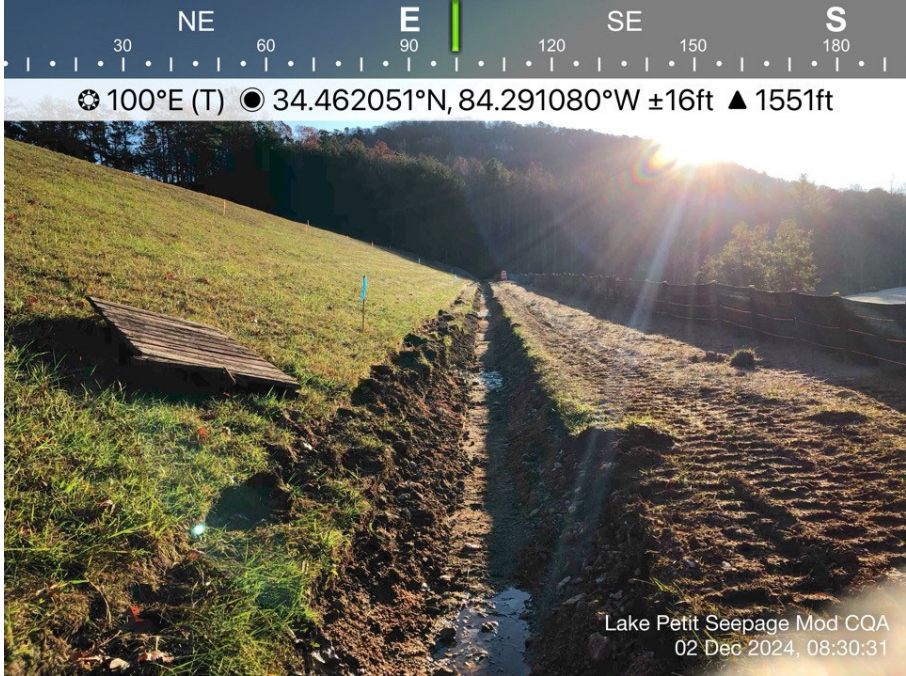
PHOTOGRAPH LOG		
PROJECT AND SITE INFORMATION		
<b>PROJECT:</b> Lake Petit Dam Seepage Collection CQA	<b>DATE:</b> December 2024 Reporting Period	
<b>DESCRIPTION:</b> Seepage Collection System Modification	<b>PROJECT NO.:</b> TCG11100	<b>TASK NO.:</b> 01/02
<p>Photograph No. 01</p> <p>Description: Site conditions prior to start of excavation. Photo taken from the right abutment (facing east).</p>

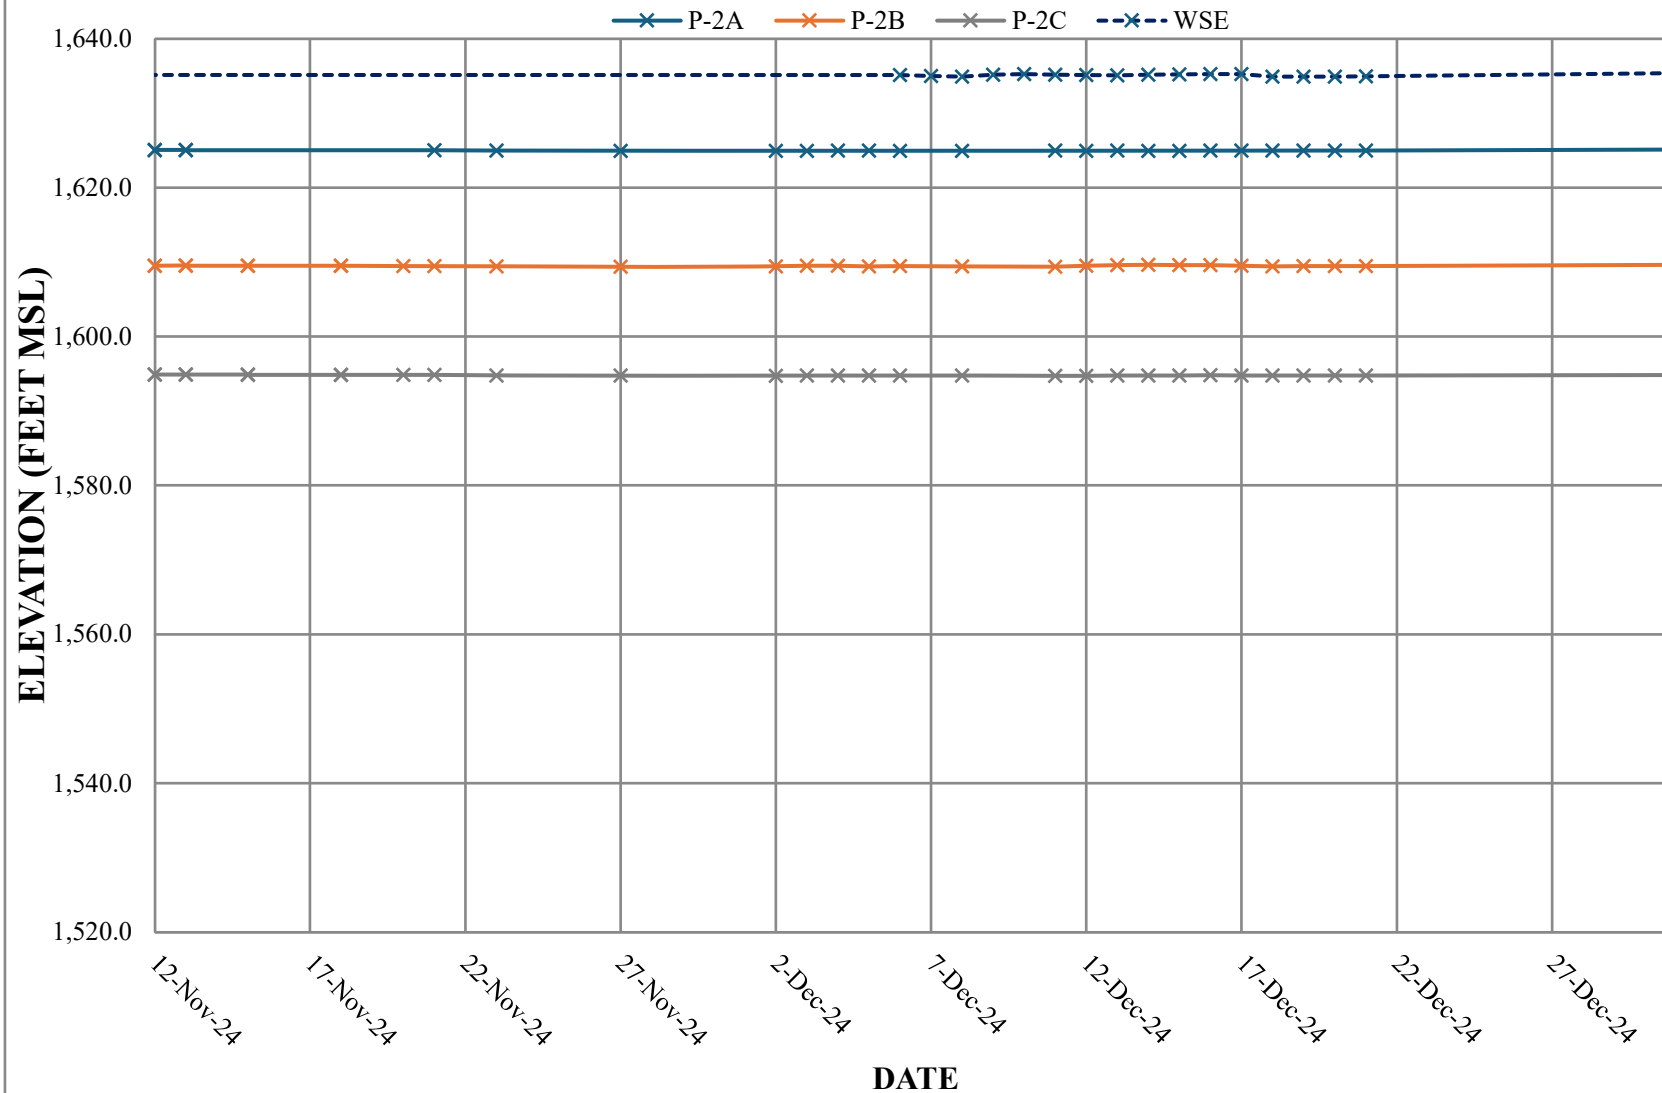
**Figure 6. Summary of Vibrating Wire Piezometer Data, P-2A, B, C (Nov. 2024 through Dec. 2024)**

WSE data collection began on 06 December 2024. Piezometer and WSE readings were conducted when construction personnel were onsite.

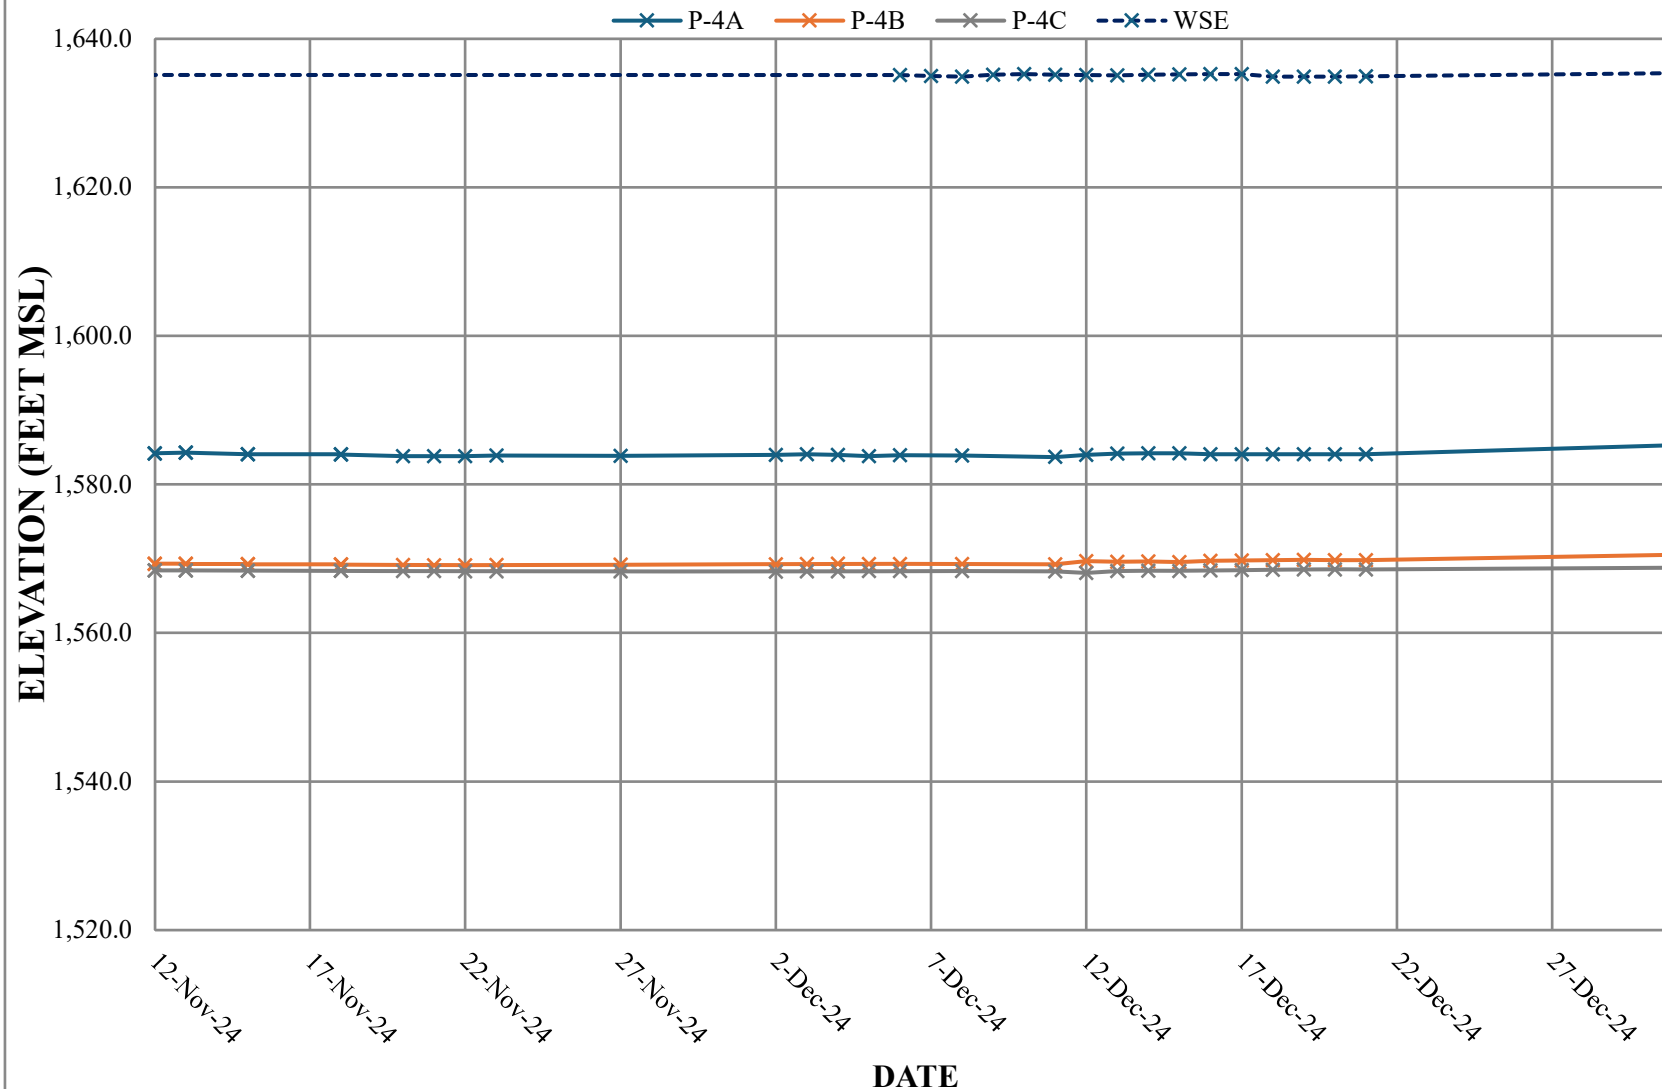
**Figure 7. Summary of Vibrating Wire Piezometer Data, P-4A, B, C (Nov. 2024 through Dec. 2024)**  
**Lake Petit Dam, Big Canoe, GA**

WSE data collection began on 06 December 2024. Piezometer and WSE readings were conducted when construction personnel were onsite.

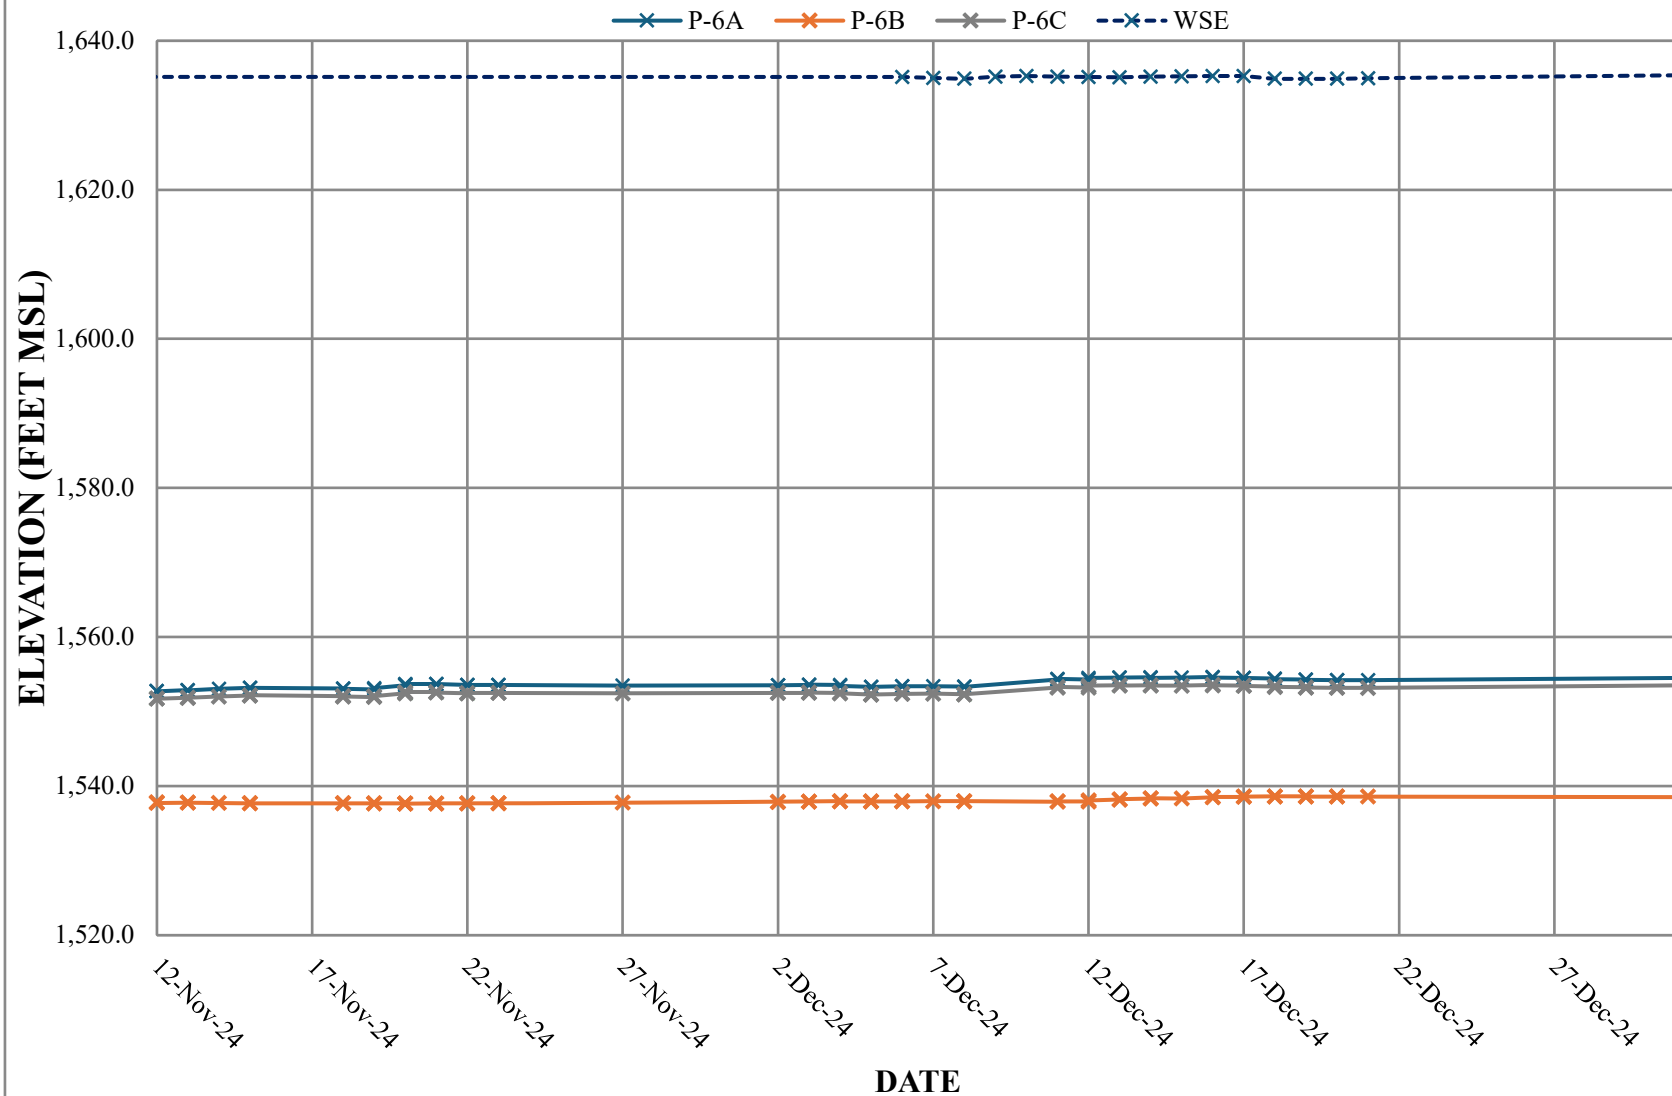
**Figure 8. Summary of Vibrating Wire Piezometer Data, P-6A, B, C (Nov. 2024 through Dec. 2024)**  
**Lake Petit Dam, Big Canoe, GA**

WSE data collection began on 06 December 2024. Piezometer and WSE readings were conducted when construction personnel were onsite.

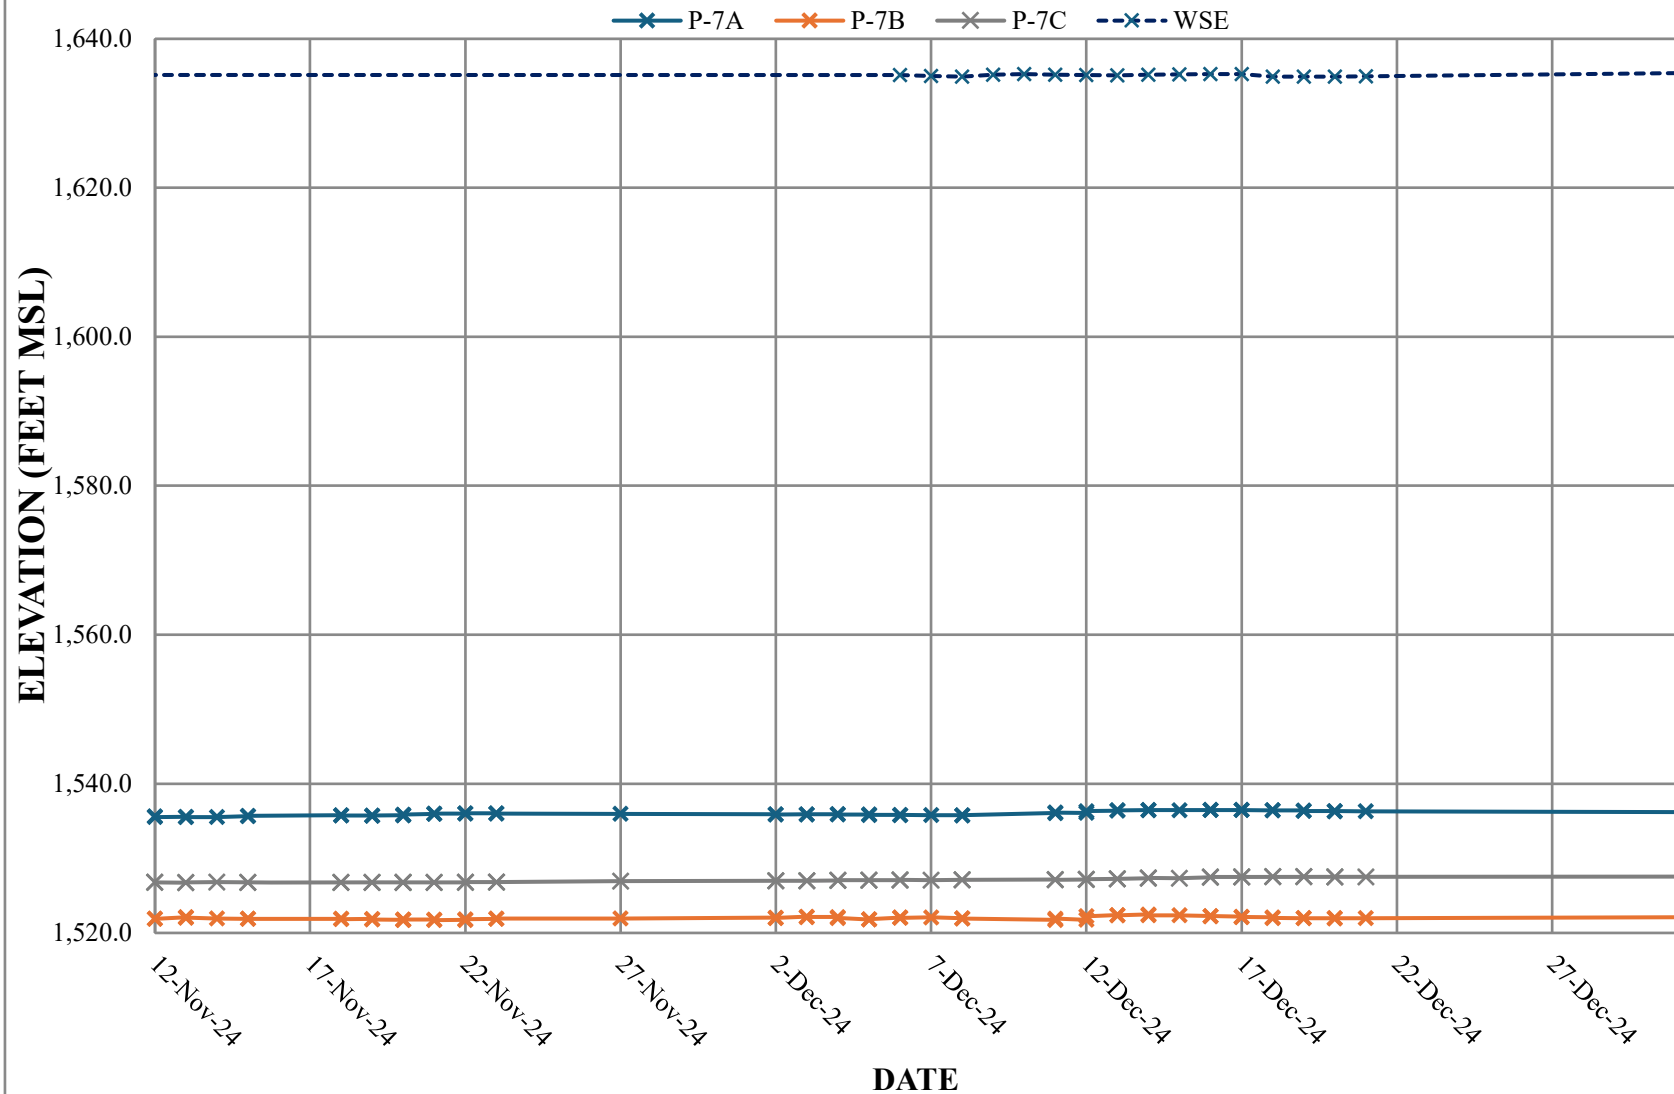
**Figure 9. Summary of Vibrating Wire Piezometer Data, P-7A, B, C (Nov. 2024 through Dec. 2024)**  
**Lake Petit Dam, Big Canoe, GA**

WSE data collection began on 06 December 2024. Piezometer and WSE readings were conducted when construction personnel were onsite.
