## Monthly Construction Progress Report

Date: 14 February 2025

Subject: Lake Petit Dam Seepage Collection System Modifications CQA

## Lake Petit Seepage Collection CQA: Monthly Construction Progress Report January 2025

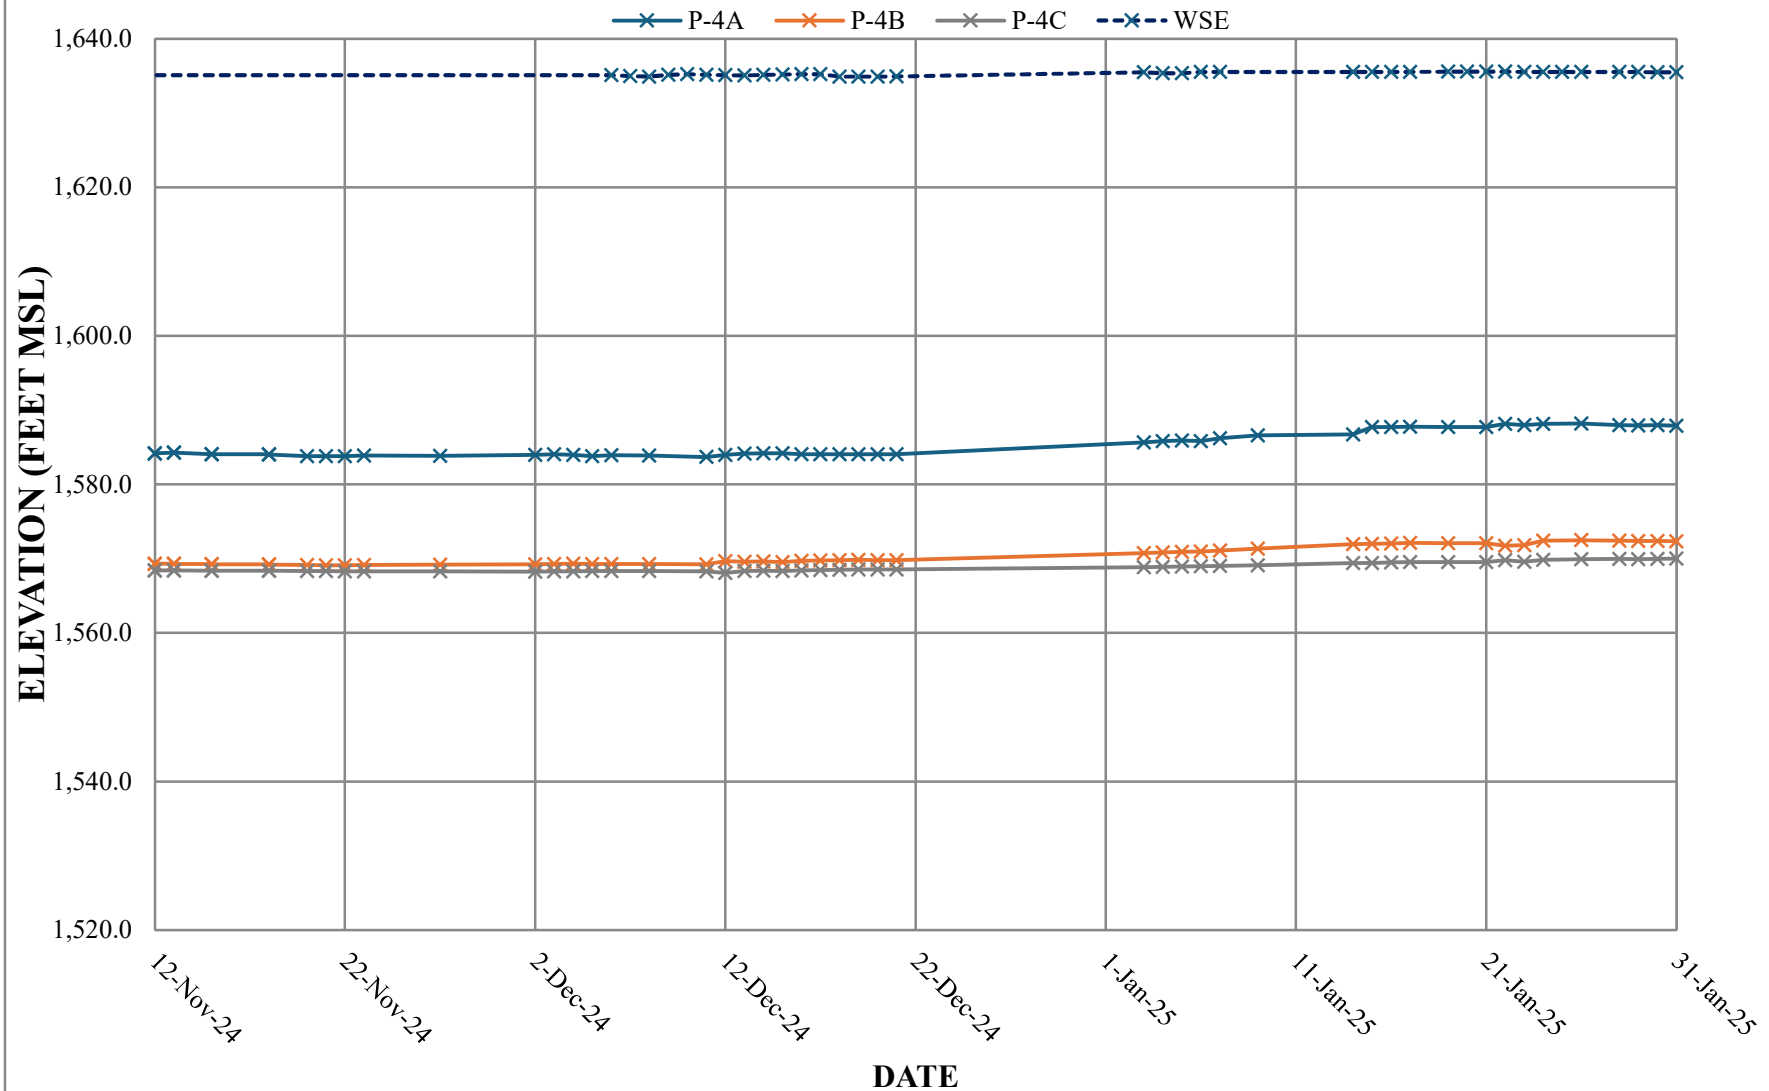
**Figure 7. Summary of Vibrating Wire Piezometer Data, P-4A, B, C (Nov. 2024 through Jan. 2025)**

WSE data collection began on 06 December 2024. Piezometer and WSE readings were conducted when construction personnel were onsite.

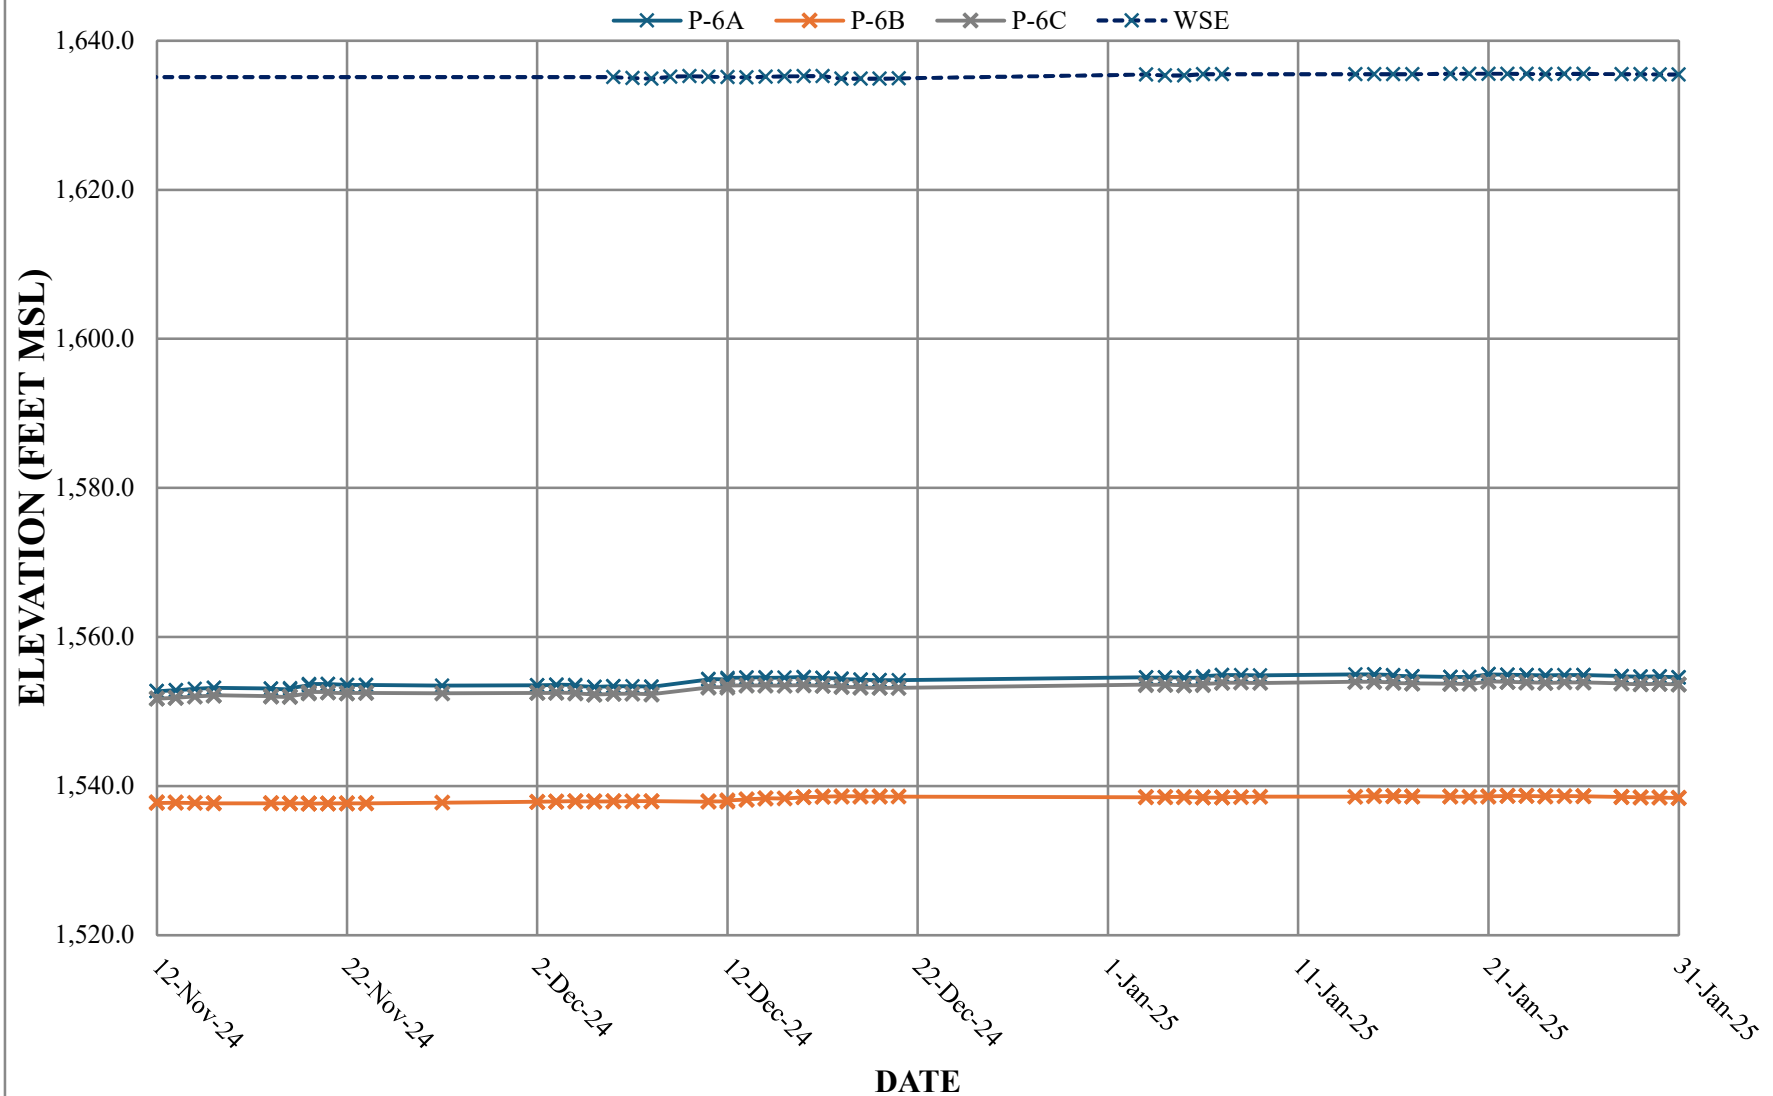
**Figure 8. Summary of Vibrating Wire Piezometer Data, P-6A, B, C (Nov. 2024 through Jan. 2025)**  
**Lake Petit Dam, Big Canoe, GA**

WSE data collection began on 06 December 2024. Piezometer and WSE readings were conducted when construction personnel were onsite.

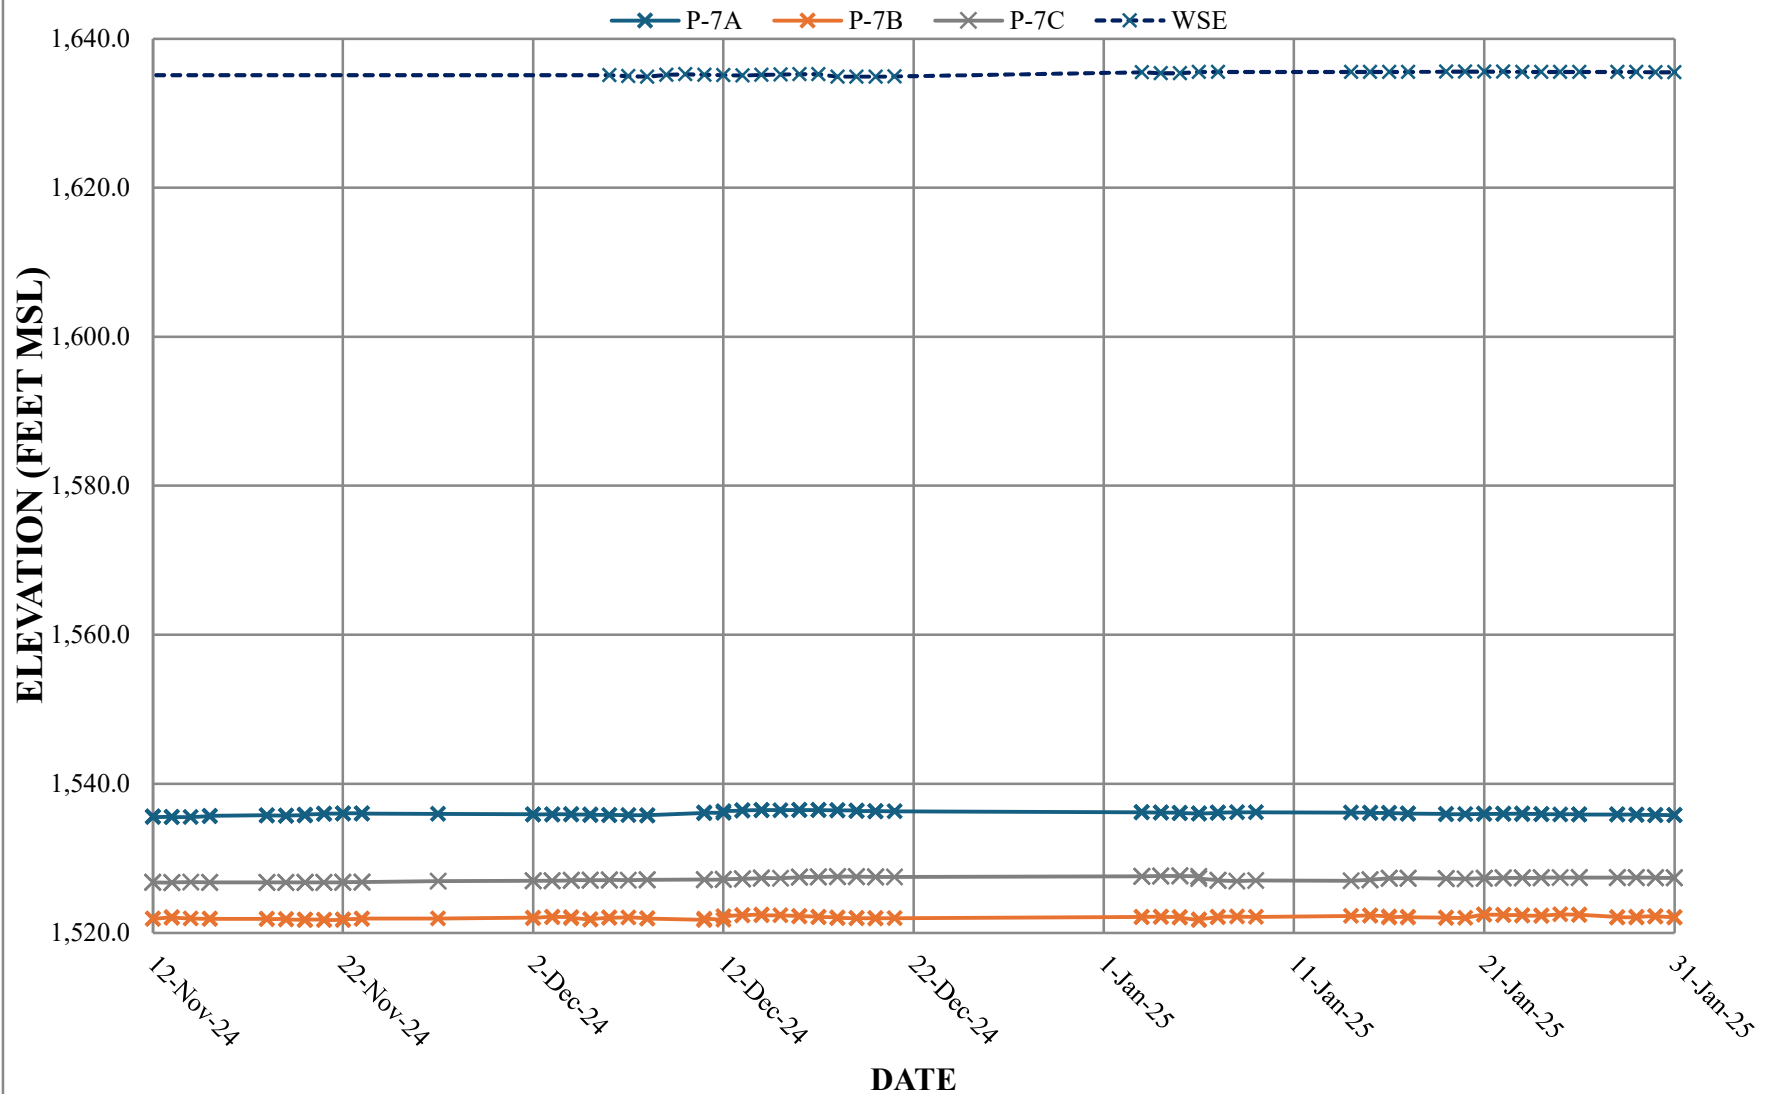
**Figure 9. Summary of Vibrating Wire Piezometer Data, P-7A, B, C (Nov. 2024 through Jan. 2025)**  
**Lake Petit Dam, Big Canoe, GA**

WSE data collection began on 06 December 2024. Piezometer and WSE readings were conducted when construction personnel were onsite.
