Monthly Construction Progress Report

Date: 17 March 2025

Subject: Lake Petit Dam Seepage Collection System Modifications CQA

Lake Petit Seepage Collection CQA: Monthly Construction Progress Report February 2025

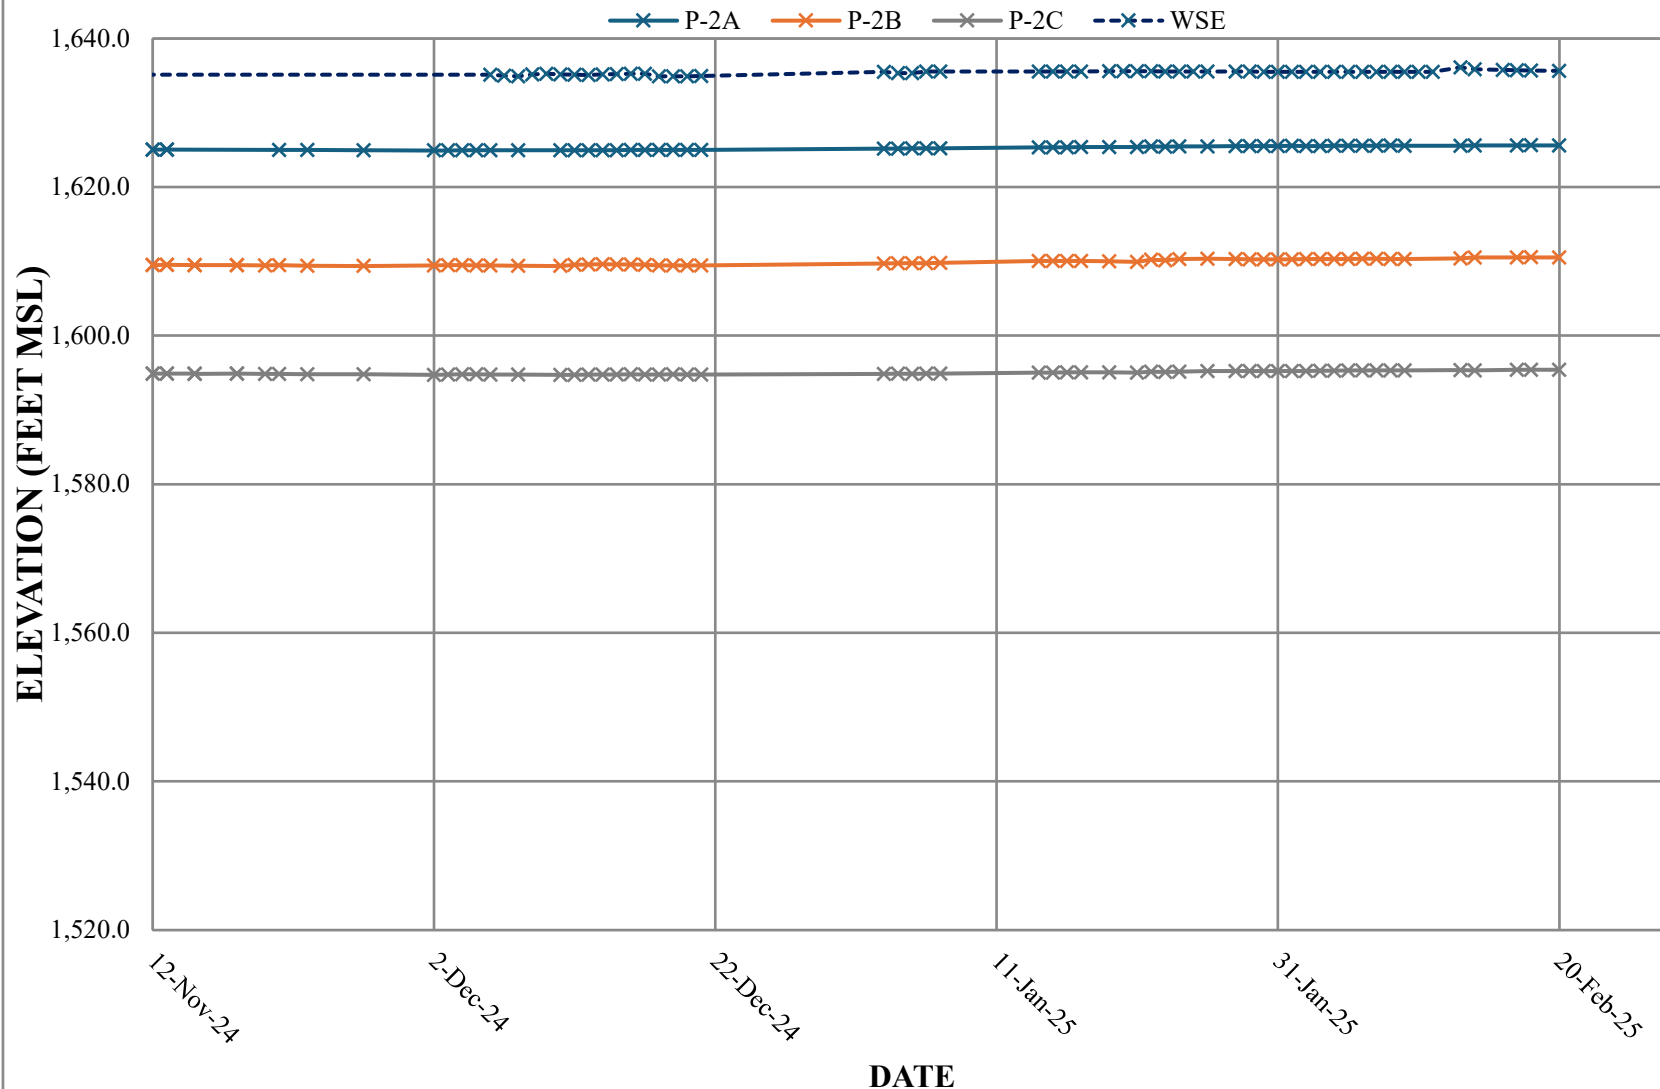
**Figure 6. Summary of Vibrating Wire Piezometer Data, P-2A, B, C (Nov. 2024 through Feb. 2025)
Lake Petit Dam, Big Canoe, GA**

WSE data collection began on 06 December 2024. Piezometer and WSE readings were conducted when construction personnel were onsite.

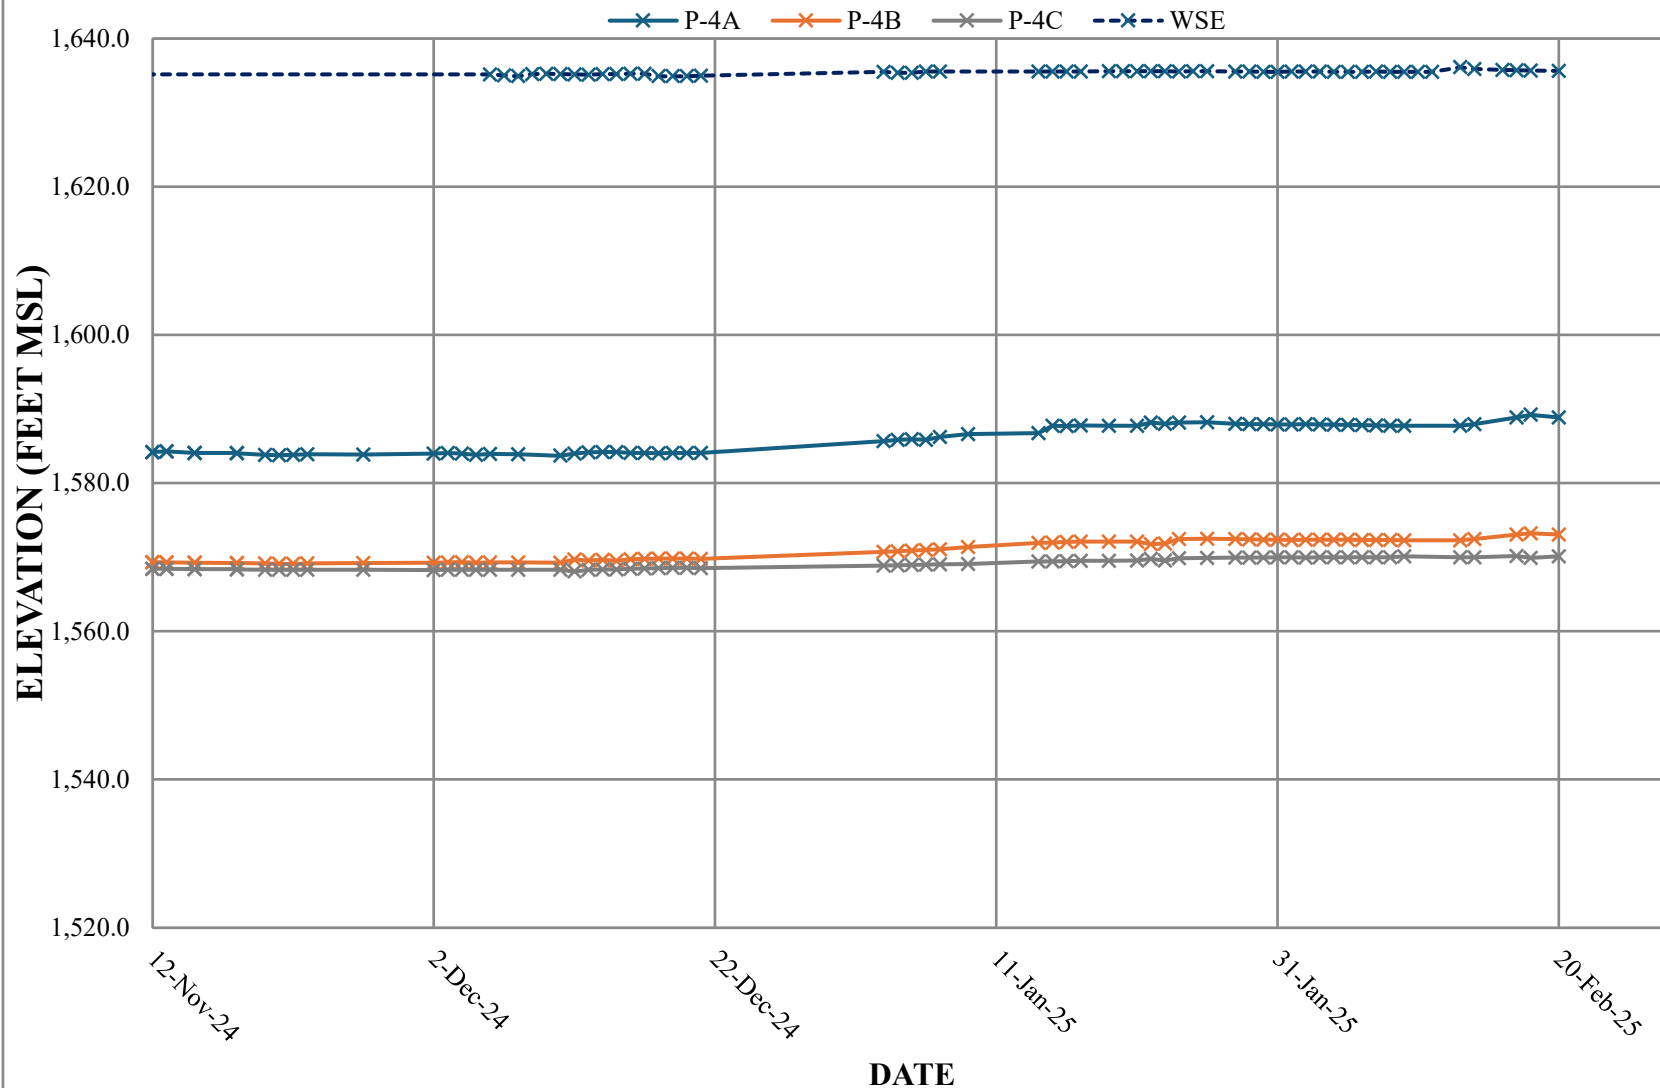
**Figure 7. Summary of Vibrating Wire Piezometer Data, P-4A, B, C (Nov. 2024 through Feb. 2025)
Lake Petit Dam, Big Canoe, GA**

WSE data collection began on 06 December 2024. Piezometer and WSE readings were conducted when construction personnel were onsite.

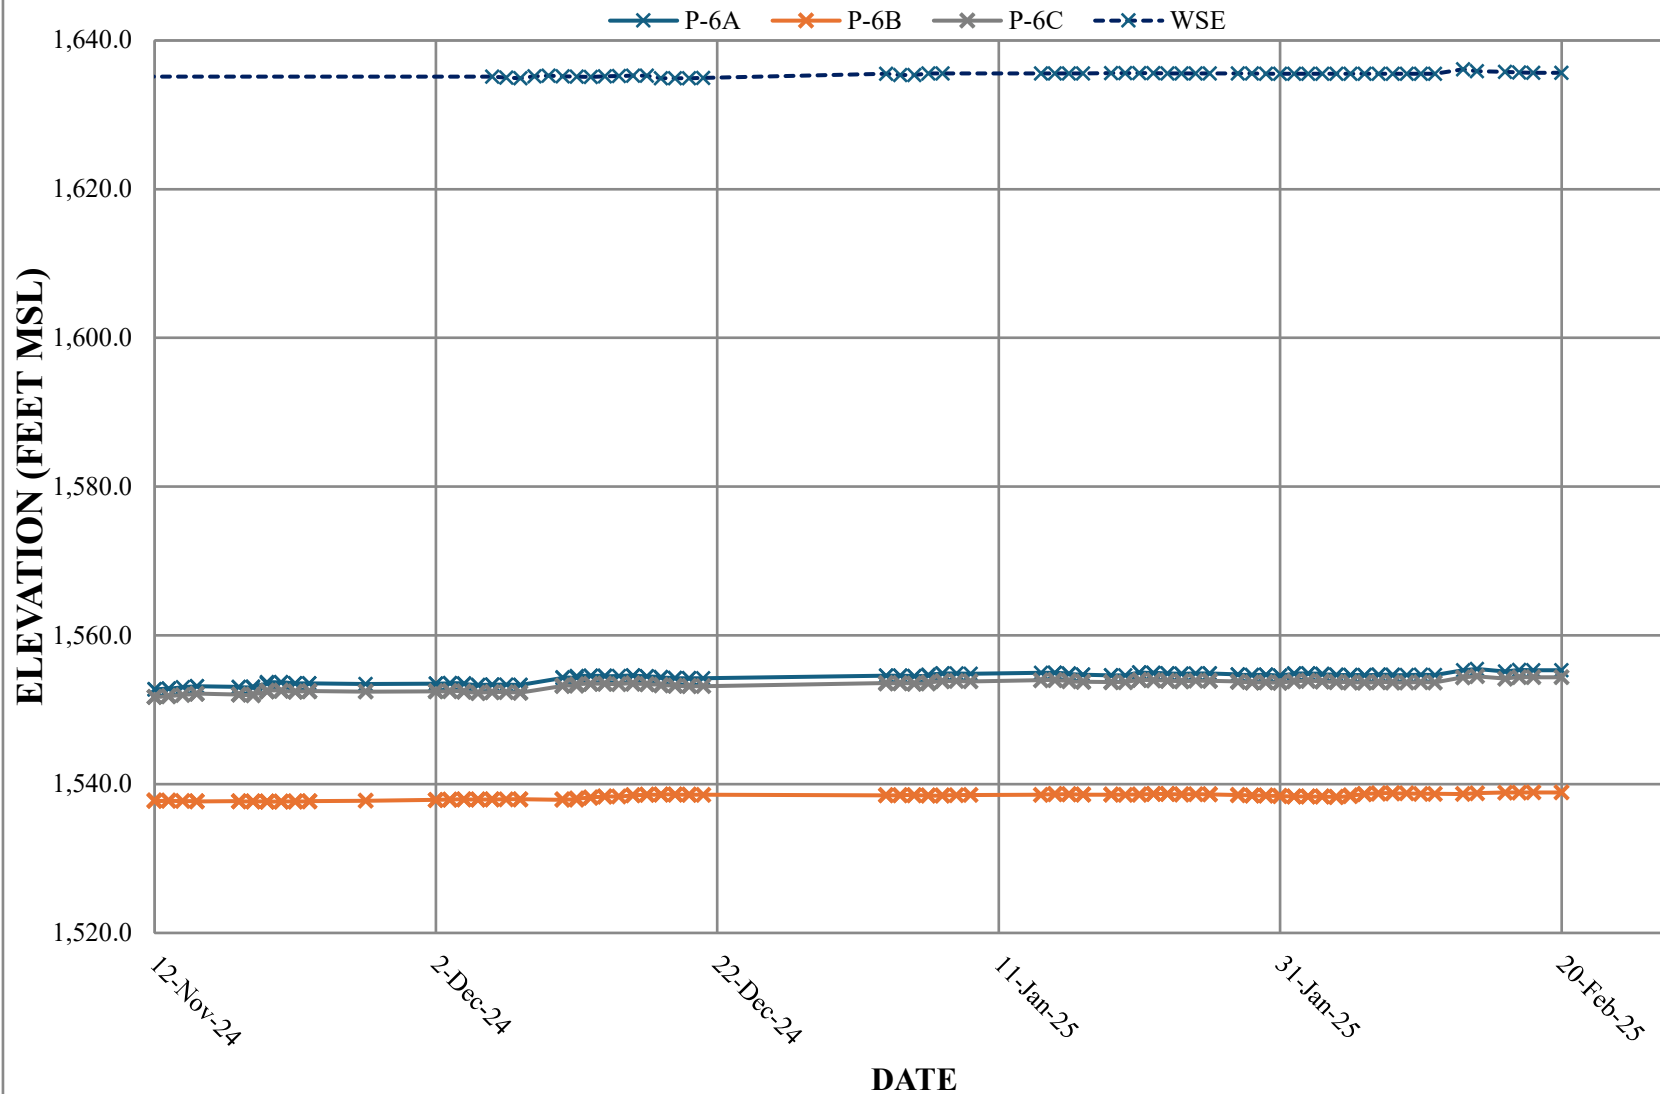
**Figure 8. Summary of Vibrating Wire Piezometer Data, P-6A, B, C (Nov. 2024 through Feb. 2025)
Lake Petit Dam, Big Canoe, GA**

WSE data collection began on 06 December 2024. Piezometer and WSE readings were conducted when construction personnel were onsite.

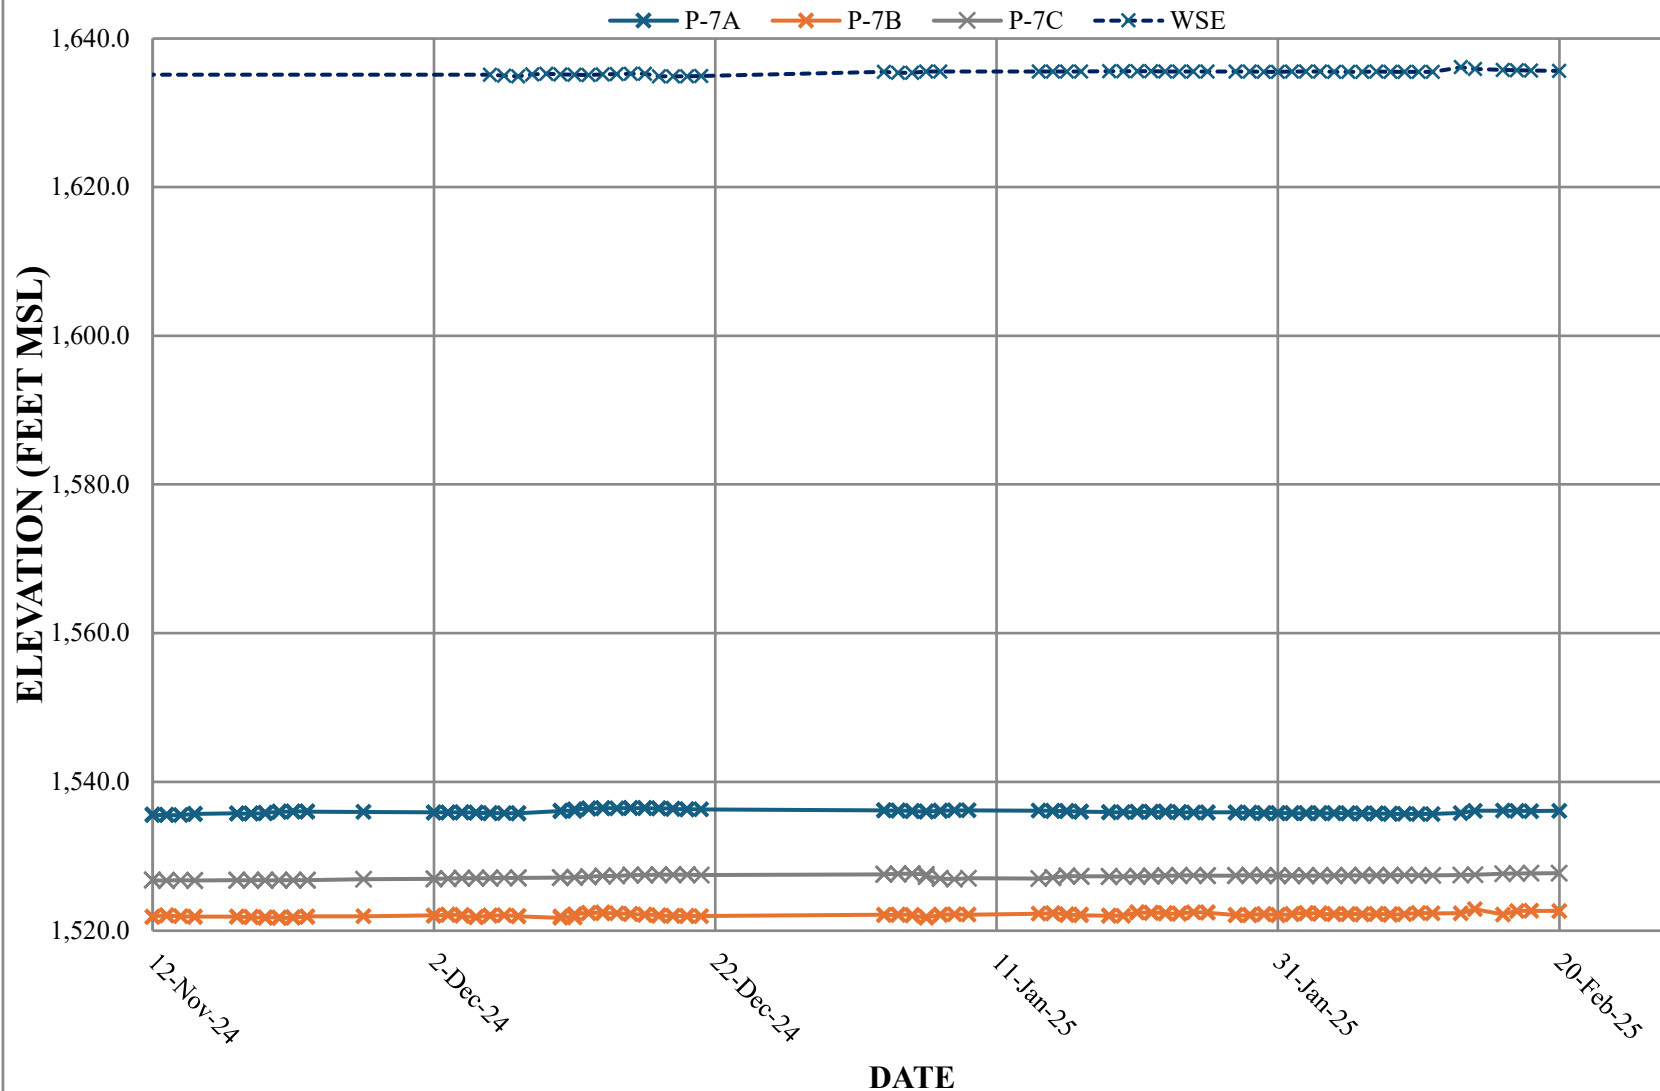
**Figure 9. Summary of Vibrating Wire Piezometer Data, P-7A, B, C (Nov. 2024 through Feb. 2025)
Lake Petit Dam, Big Canoe, GA**

WSE data collection began on 06 December 2024. Piezometer and WSE readings were conducted when construction personnel were onsite.

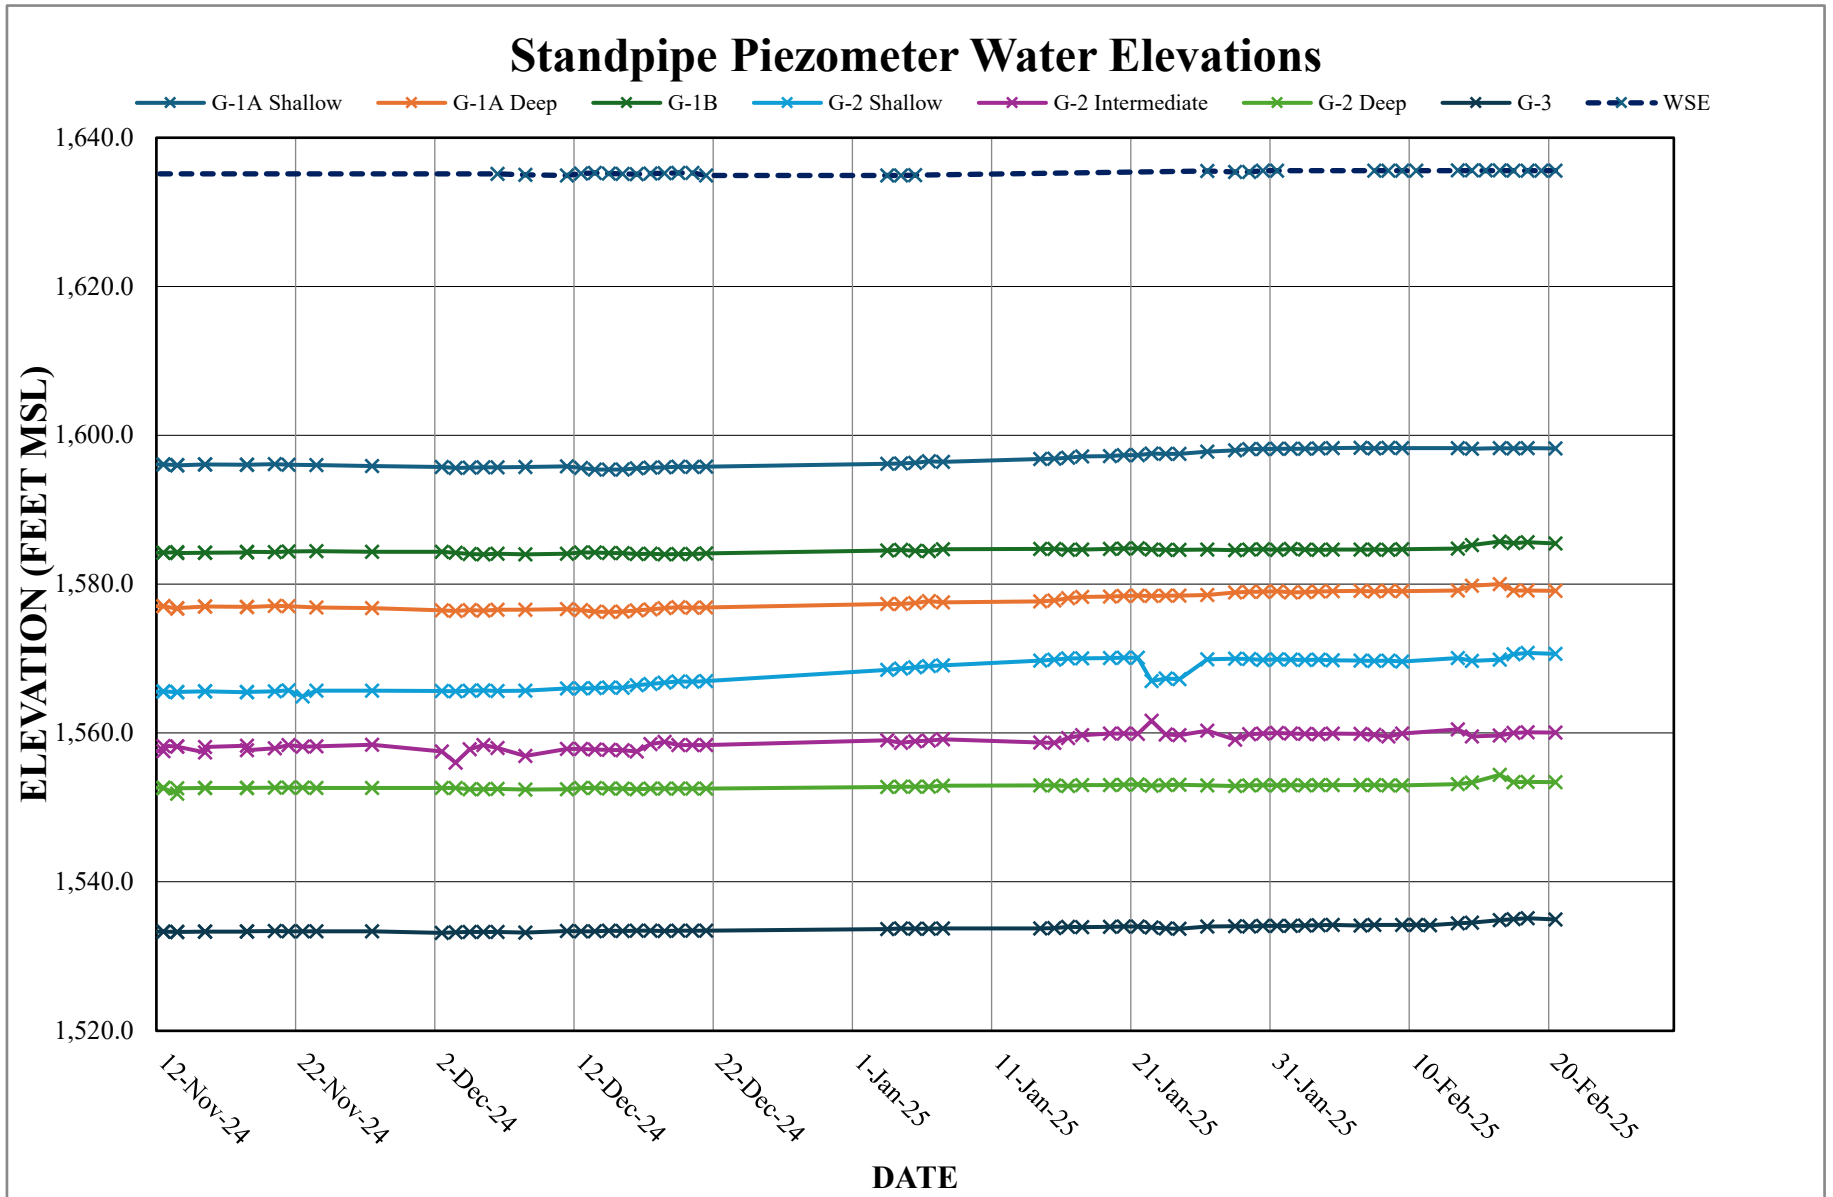
**Figure 10. Summary of Standpipe Piezometer Data (Nov. 2024 through Feb. 2025)
Lake Petit Dam, Big Canoe, GA**

WSE data collection began on 06 December 2024. Piezometer and WSE readings were conducted when construction personnel were onsite.
