LAKE PETIT DAM

Summary of Visual Assessment

Geosyntec Consultants, Inc.

April 2024

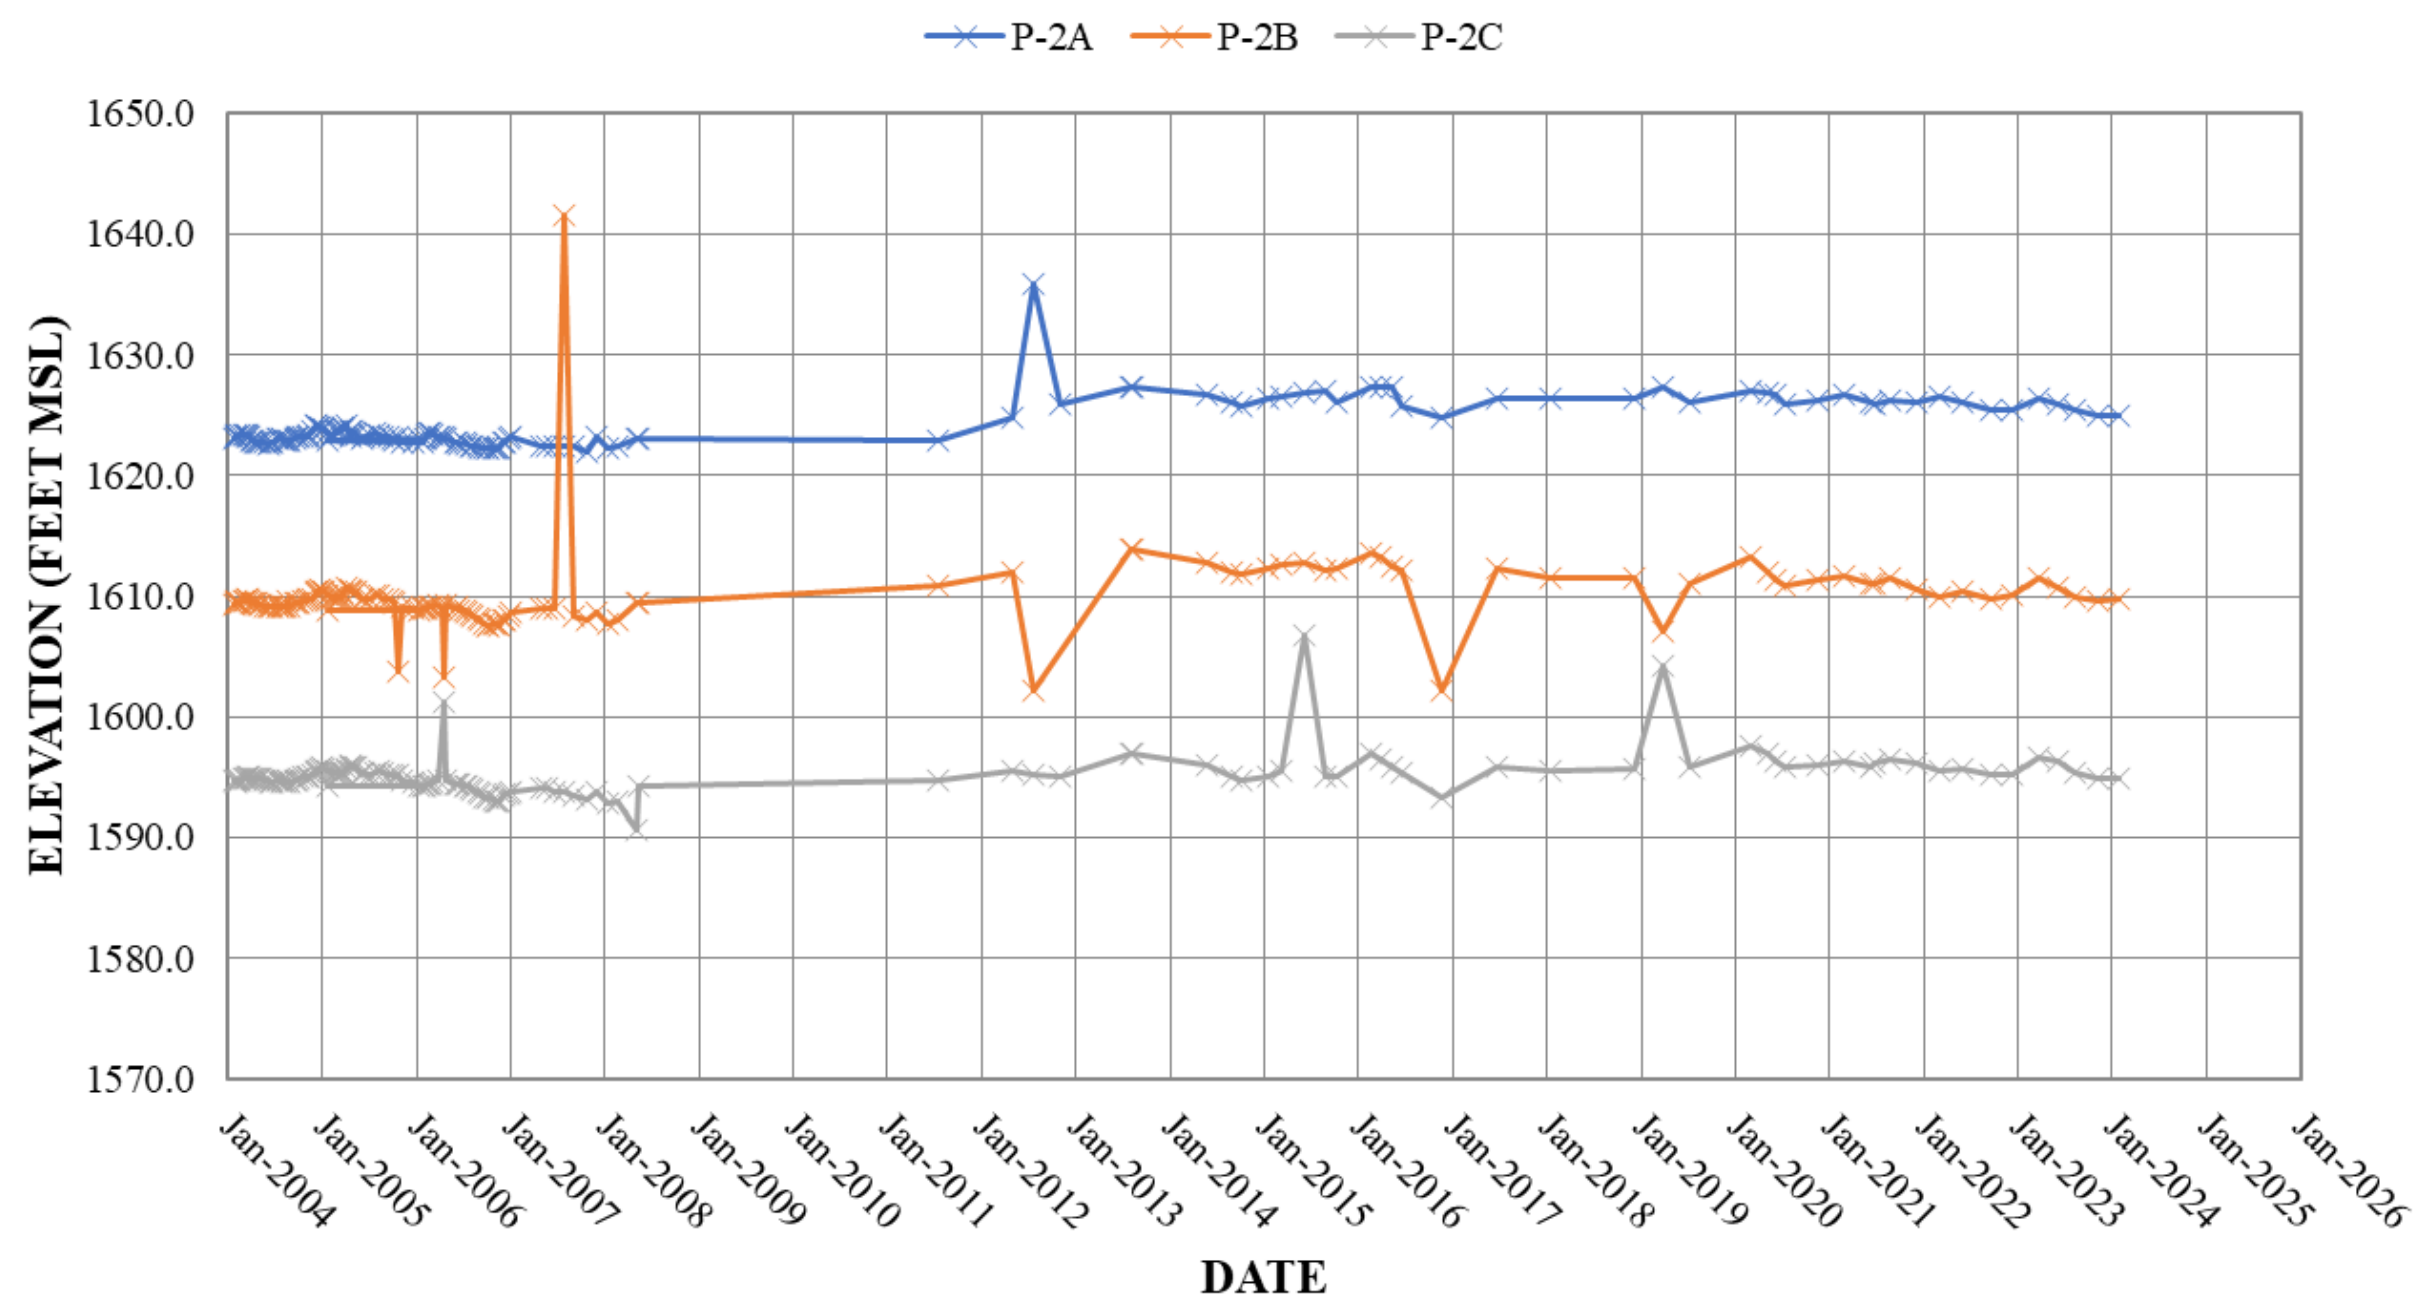
Vibrating Wire Piezometer Water Elevations

Note: Historical data anomalies generally appear to be the result of transcription errors.

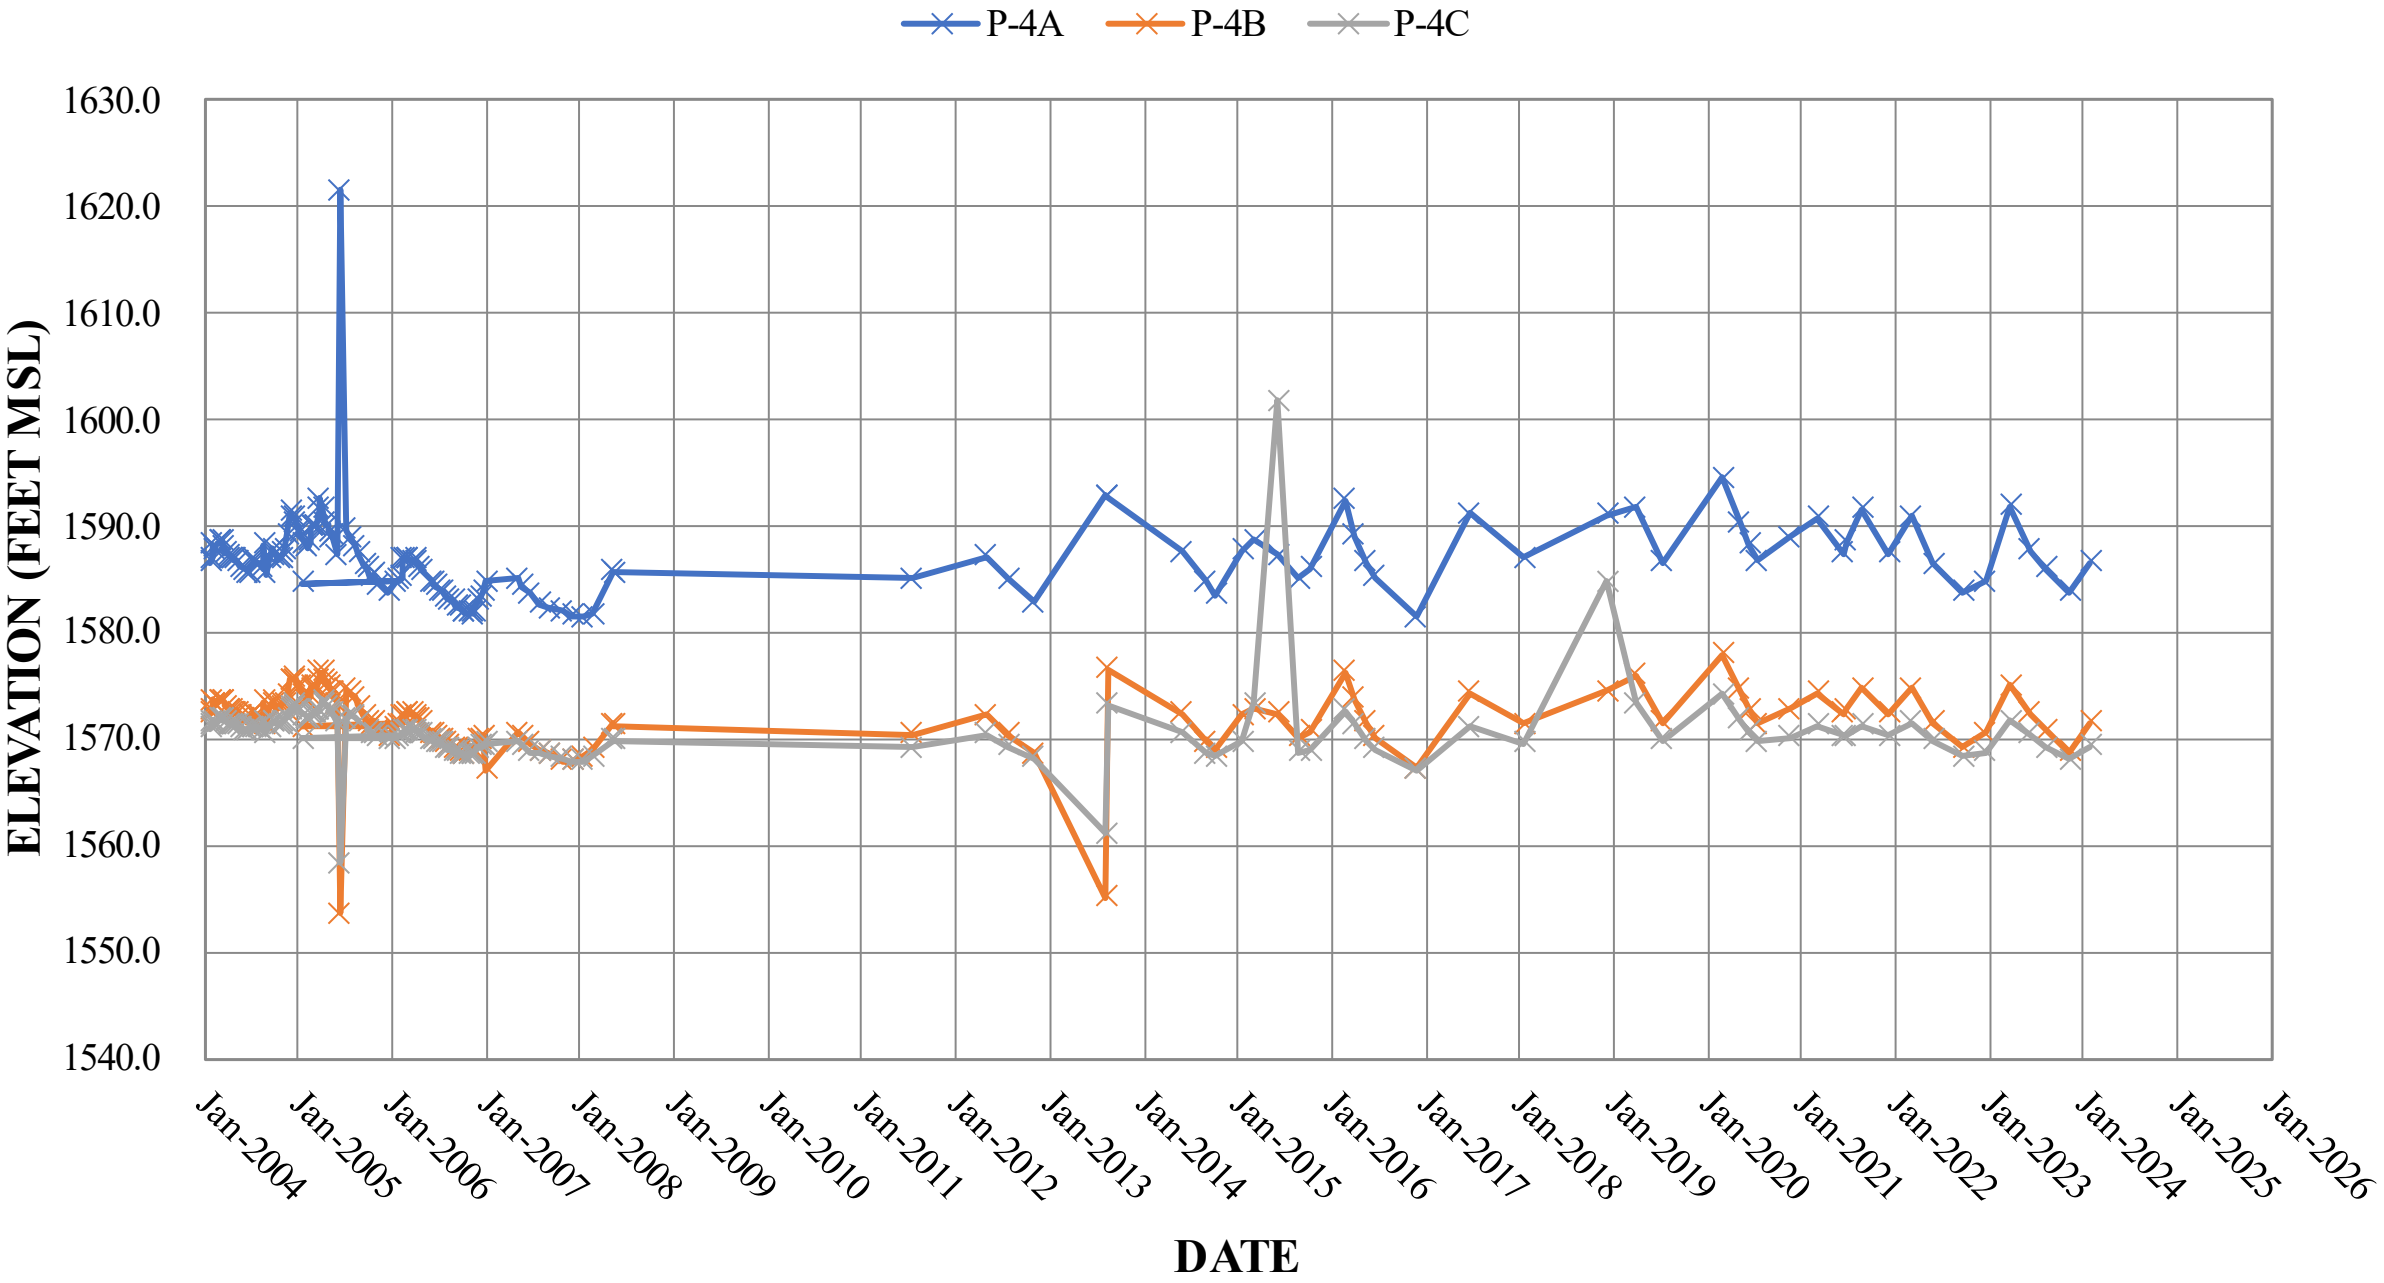
Vibrating Wire Piezometer Water Elevations

Note: Historical data anomalies generally appear to be the result of transcription errors.

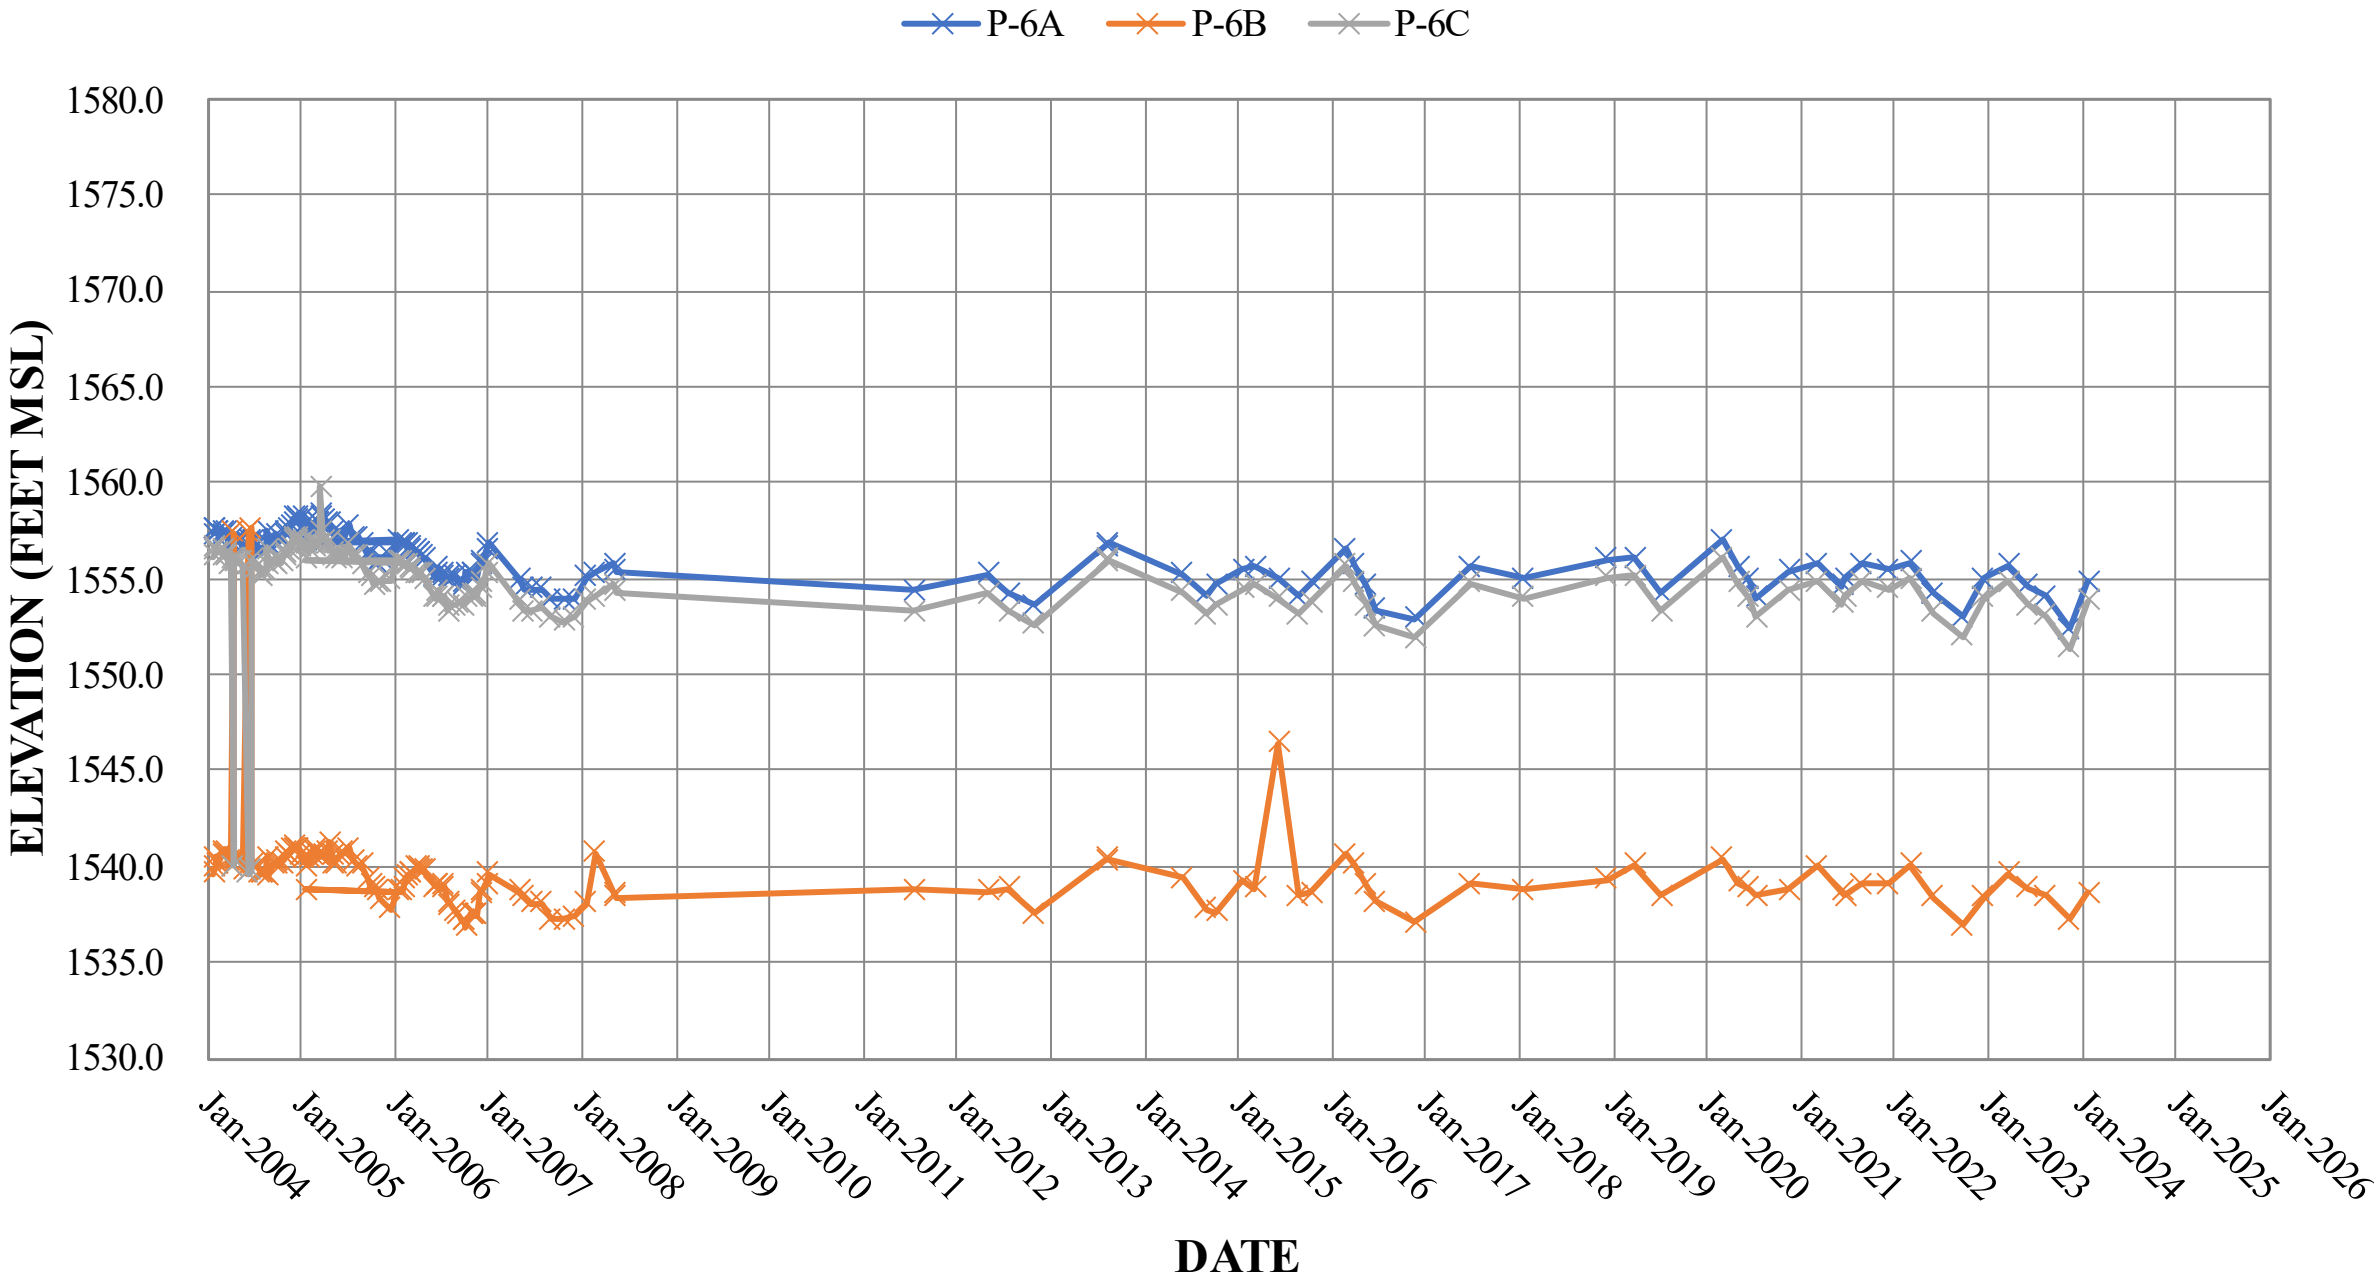
Vibrating Wire Piezometer Water Elevations

Note: Historical data anomalies generally appear to be the result of transcription errors.

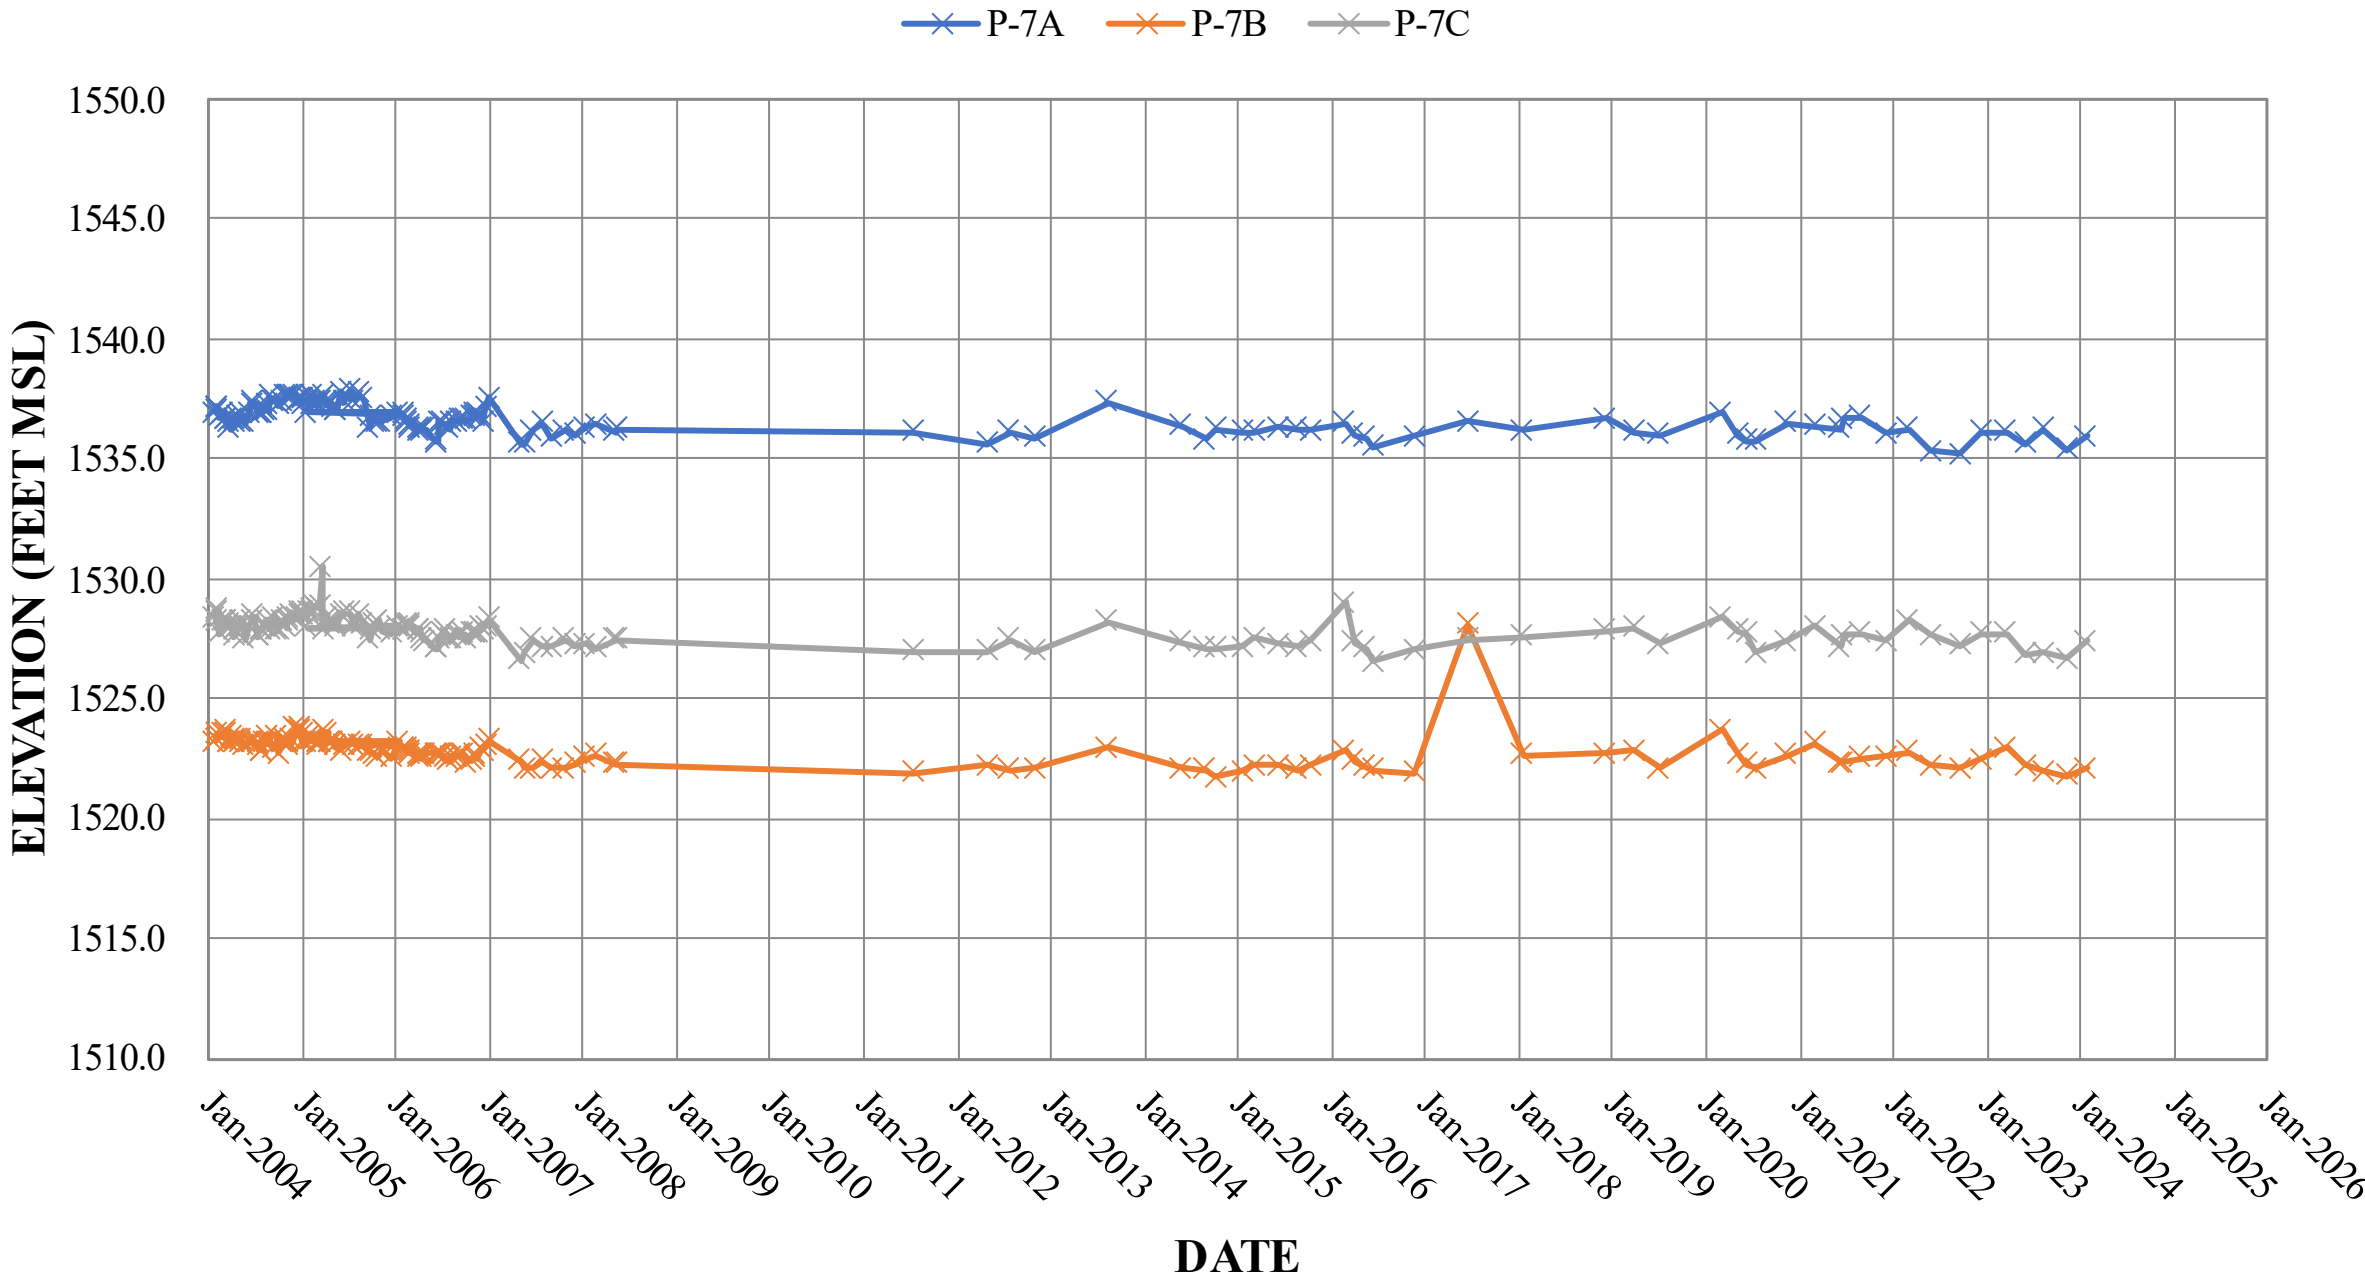
Vibrating Wire Piezometer Water Elevations

Note: Historical data anomalies generally appear to be the result of transcription errors.

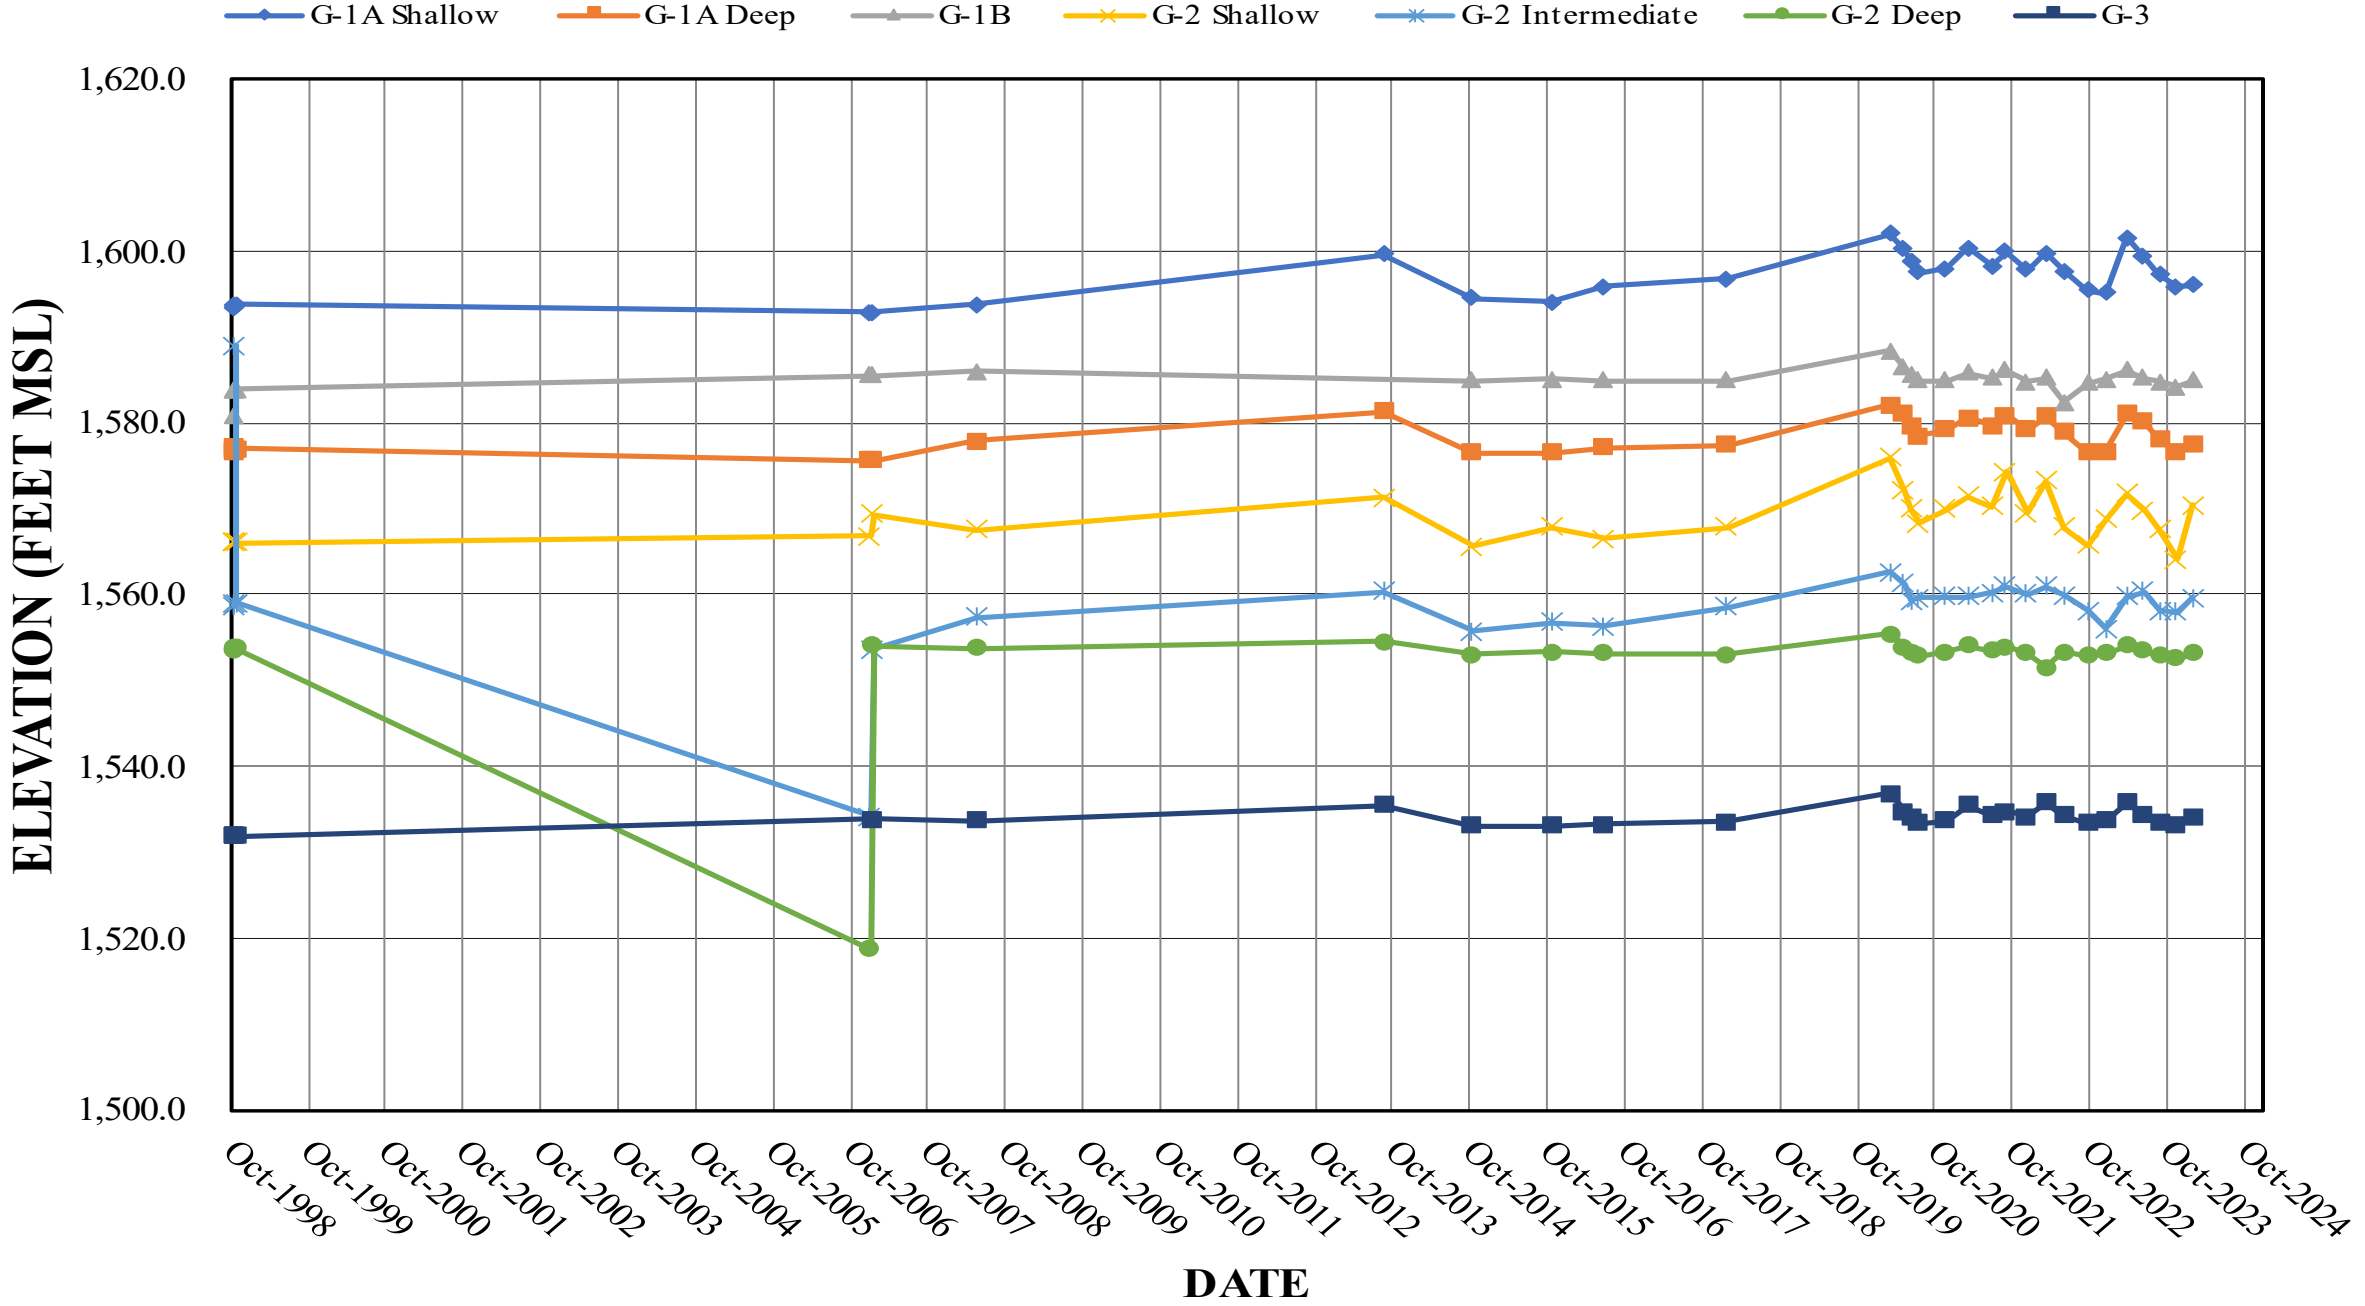
Standpipe Piezometer Water Elevations

Note: G-2 Shallow water levels noted as anomalous on 03 Jan 2007. Re-measured 19 Jan 2007, and levels more consistent with previous readings.
