**LAKE PETIT DAM**  
**Pickens County, Georgia**  
**State ID No. 112-009-00462**  
**NID No. GA00685**  
**Emergency Action Plan**

**Geosyntec Consultants, Inc.**

November 2021

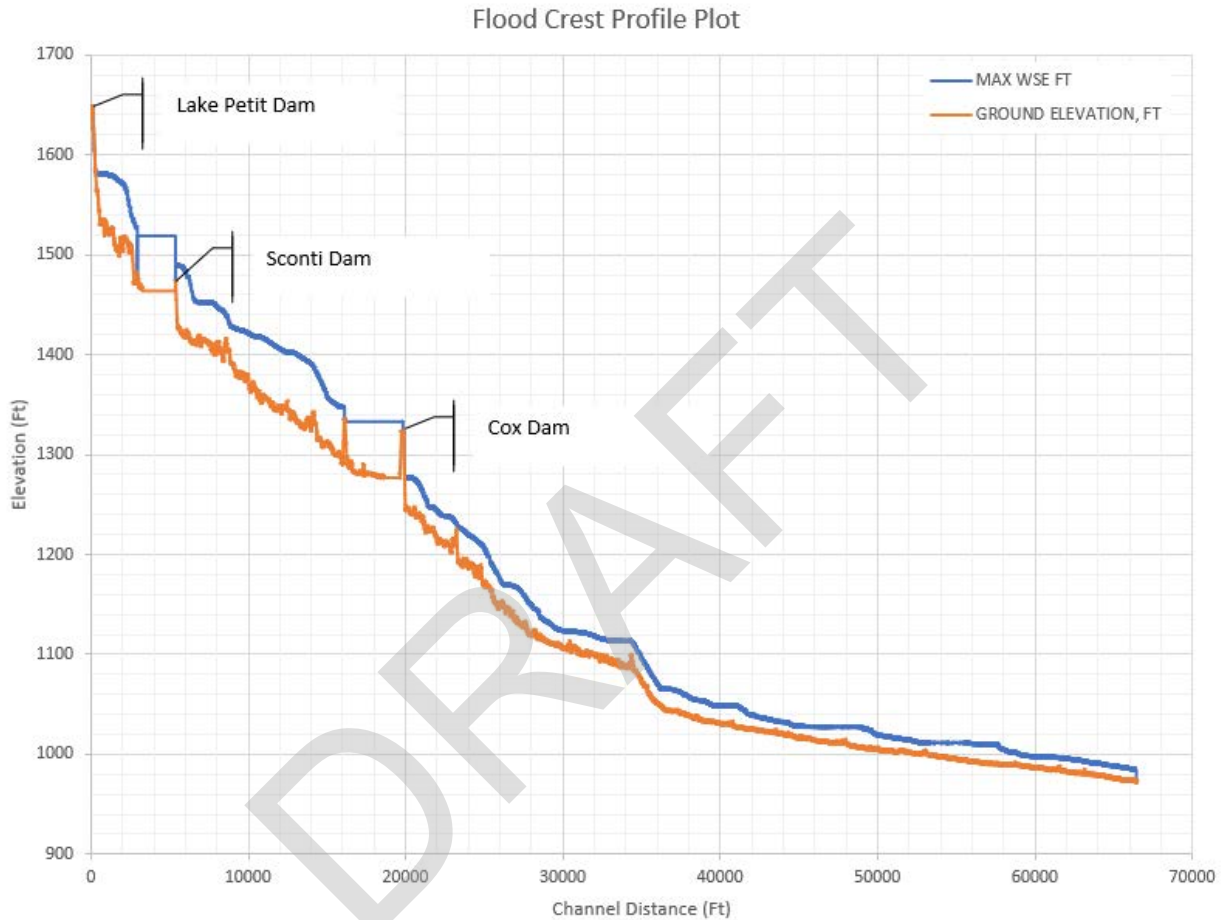
**Figure 3: Flood Crest Profile Plot**

Figure 3 presents the flood crest profile plot showing the three dams mentioned. Lake Petit Dam and Sconti Dam breached as they were overtopped by two (2) feet. Cox Dam did not breach. The depth of overtopping for all structures are presented in Table 7. See Attachment J for hydrographs at each of the points of interest listed in Table 7.

Based on the profile plot (Figure 3), Lake Cox Dam appears to overtop with depth greater than two feet indicating breach of Lake Cox Dam however computation message from HEC-RAS and hydrograph directly taken from HEC-RAS confirm that Lake Cox Dam did not breach. The maximum water surface elevation at Lake Cox Dam is 1,333 feet and the dam crest is at 1,335.5 feet as seen in terrain profile. The ground elevation as seen in the profile plots are based on a profile line that goes through the spillway and thus shows a lower ground elevation of approximately 1,324 feet. See Figure 4 for terrain profile of Lake Cox Dam and Figure 5 for zoomed in flood crest profile plot at Lake Cox Dam.

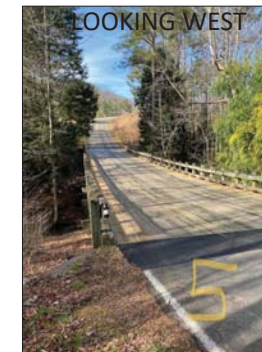
### SITE 5 GOLF COURSE ROAD

Big Canoe Stream Sections  
Pickens County, Georgia

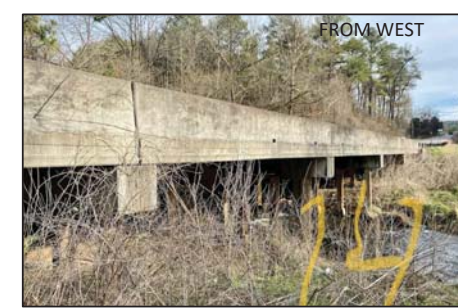
**SITE 14  
STATE ROUTE 53  
(NEAR HARRINGTON RD)**

**SITES:**  
 11 - OLD MILL WHITE ROAD  
 12 - OLD MILL WHITE ROAD  
 13 - McARTHUR ROAD  
 14 - STATE ROUTE 53 (HARRINGTON RD)

**Big Canoe Stream Sections**  
 Pickens County, Georgia
