LAKE PETIT DAM

Emergency Action Plan

Geosyntec Consultants, Inc.

Document No. GA220320

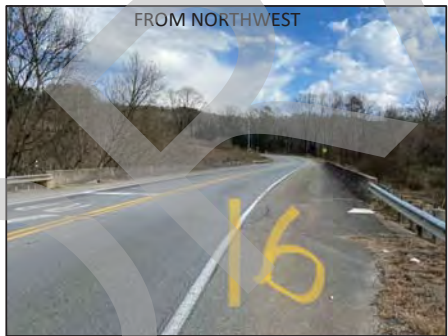
SITES:
16 - IMERYS ENTRANCE DRIVE
15 - STATE ROUTE 53
17 - STATE ROUTE 53

Big Canoe Stream Sections
Pickens County, Georgia
