LAKE PETIT DAM

Emergency Action Plan

Geosyntec Consultants, Inc.

October 2022

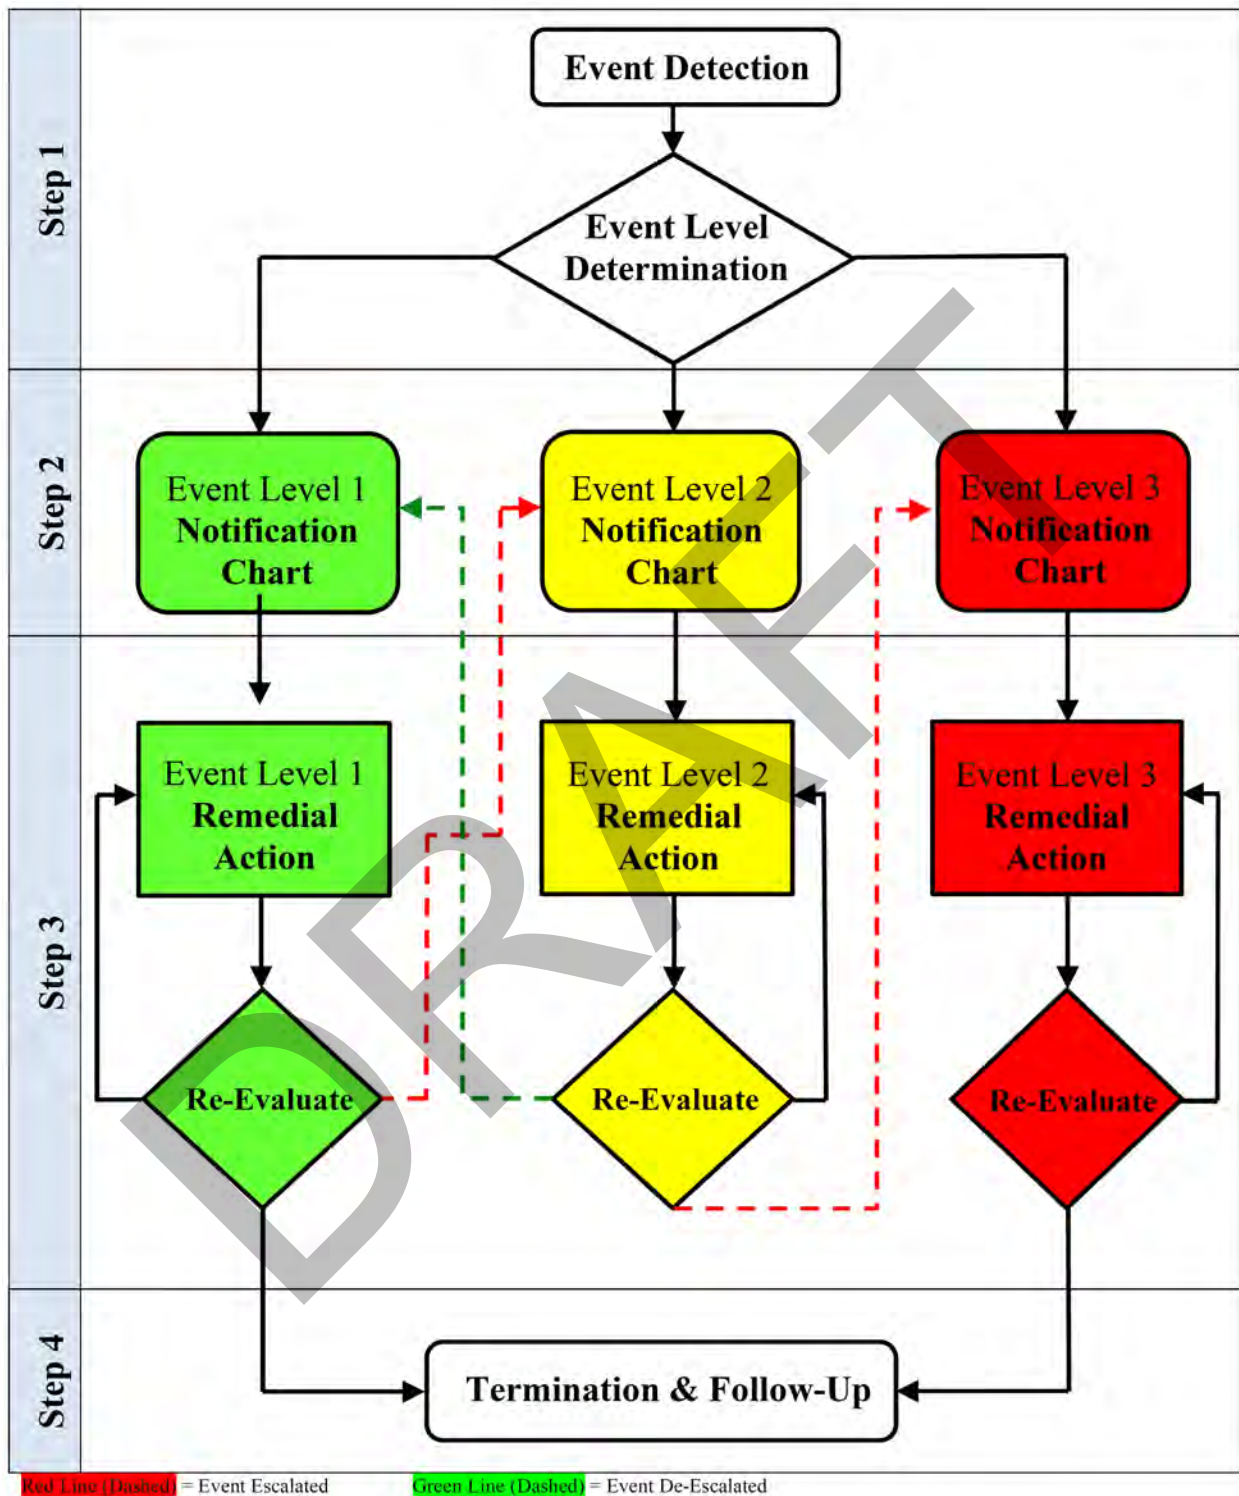
Figure 6 – EAP Process Overview Flowchart

There are four steps that must be followed anytime an unusual or emergency event is detected at the Dam. The steps are described in the following sections. An EAP Process Overview Flowchart outlining the following steps is provided in Figure 6 – EAP Process Overview Flowchart. The forms that should be used to document unusual or emergency events are provided in Appendix E (E-1: Contact Checklist; E-2: Condition B (Level 2) or C (Level 3) Event Log; and E-3: Dam Emergency Situation Report forms).

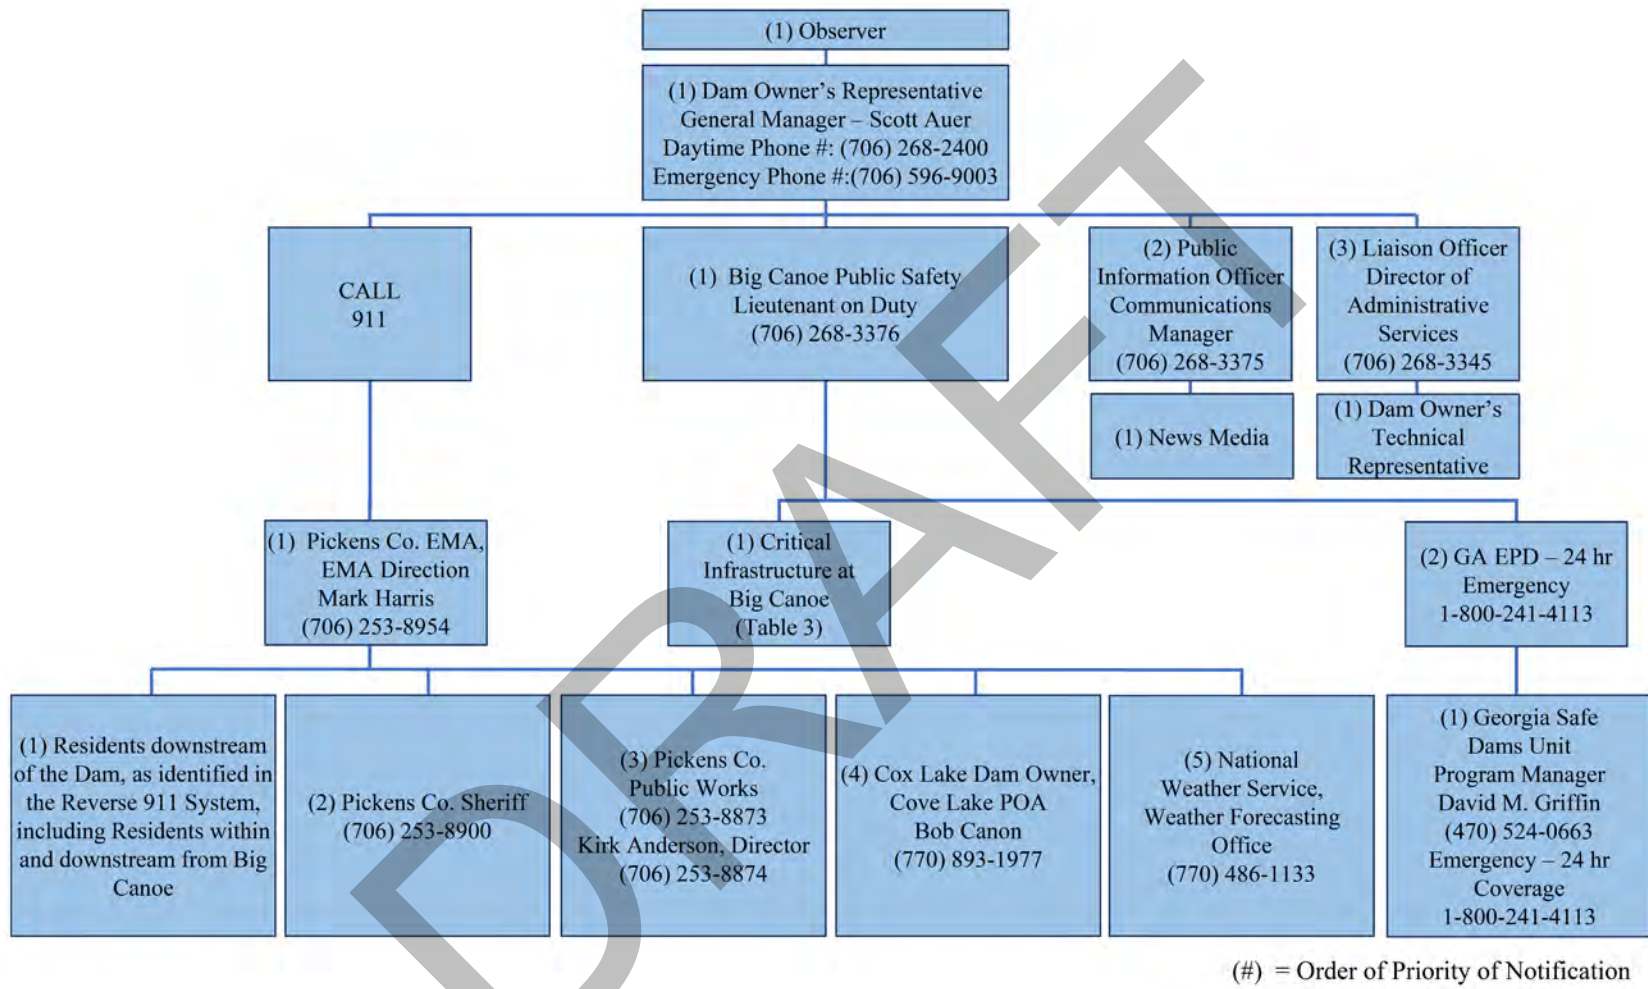
Figure 8: Dam Failure Notification Flowchart for **Conditions B (Level 2)** & **C (Level 3)** Emergencies

The Notification Flowcharts (Figures 7 and 8) summarize the following information which is applicable during an impending or imminent failure of the Dam:

- a) If a Condition A (Level 1) is determined, initiate Figure 7 – Dam Failure Notification Flowchart for Condition A (Level 1) Emergencies;
- b) If a Condition B (Level 2) is determined, initiate the preplanned actions in Table 5 – Preplanned Actions for Emergency Condition B (Level 2), and Figure 8 – Dam Failure Notification Flowchart for Condition B (Level 2) & C (Level 3) Emergencies; and
- c) If a Condition C (Level 3) is determined, initiate Figure 8 – Dam Failure Notification Flowchart for Condition B (Level 2) and C (Level 3) Emergencies.

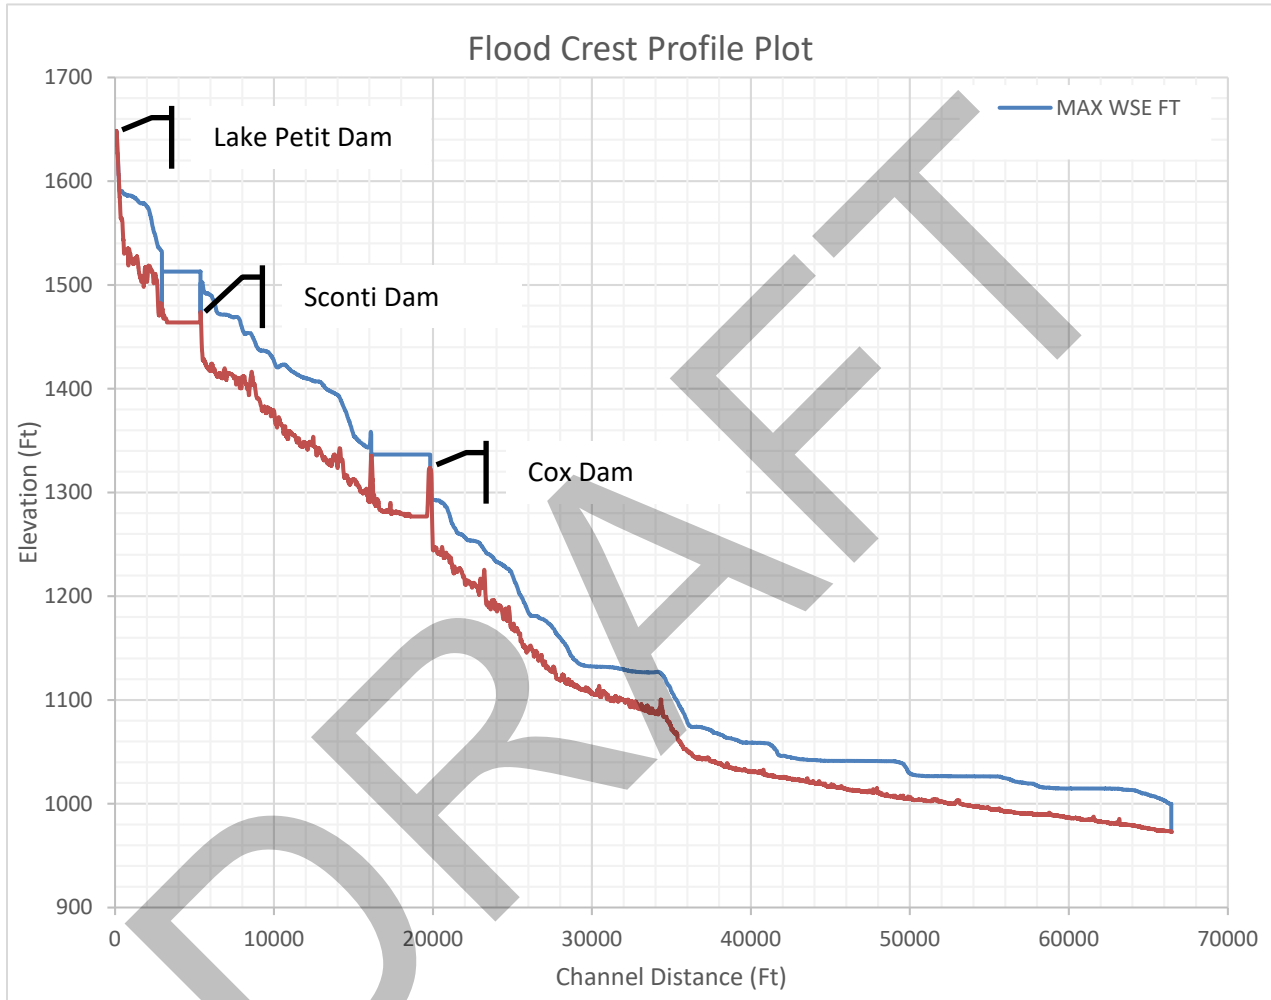
Figure 3: Flood Crest Profile Plot

Figure 3 presents the flood crest profile plot showing the three dams mentioned. Lake Petit Dam and Sconti Dam breached as they were overtopped by two (2) feet. Cox Dam did not breach. The depth of overtopping for all structures are presented in Table 7. See Attachment J for hydrographs at each of the points of interest listed in Table 7.

Based on the profile plot (Figure 3), Lake Cox Dam appears to overtop with depth greater than two feet indicating breach of Lake Cox Dam however, computation message from HEC-RAS and hydrograph directly taken from HEC-RAS confirm that Lake Cox Dam overtopped by one foot and did not breach. The maximum water surface elevation at Lake Cox Dam is 1,336.5 feet and the dam crest is at 1,335.5 feet as seen in terrain profile. The ground elevation as seen in the profile plots are based on a profile line that goes through the spillway and thus shows a lower ground elevation of approximately 1,324 feet. See Figure 4 for terrain profile of Lake Cox Dam and Figure 5 for zoomed in flood crest profile plot at Lake Cox Dam.

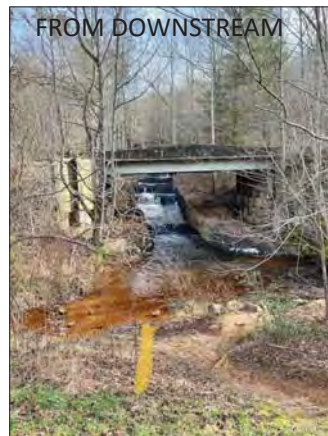
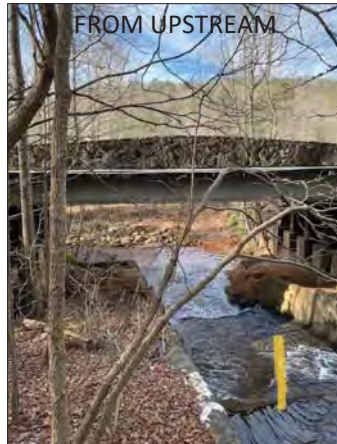
SITE 1 WOLFSCRATCH DRIVE

PETTIT CREEK

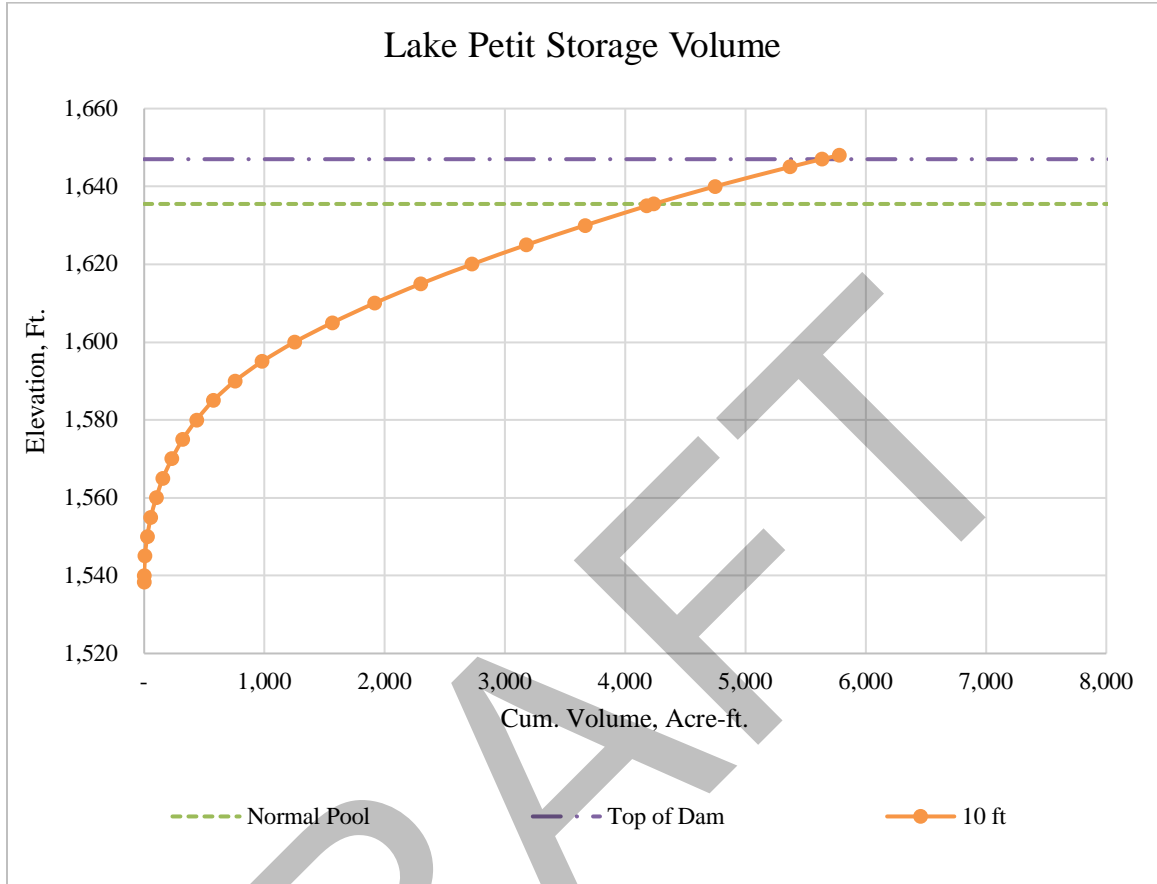
1. Lake Petit Stage-storage Table

Elevation (ft)	Volume (Acre-ft)
1,538.38	0
1,540	0.4
1,560	100
1,580	435
1,600	1250
1,620	2725
1,635	4180
1,647	5635
1,648	5780

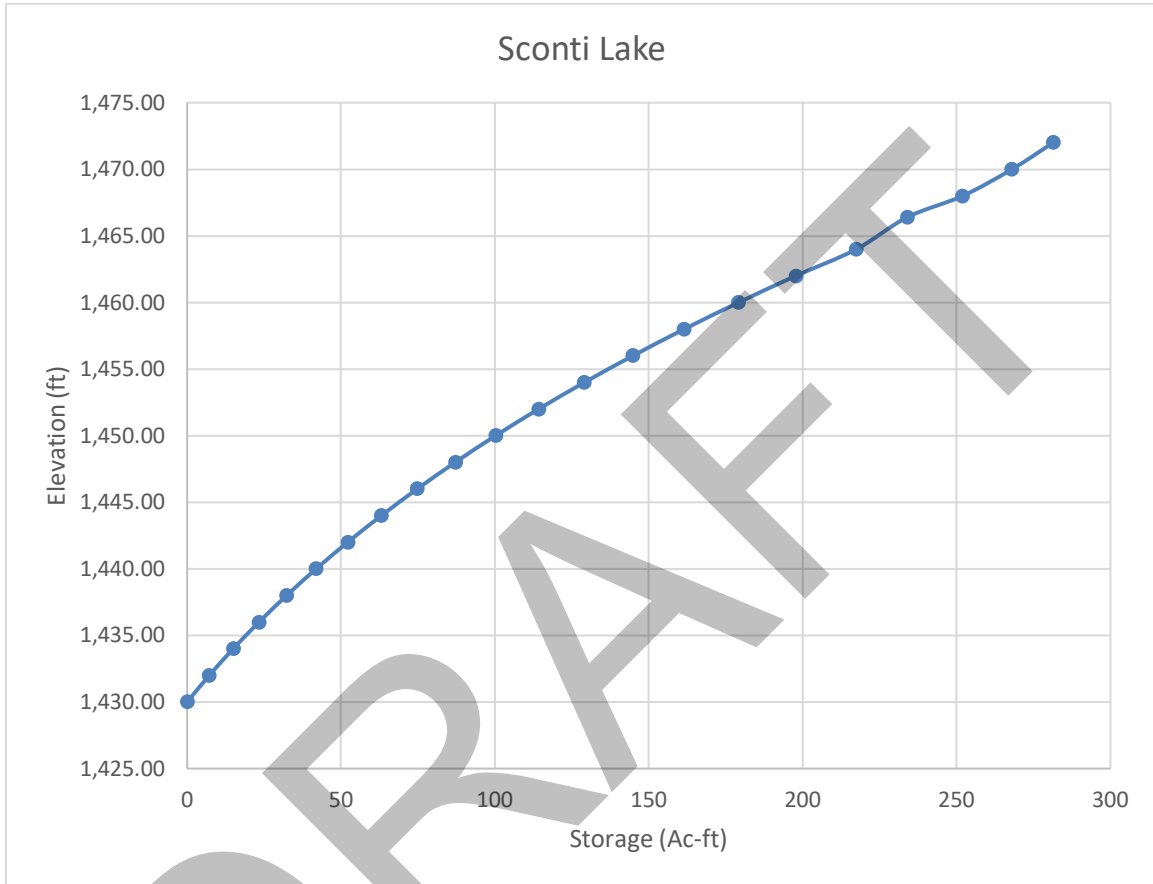
2. Lake Sconti Stage-storage Table

Elevation (ft)	Volume (Acre-ft)
1,430.00	0
1,432.00	7.21
1,434.00	14.99
1,436.00	23.36
1,438.00	32.34
1,440.00	41.95
1,442.00	52.21
1,444.00	63.15
1,446.00	74.79
1,448.00	87.14
1,450.00	100.27
1,452.00	114.26
1,454.00	129.12
1,456.00	144.88
1,458.00	161.56
1,460.00	179.21
1,462.00	197.83
1,464.00	217.46
1,466.40	234
1,468.00	252
1,470.00	268
1,472.00	281.40

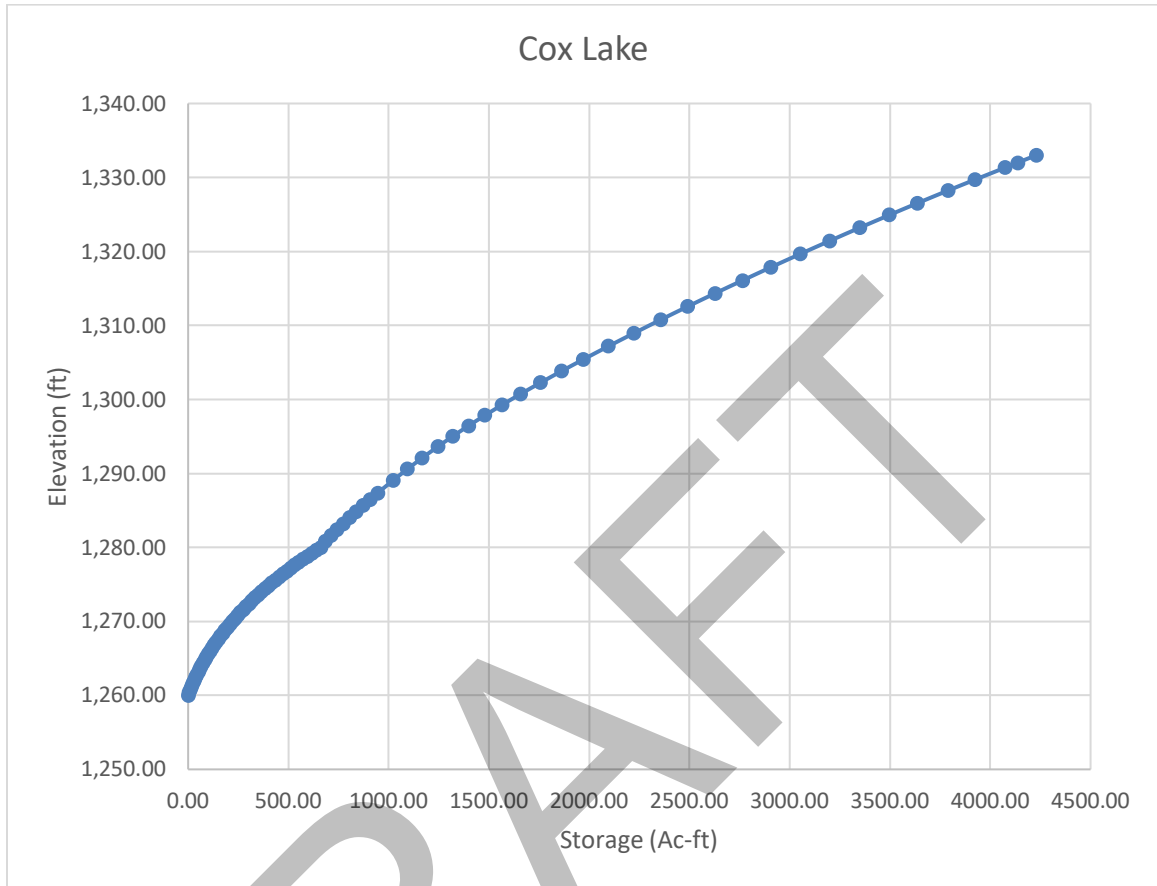
3. Lake Cox Stage-storage Table

Elevation (ft)	Volume (Acre-ft)
1,260.00	0.00
1,260.40	5.57
1,260.80	11.38
1,261.20	17.42
1,261.60	23.71
1,262.00	30.25
1,262.40	37.05
1,262.80	44.10
1,263.20	51.42
1,263.60	59.00
1,264.00	66.86
1,264.40	75.00
1,264.80	83.42
1,265.20	92.13
1,265.60	101.13
1,266.00	110.43
1,266.40	120.03
1,266.80	129.94
1,267.20	140.16
1,267.60	150.70
1,268.00	161.57
1,268.40	172.75
1,268.80	184.27
1,269.20	196.13
1,269.60	208.33
1,270.00	220.87
1,270.40	233.77
1,270.80	247.02
1,271.20	260.63
1,271.60	274.61
1,272.00	288.95
1,272.40	303.68
1,272.80	318.78
1,273.20	334.27
1,273.60	350.15
1,274.00	366.42

Elevation (ft)	Volume (Acre-ft)
1,274.40	383.09
1,274.80	400.17
1,275.20	417.66
1,275.60	435.56
1,276.00	453.88
1,276.40	472.62
1,276.80	491.79
1,277.20	511.40
1,277.60	531.44
1,278.00	551.93
1,278.40	572.86
1,278.80	594.25
1,279.20	616.09
1,279.60	638.40
1,280.00	661.18
1,280.83	685.85
1,281.60	713.28
1,282.39	742.58
1,283.19	772.93
1,284.00	804.74
1,284.82	837.71
1,285.65	872.23
1,286.49	907.89
1,287.34	944.58
1,289.04	1,021.15
1,290.60	1,094.26
1,292.10	1,167.52
1,293.61	1,244.65
1,295.01	1319.24
1,296.44	1,398.50
1,297.84	1,479.73
1,299.28	1,566.68
1,300.75	1,658.89
1,302.25	1,756.54
1,303.81	1,860.78
1,305.43	1,972.16
Elevation (ft)	Volume (Acre-ft)

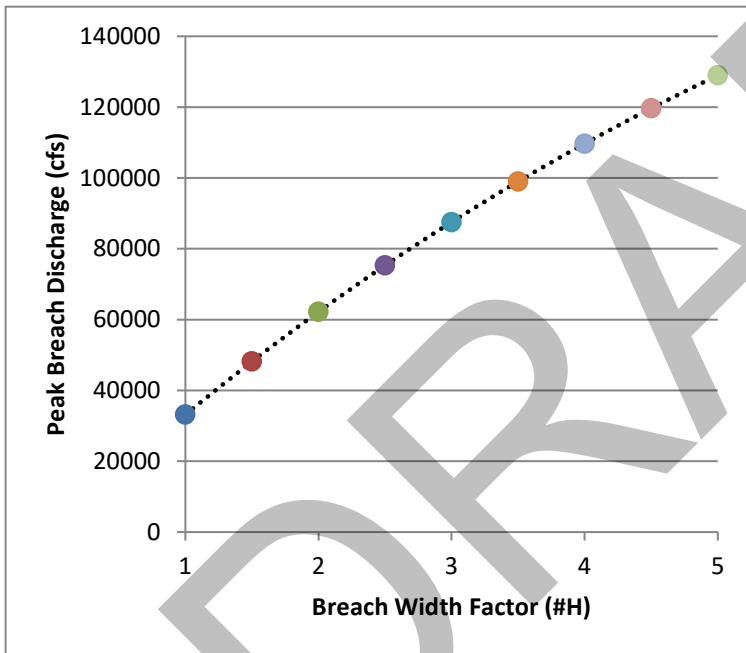
Factor	Breach Width (feet)	C	Q_b (cfs)
[H]	42	78.39	33168
[1.5H]	63	52.26	48158
[2H]	84	39.20	62174
[2.5H]	105	31.36	75279
[3H]	126	26.13	87530
[3.5H]	147	22.40	98979
[4.0H]	168	19.60	109678
[4.5H]	189	17.42	119671
[5.0H]	210	15.68	129003

Peak Breach Discharge: 129002.8 cfs

Avg. Breach Width (ft) from previous sheet:	120
Time of failure (hrs) from previous sheet:	0.27
Height of water above breach bottom (ft):	42
Reservoir Surface Area at Failure (acres):	140.7
Discharge through spillways at failure (Q_o , cfs):	0
