**LAKE PETIT DAM**  
**Pickens County, Georgia**  
**State ID No. 112-009-00462**  
**NID No. GA00685**  
**Emergency Action Plan**

**Geosyntec Consultants, Inc.**

Document No. GA220320

December 2022

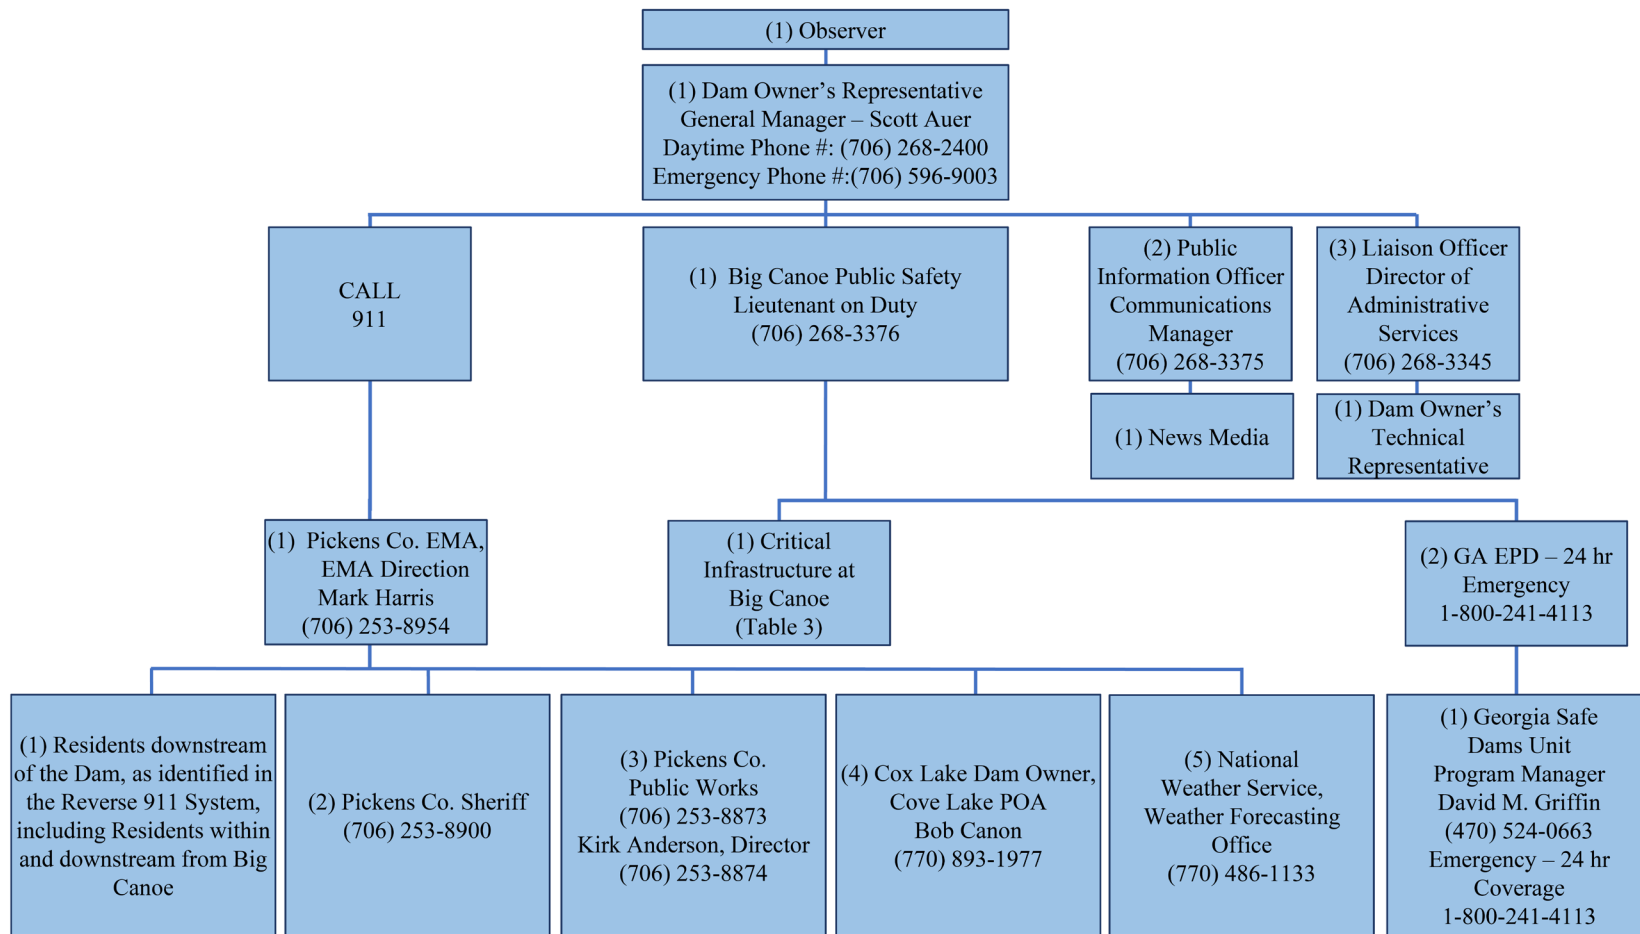
**Figure 8:** Dam Failure Notification Flowchart for **Conditions B (Level 2)** & **C (Level 3)** Emergencies

(#) = Order of Priority of Notification

The Notification Flowcharts (Figures 7 and 8) summarize the following information which is applicable during an impending or imminent failure of the Dam:

- a) If a Condition A (Level 1) is determined, initiate Figure 7 – Dam Failure Notification Flowchart for Condition A (Level 1) Emergencies;
- b) If a Condition B (Level 2) is determined, initiate the preplanned actions in Table 5 – Preplanned Actions for Emergency Condition B (Level 2), and Figure 8 – Dam Failure Notification Flowchart for Condition B (Level 2) & C (Level 3) Emergencies; and
- c) If a Condition C (Level 3) is determined, initiate Figure 8 – Dam Failure Notification Flowchart for Condition B (Level 2) and C (Level 3) Emergencies.

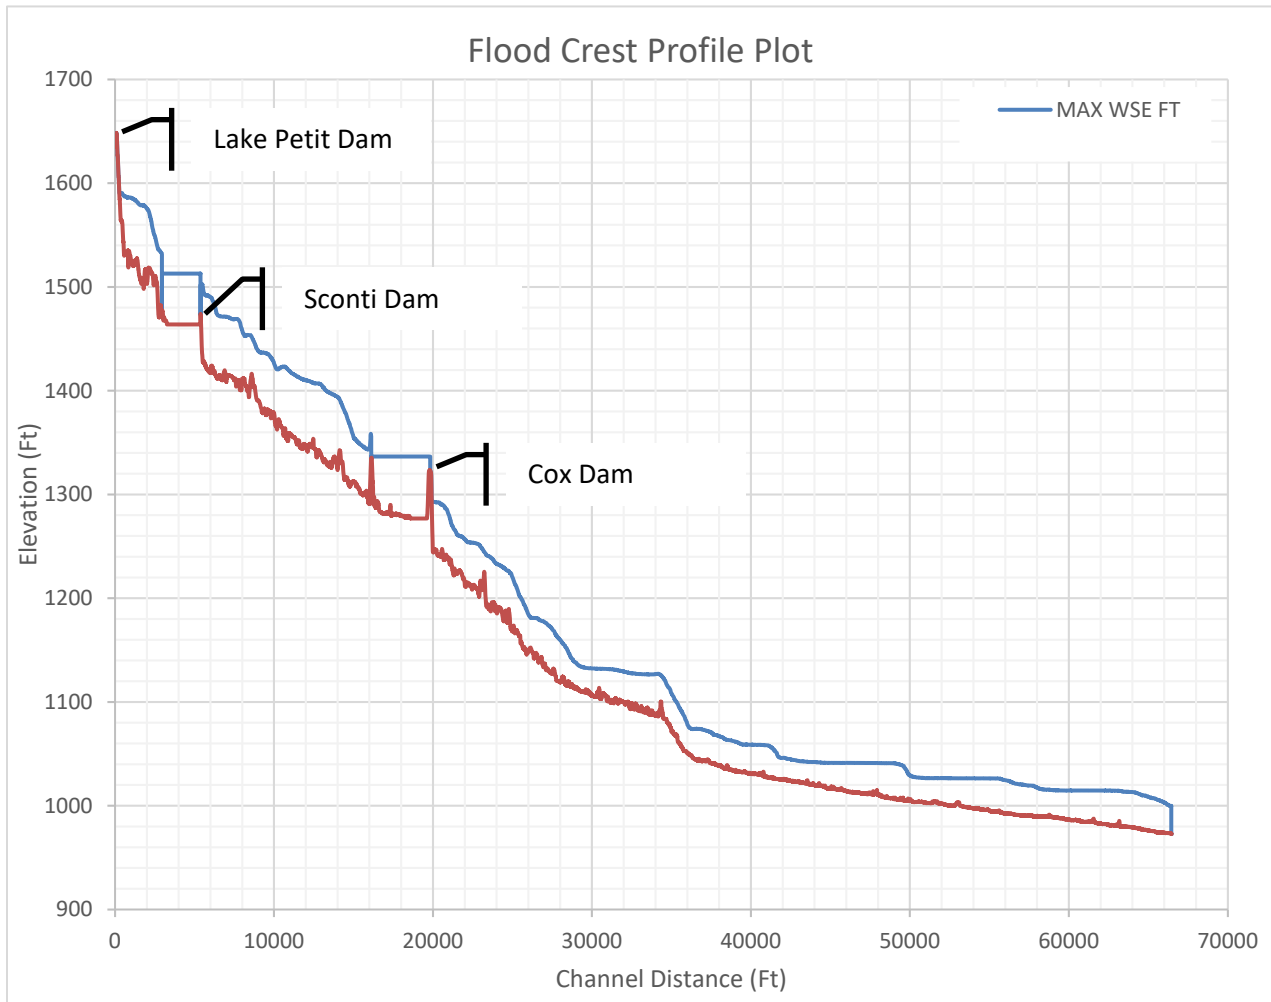
**Figure 3: Flood Crest Profile Plot**

Figure 3 presents the flood crest profile plot showing the three dams mentioned. Lake Petit Dam and Sconti Dam breached as they were overtopped by two (2) feet. Cox Dam did not breach. The depth of overtopping for all structures are presented in Table 7. See Attachment J for hydrographs at each of the points of interest listed in Table 7.

Based on the profile plot (Figure 3), Lake Cox Dam appears to overtop with depth greater than two feet indicating breach of Lake Cox Dam however, computation message from HEC-RAS and hydrograph directly taken from HEC-RAS confirm that Lake Cox Dam overtopped by one foot and did not breach. The maximum water surface elevation at Lake Cox Dam is 1,336.5 feet and the dam crest is at 1,335.5 feet as seen in terrain profile. The ground elevation as seen in the profile plots are based on a profile line that goes through the spillway and thus shows a lower ground elevation of approximately 1,324 feet. See Figure 4 for terrain profile of Lake Cox Dam and Figure 5 for zoomed in flood crest profile plot at Lake Cox Dam.

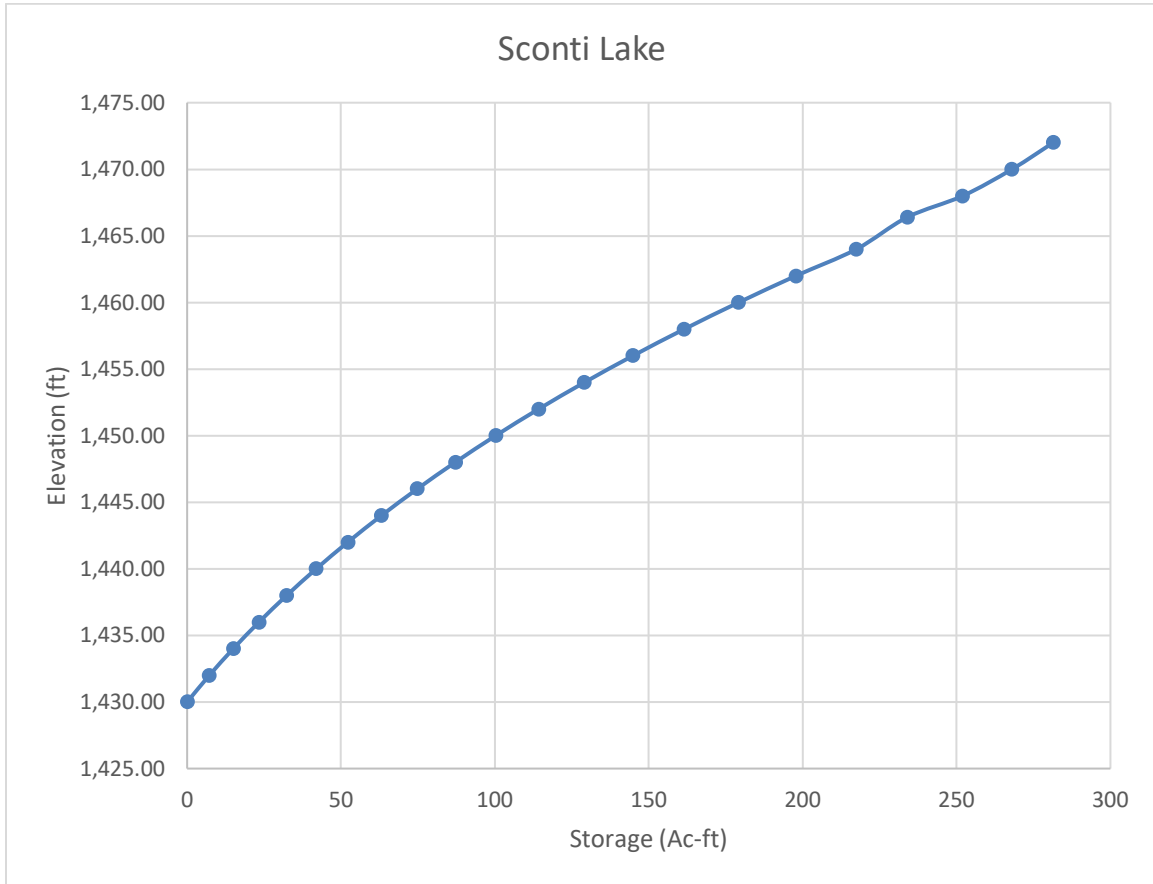
## 2. Lake Sconti Stage-storage Table

| Elevation (ft) | Volume (Acre-ft) |
