# LAKE PETIT DAM

## Operation and Maintenance Plan

**Big Canoe® Property Owners Association, Inc.**  
10586 Big Canoe  
Jasper, GA 30143  
Pickens County

**Geosyntec Consultants, Inc.**  
835 Georgia Avenue, Suite 500  
Chattanooga, TN 37402

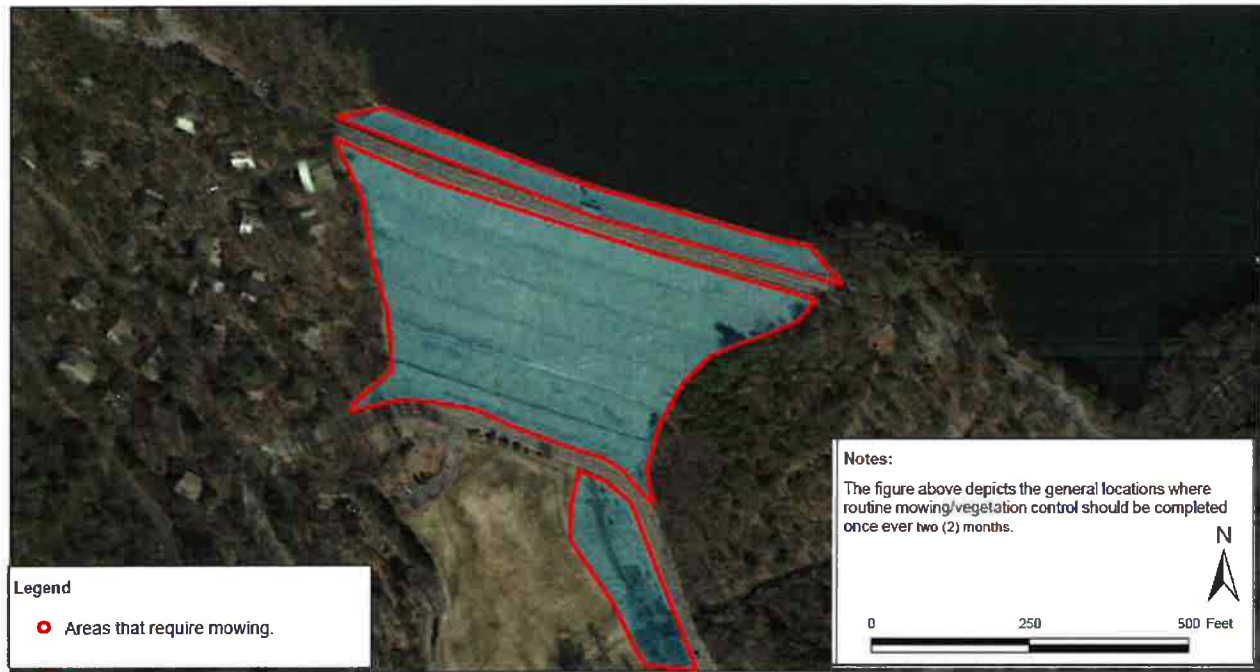
Figure 4 – Lake Petit Dam Mowing Plan

A figure depicting areas to be routinely mowed once every two (2) months is provided below as Figure 4. In general, the areas include the upstream and downstream slope, toe, and areas near the low-level discharge outlet.

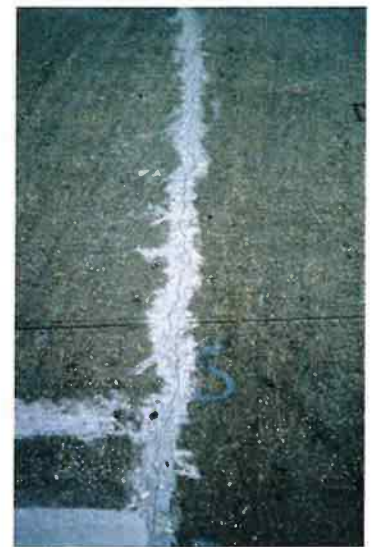
*Example of cracking.*

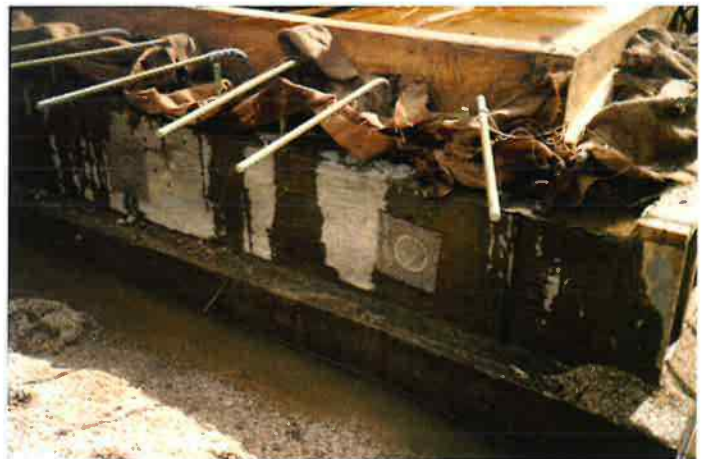
*Weep holes with screens to control seepage.*

are used to allow free drainage and relieve excessive hydrostatic pressures from building up underneath the structure. Excessive hydrostatic pressures underneath the concrete could cause it to heave or crack which increases the potential for accelerated deterioration and undermining. Periodic monitoring of the weep hole drains should be performed and documented on a regular and routine basis to ensure that they are functioning as designed.

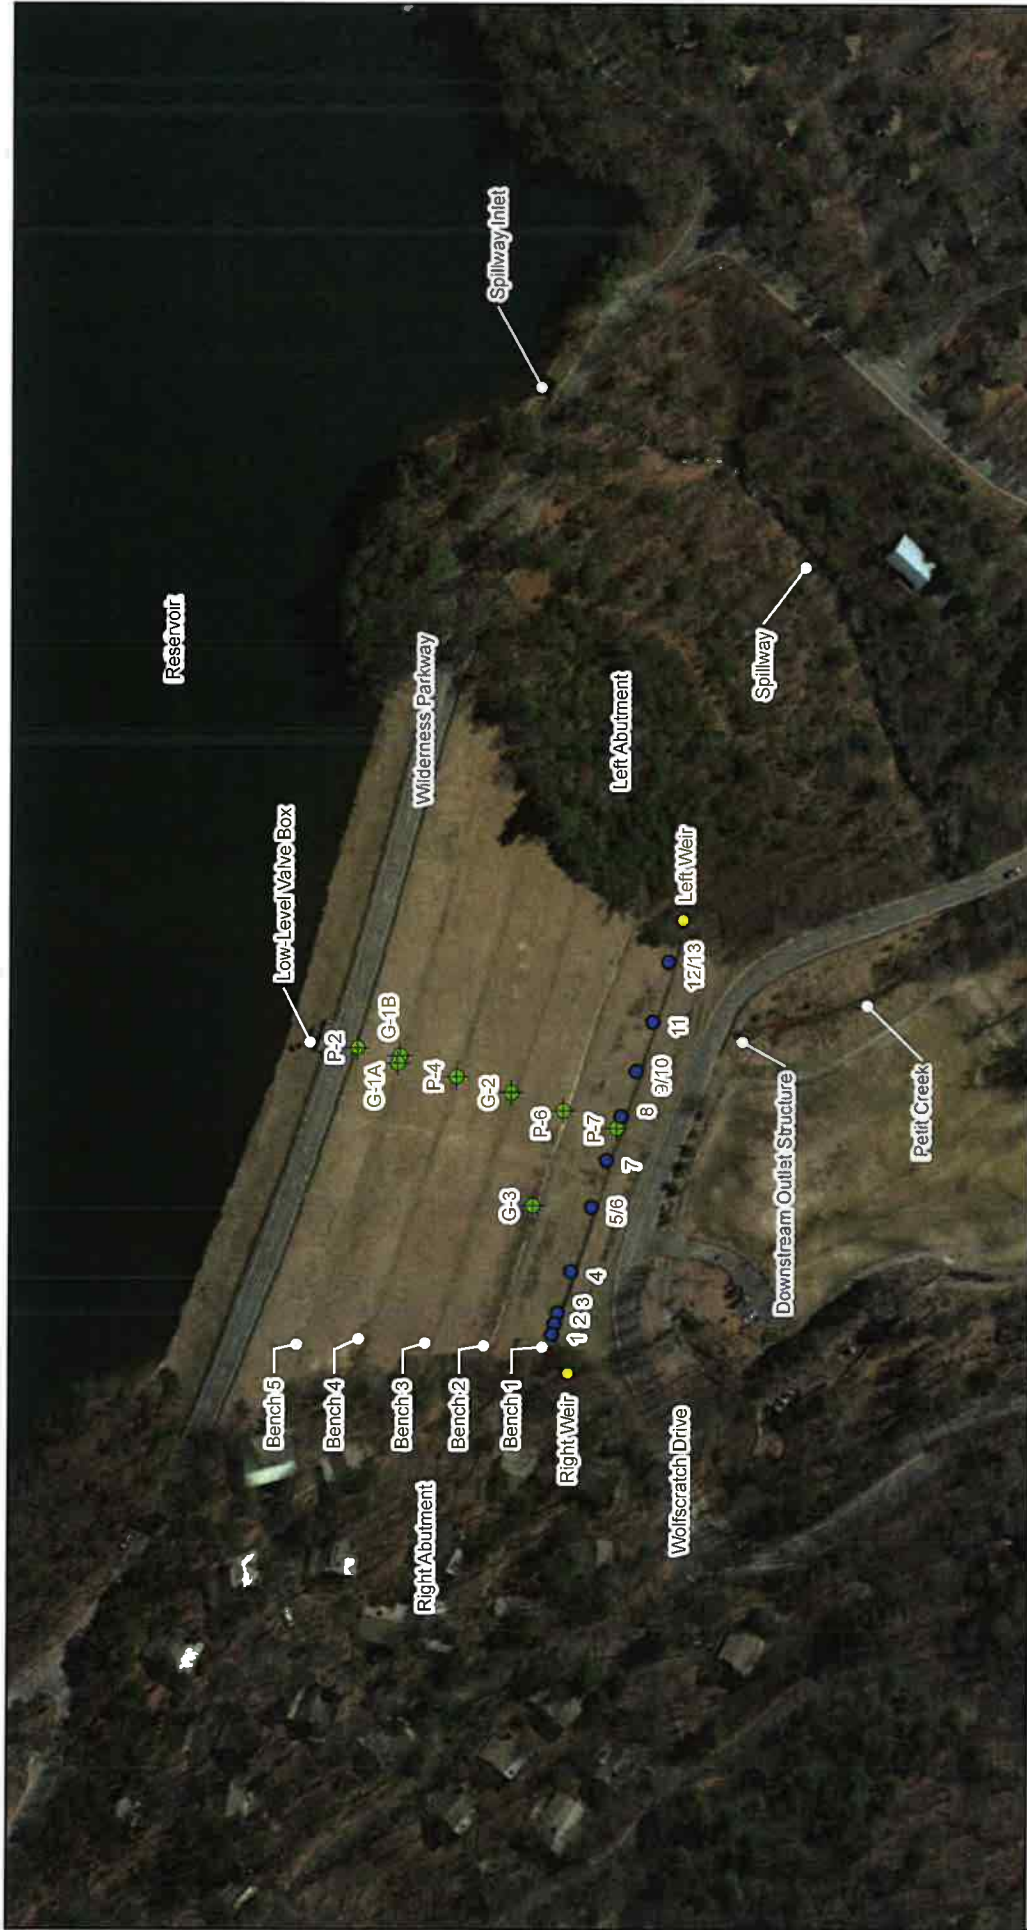
ATTACHMENT H

Lake Petit Dam Features
